Baptiste Creek Bridge Landslide

Design and Construction of Remedial Measures

THURBER ENGINEERING LTD.

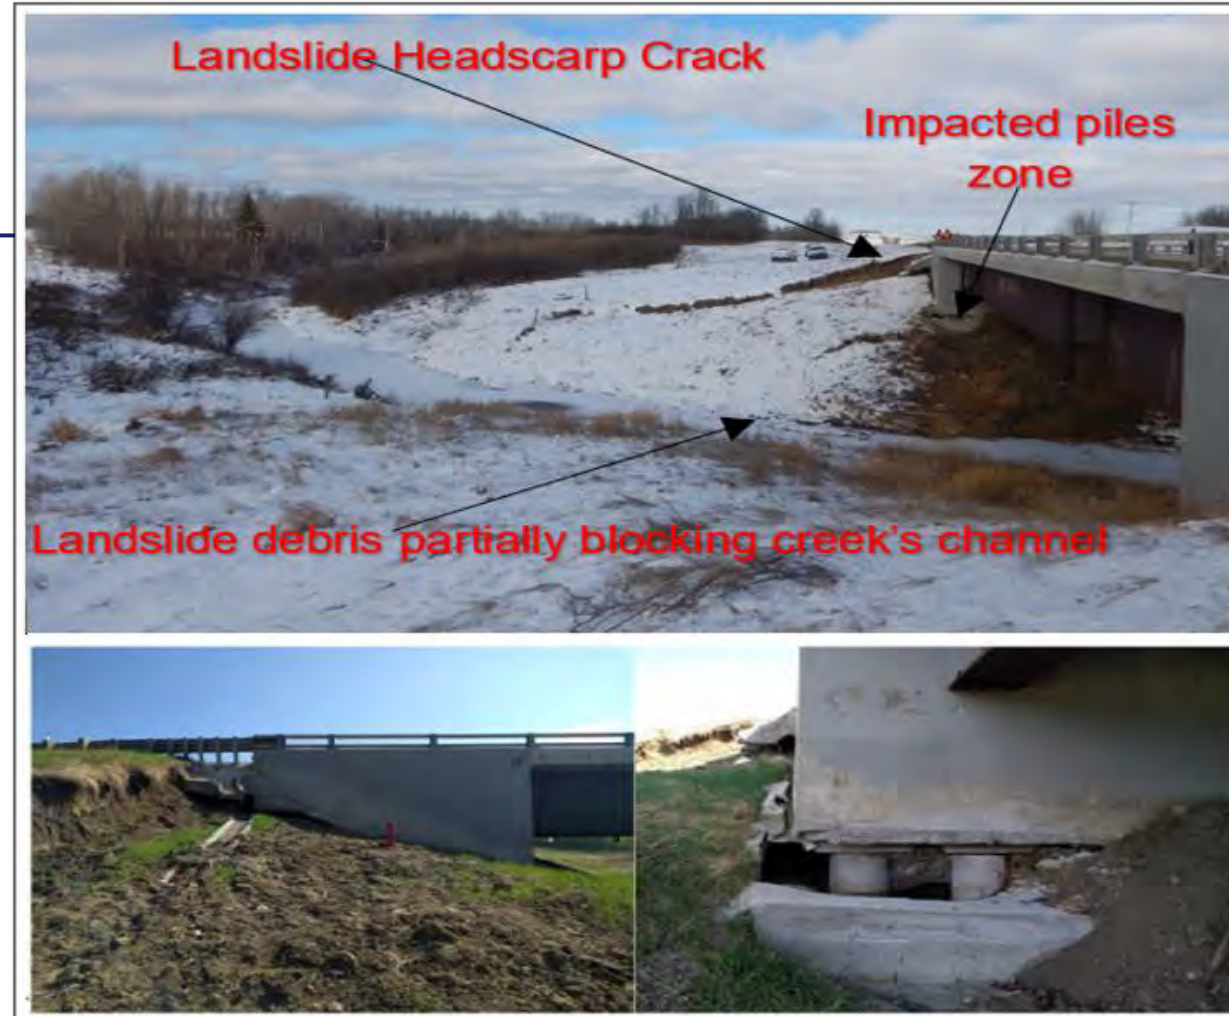
- Resulted in voids and a gap in the highway surface and exposed the underside of the wing wall and abutment seat
- Exposed two of the exterior pile casings
- Caused rotation of casings to jam against and restrain the piles movement during thermal expansion of the bridge structure
- Partially blocked the creeks channel

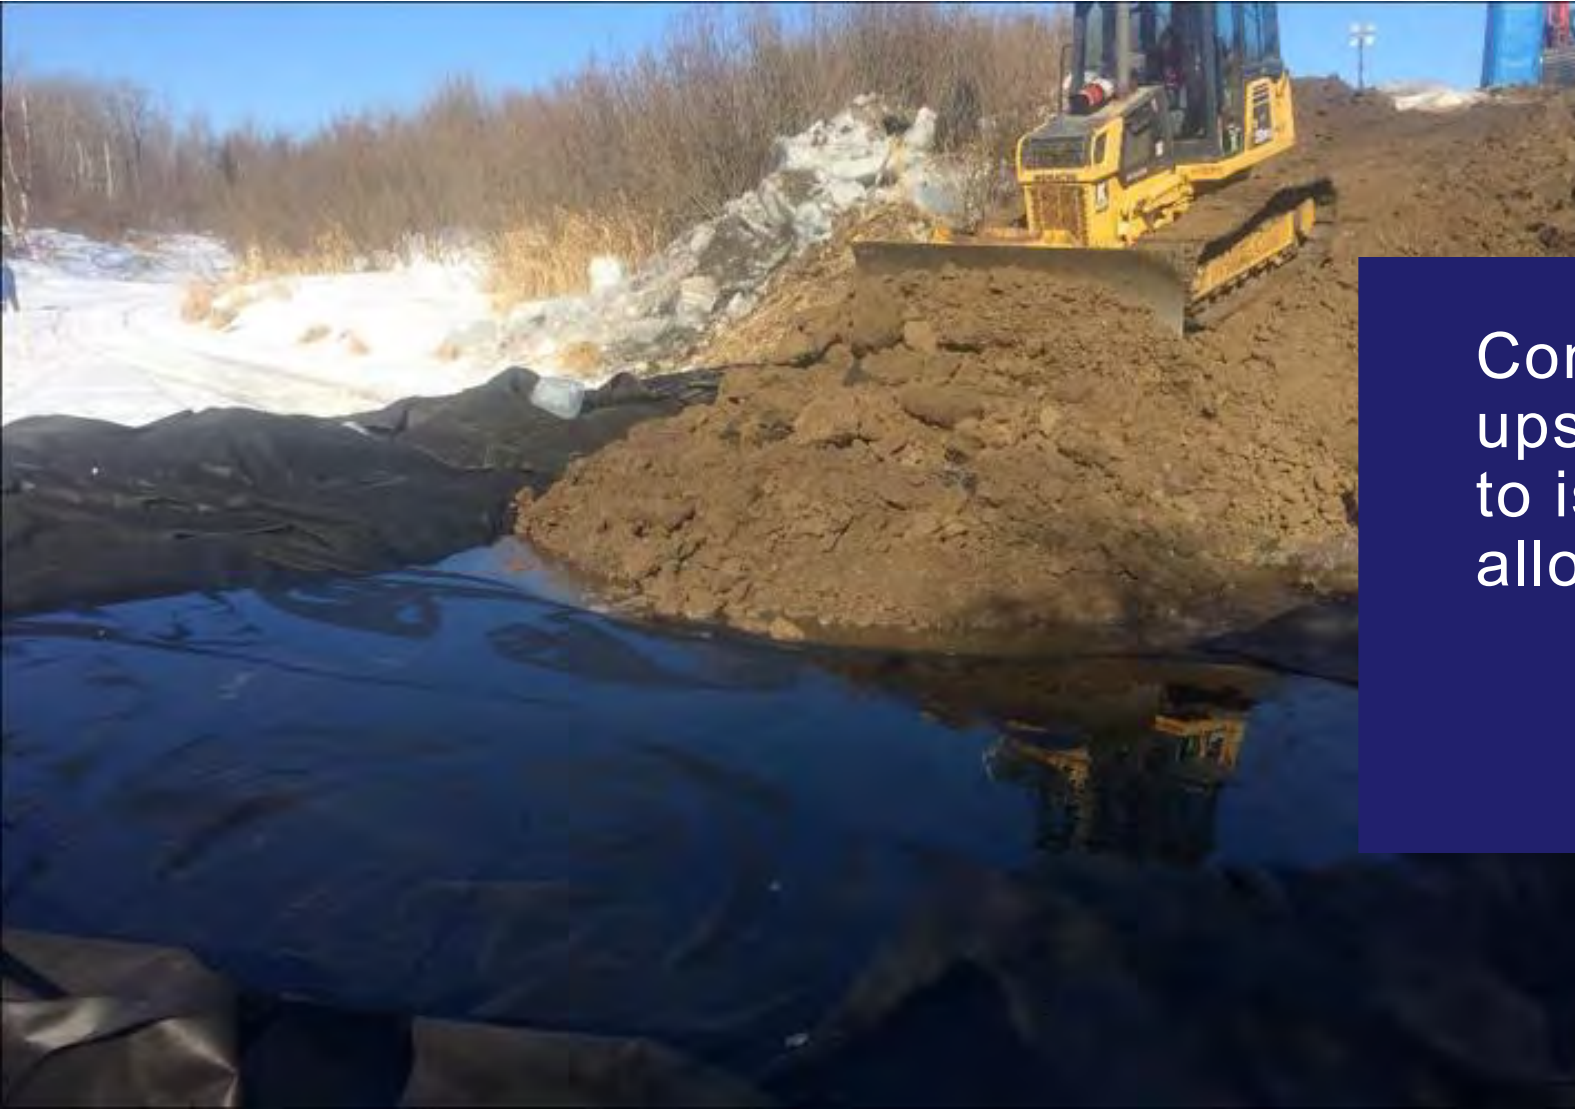
Construction of coffer dams upstream and downstream of site to isolate the working area to allow work under the bridge

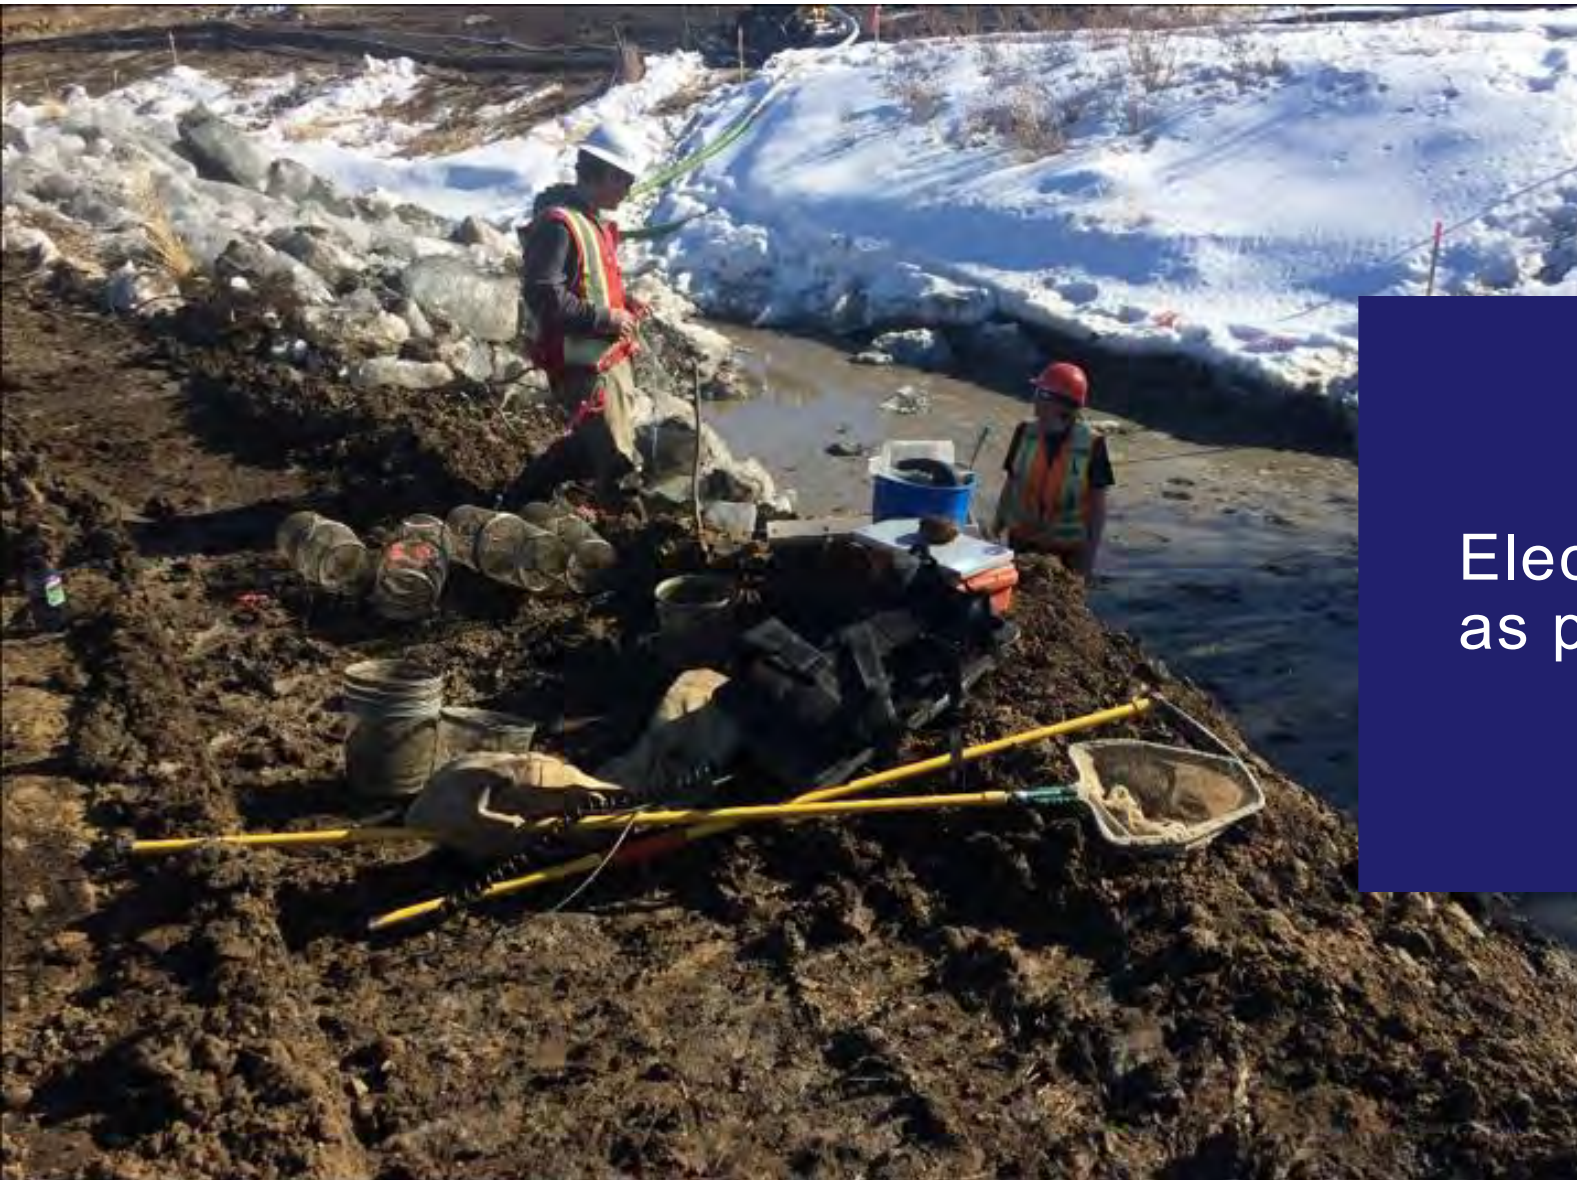
Electro fishing within isolated area
as part of care of water

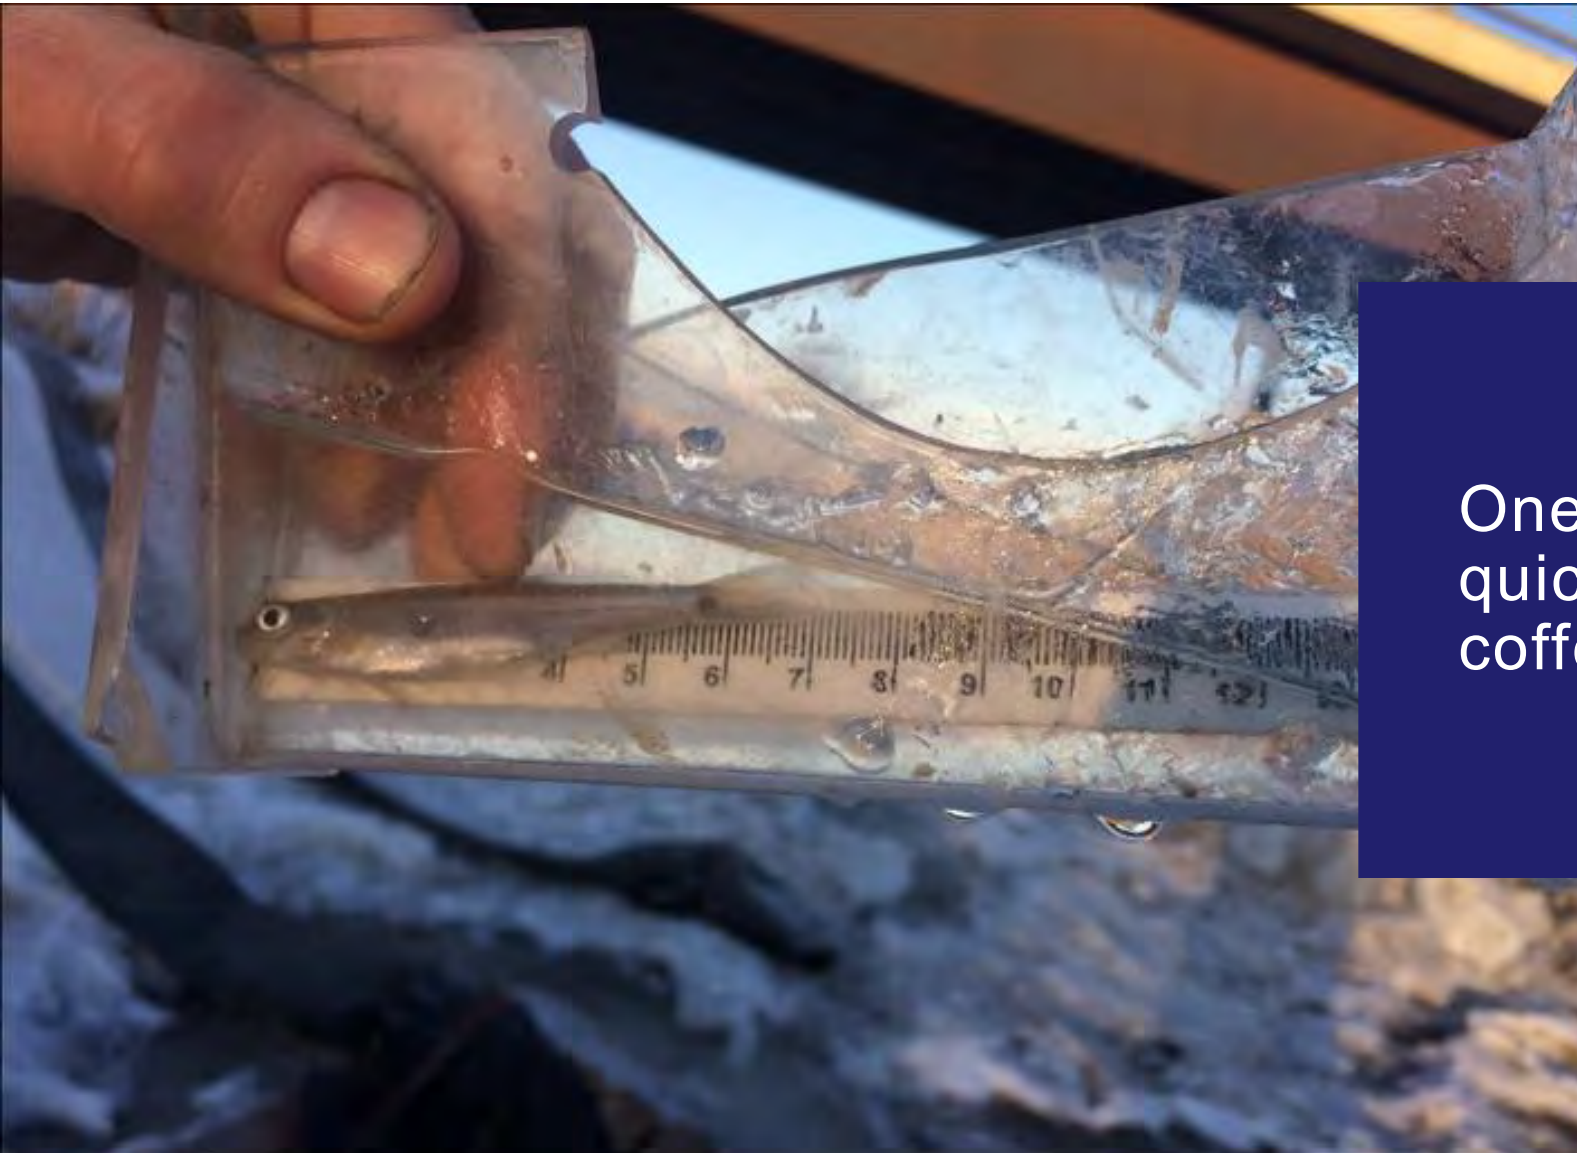
One fish was caught and quickly released downstream of coffer dam

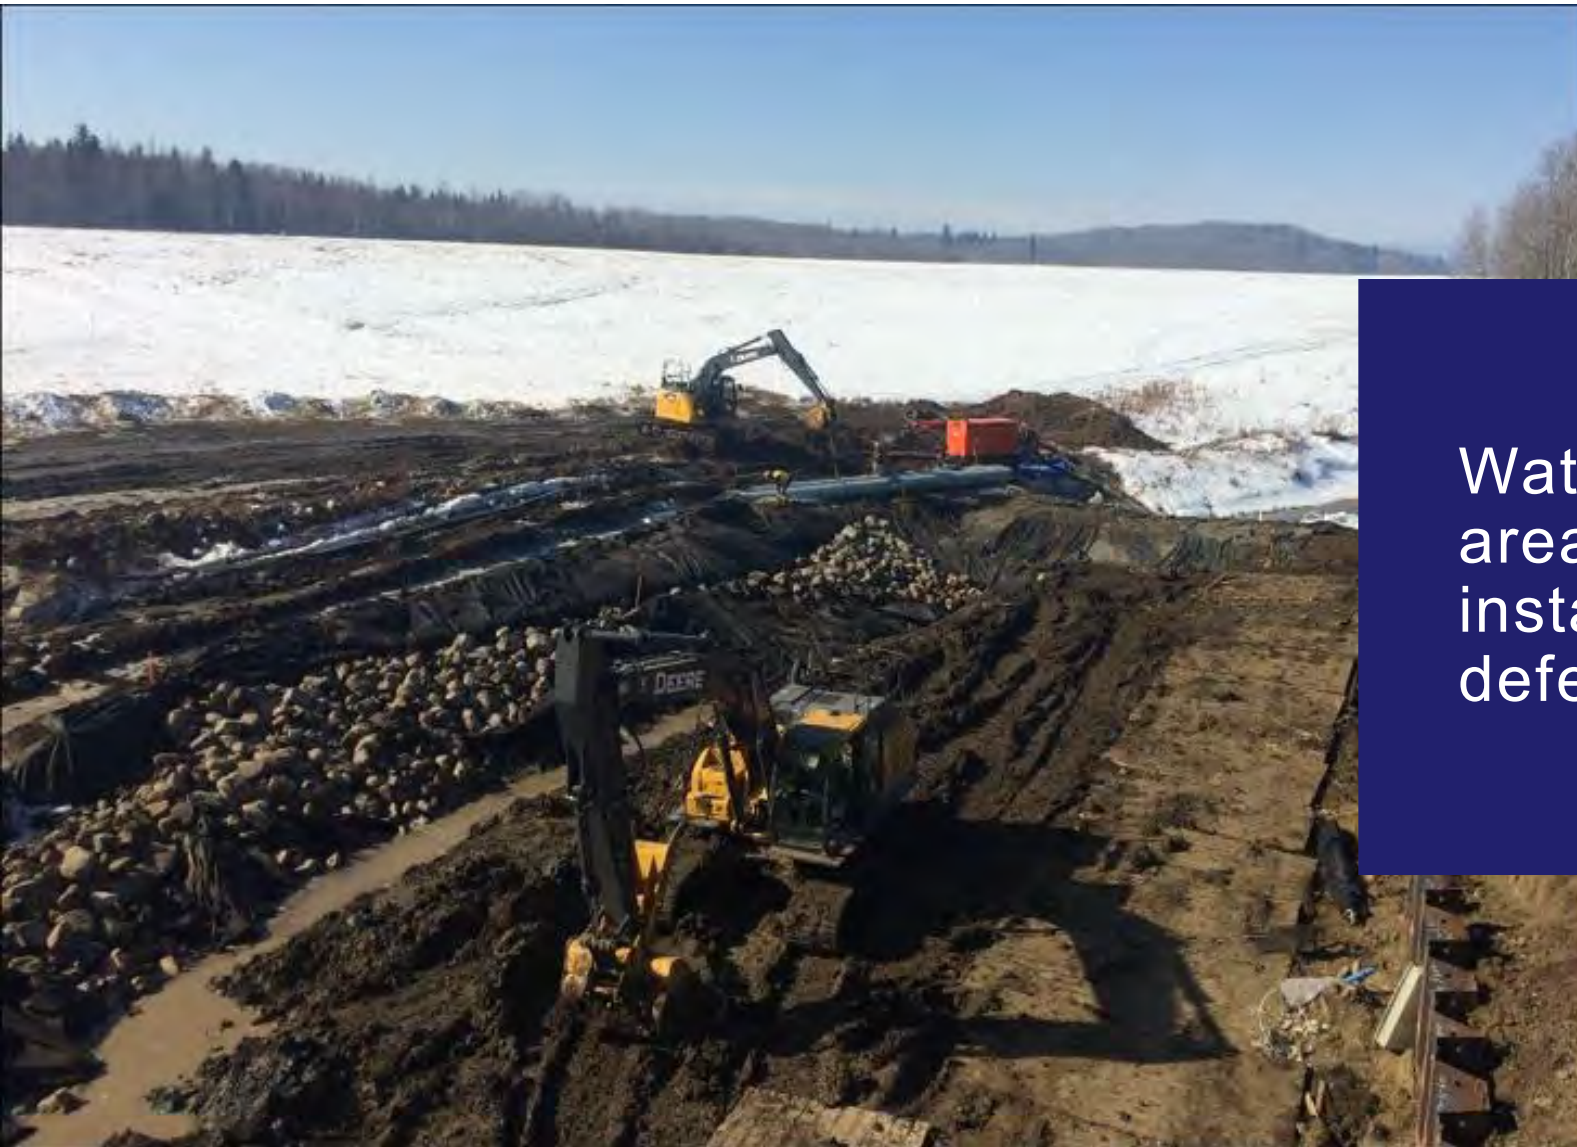
Water works within isolated area. Note overflow pipes being installed as second line of defense

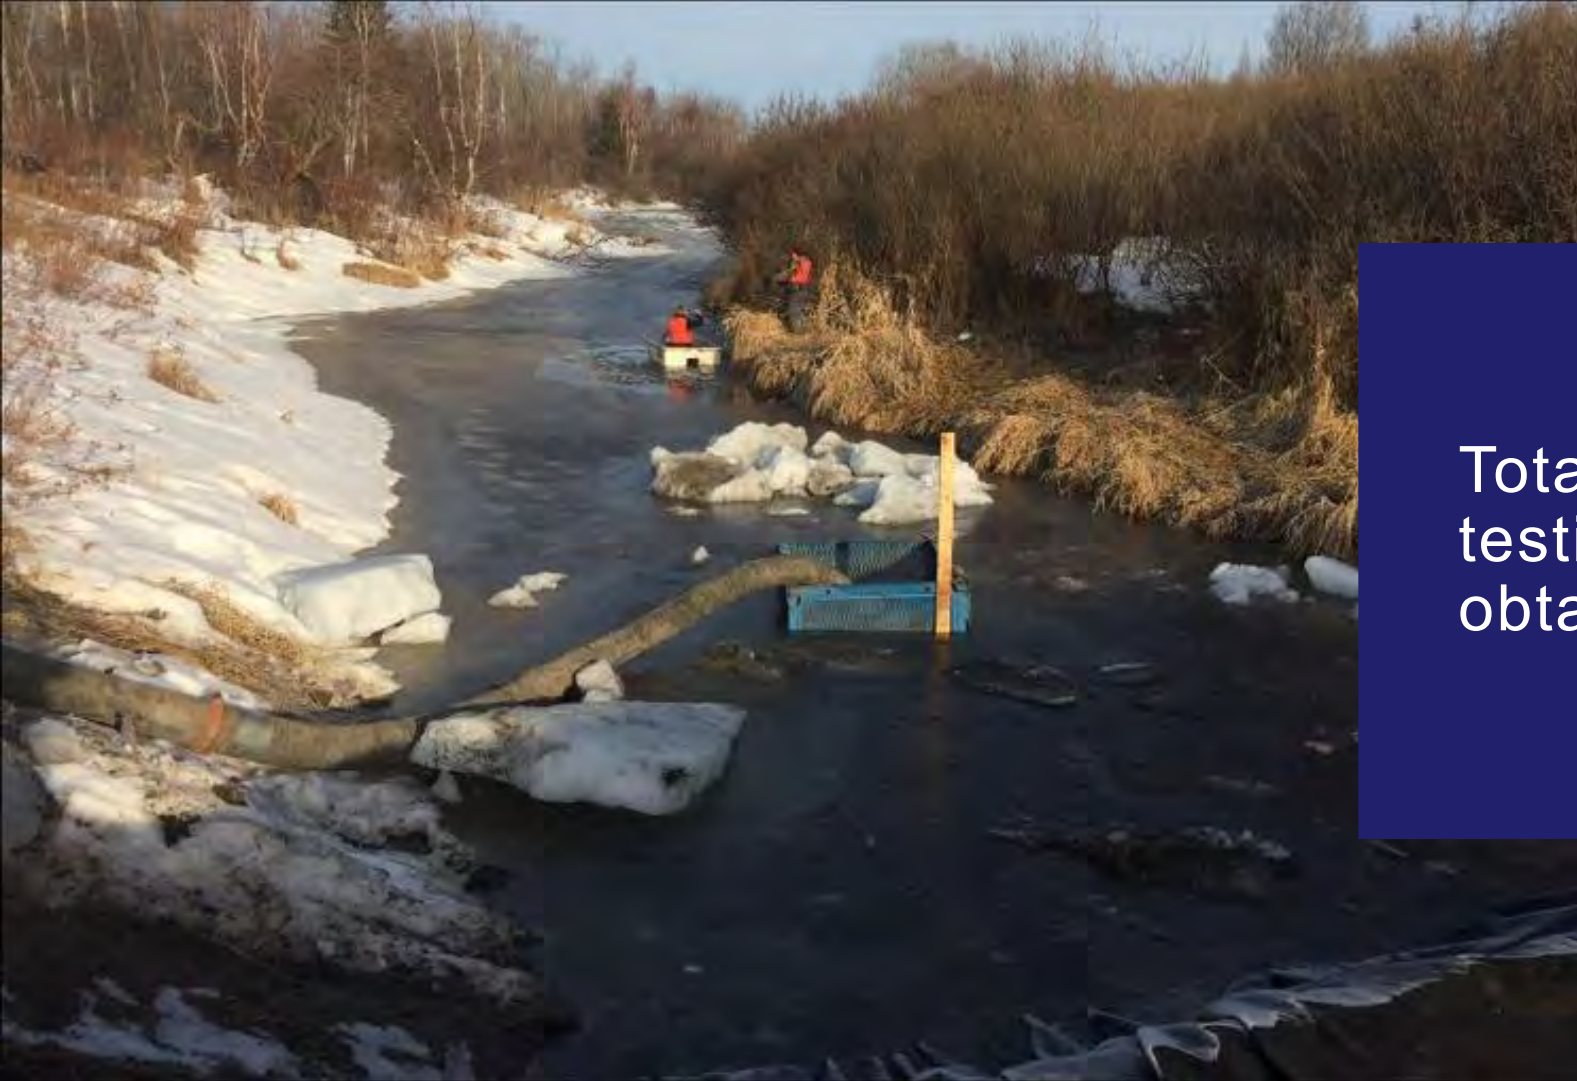
Total Suspended Solids (TSS) testing. Note boat upstream obtaining baseline readings

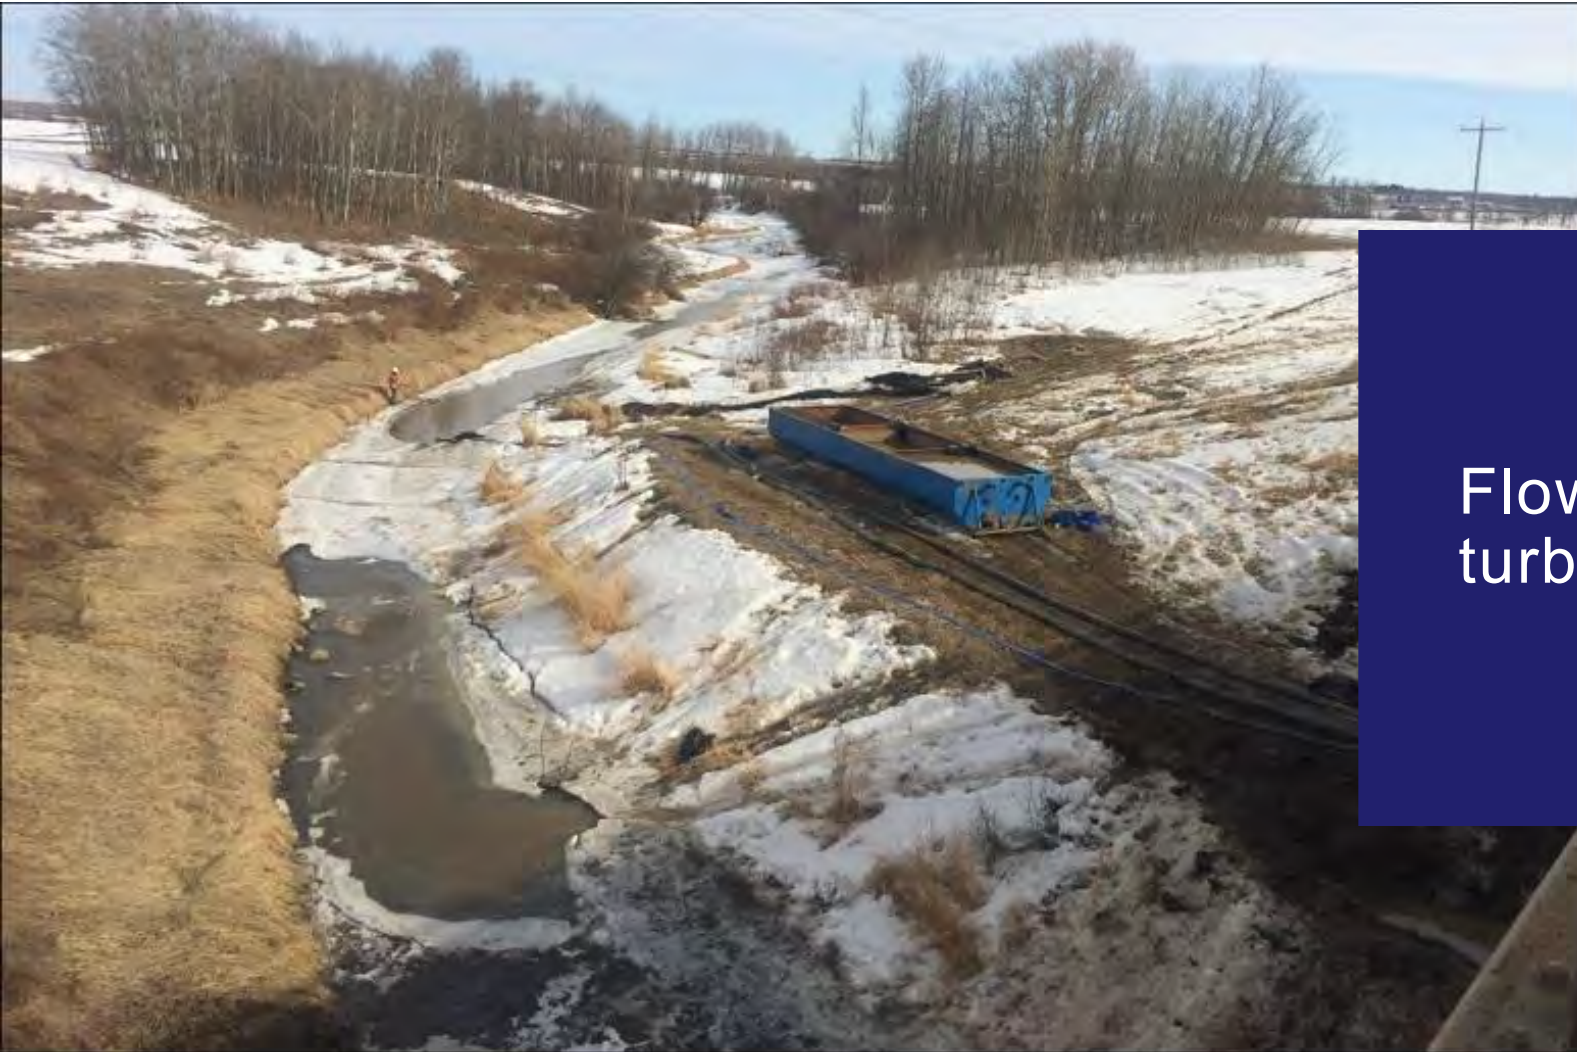
Flow is discharged to return turbidity to acceptable levels

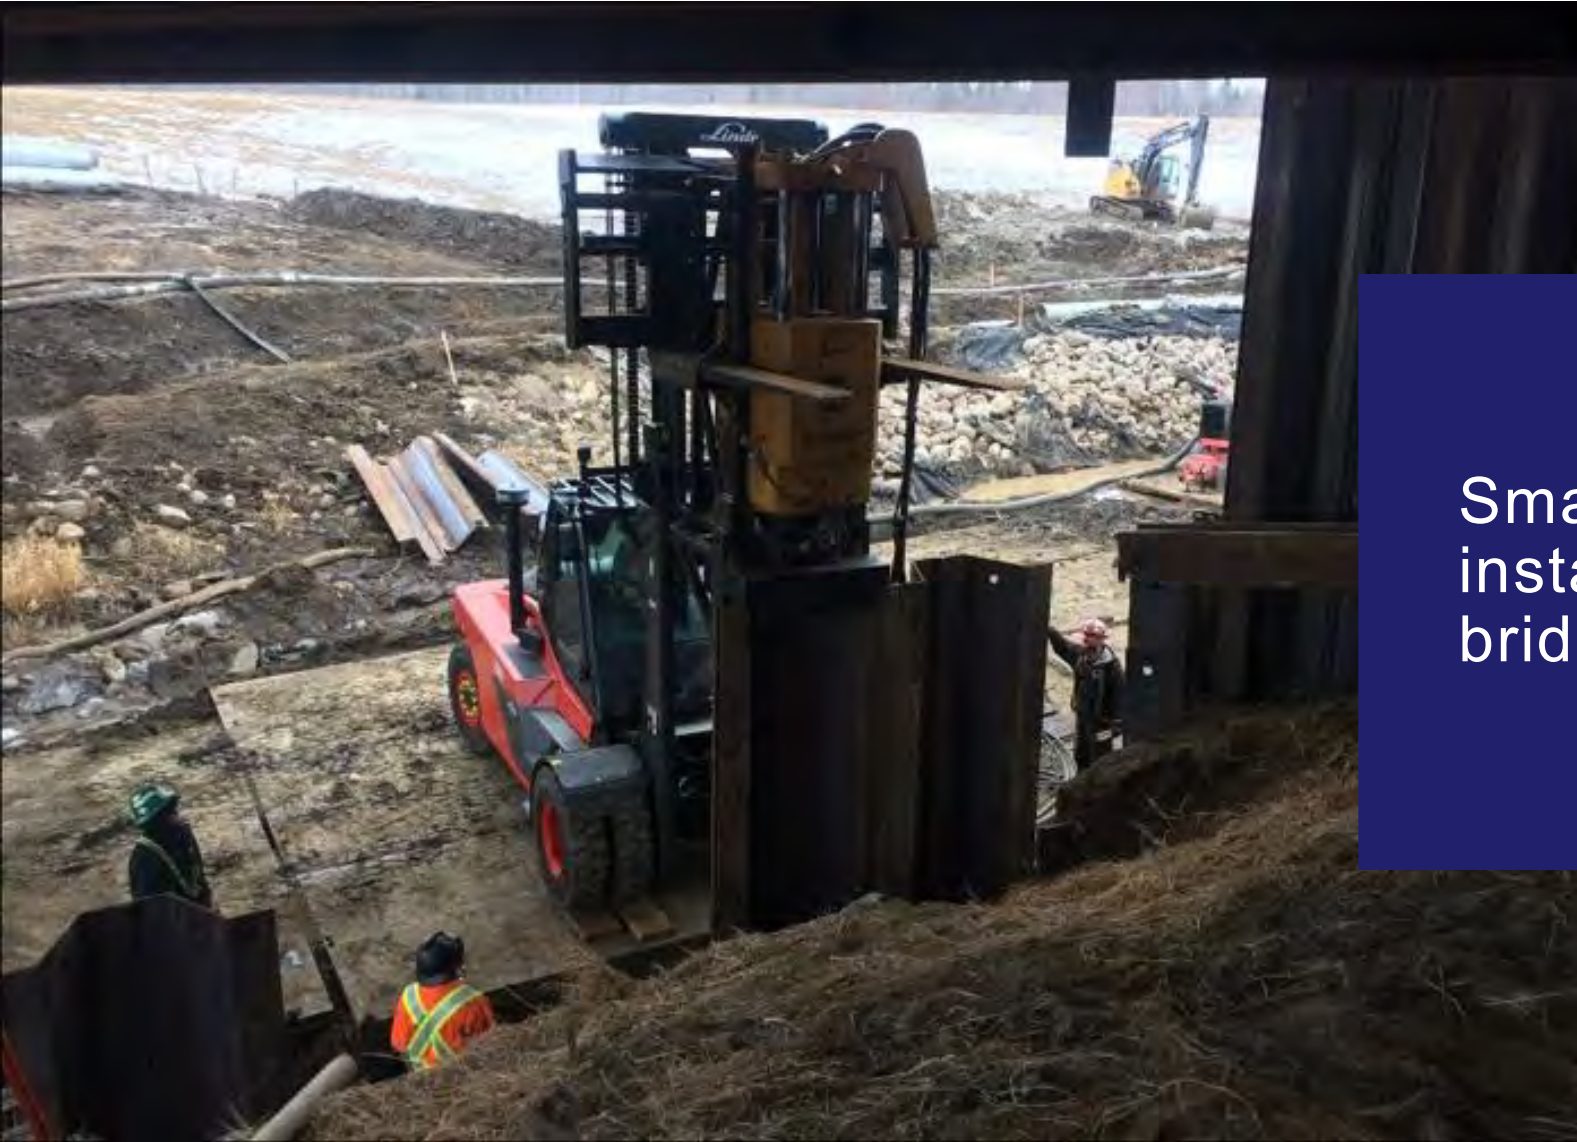
Small hydraulic hammer
installing sheet piling under the
bridge

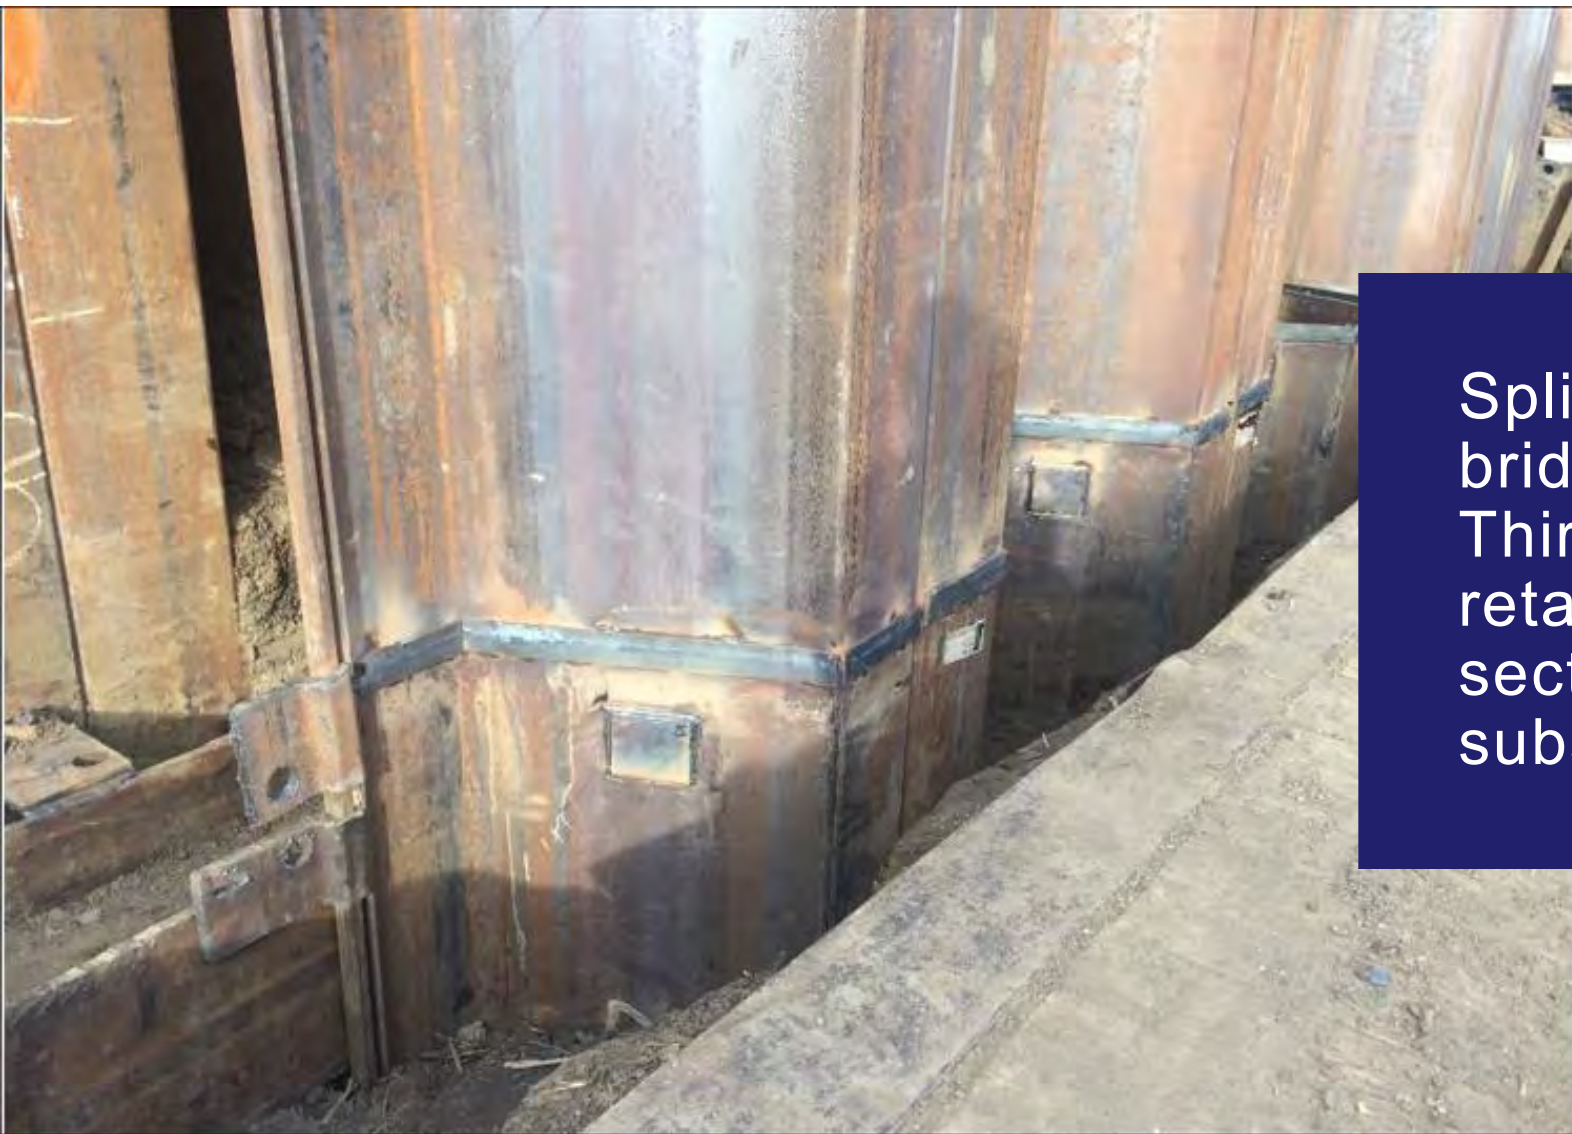
Splicing conducted under the bridge due to low head room. Third party inspector was retained to approve each weld section before driving subsequent section

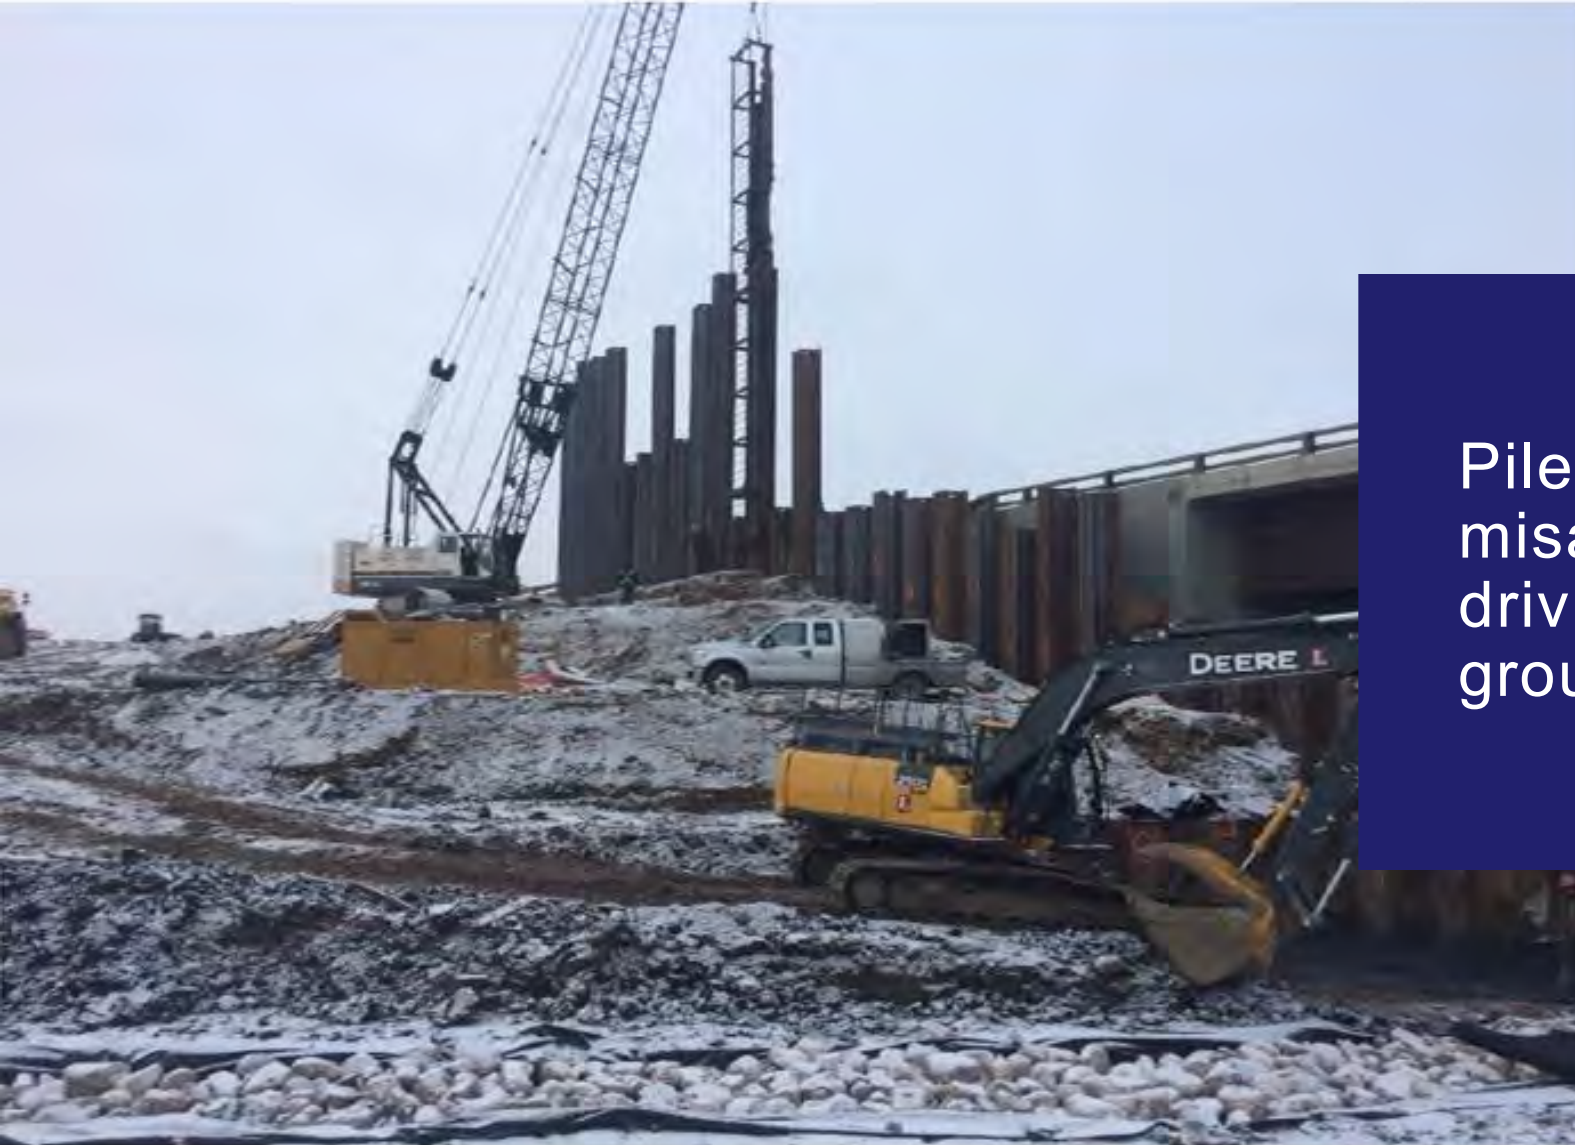
Pile wall B resulted in a misalignment due to difficult driving conditions, sloping ground, installation technique

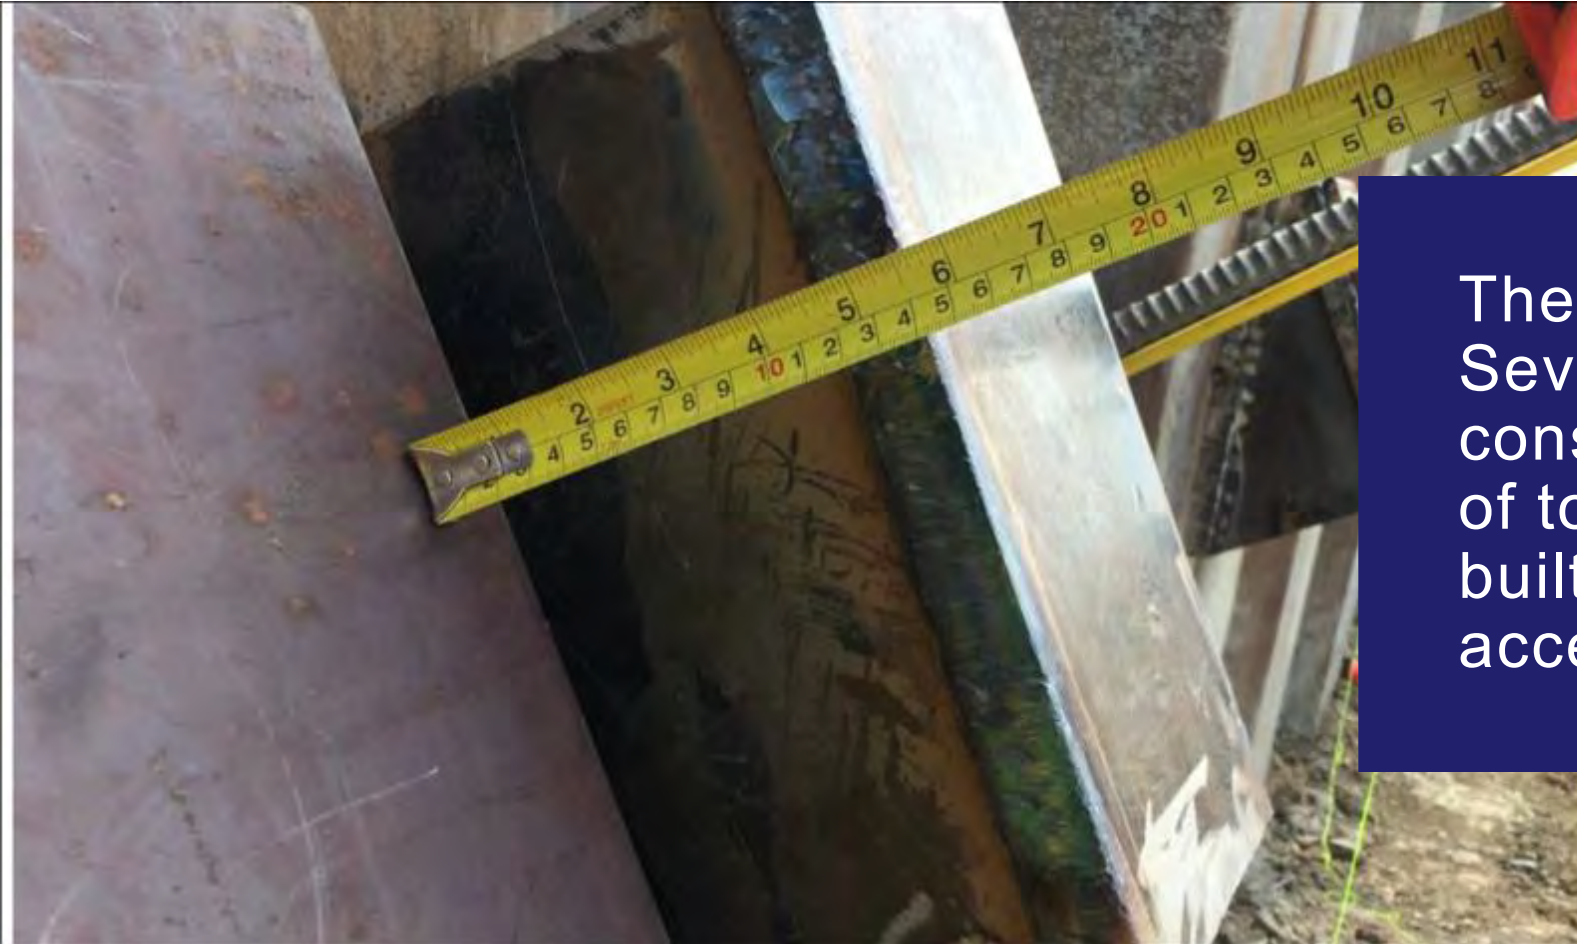
The offset was up to 125 mm. Several options were considered to mitigate the out of tolerance. Ultimately, the as-built condition was deemed acceptable

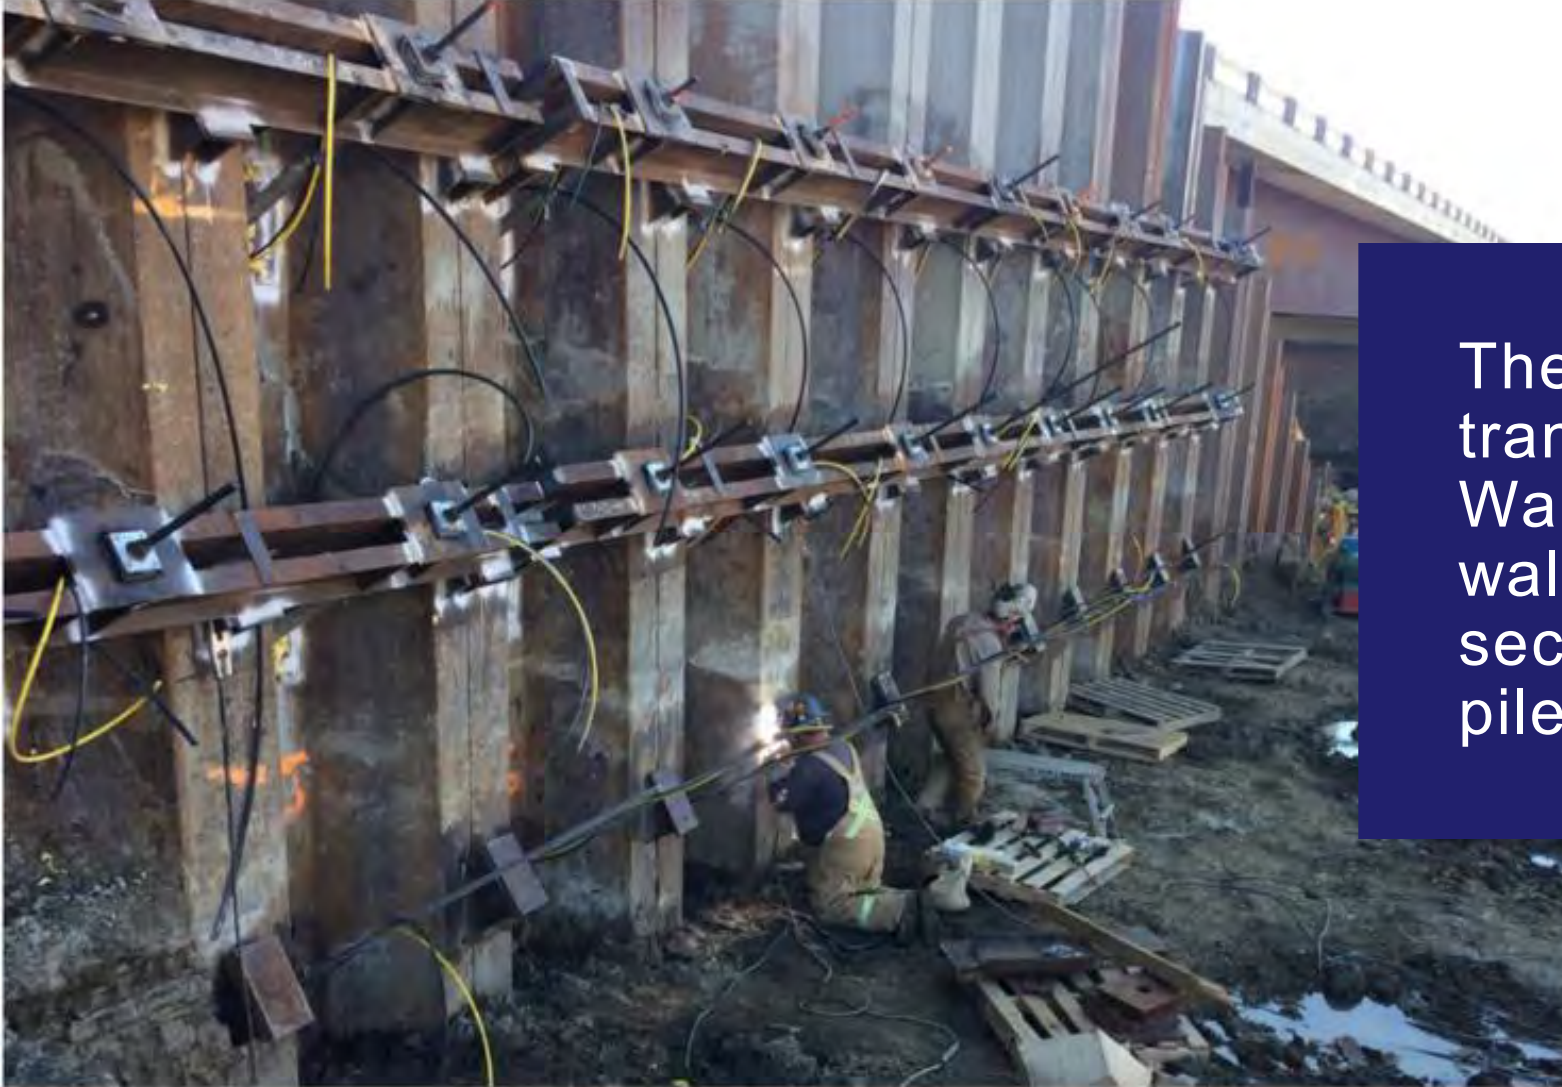
The anchor loads were transferred to Sheet Pile Wall 'B' by three welded steel walers (C310x45 channel sections) affixed to the sheet piles.

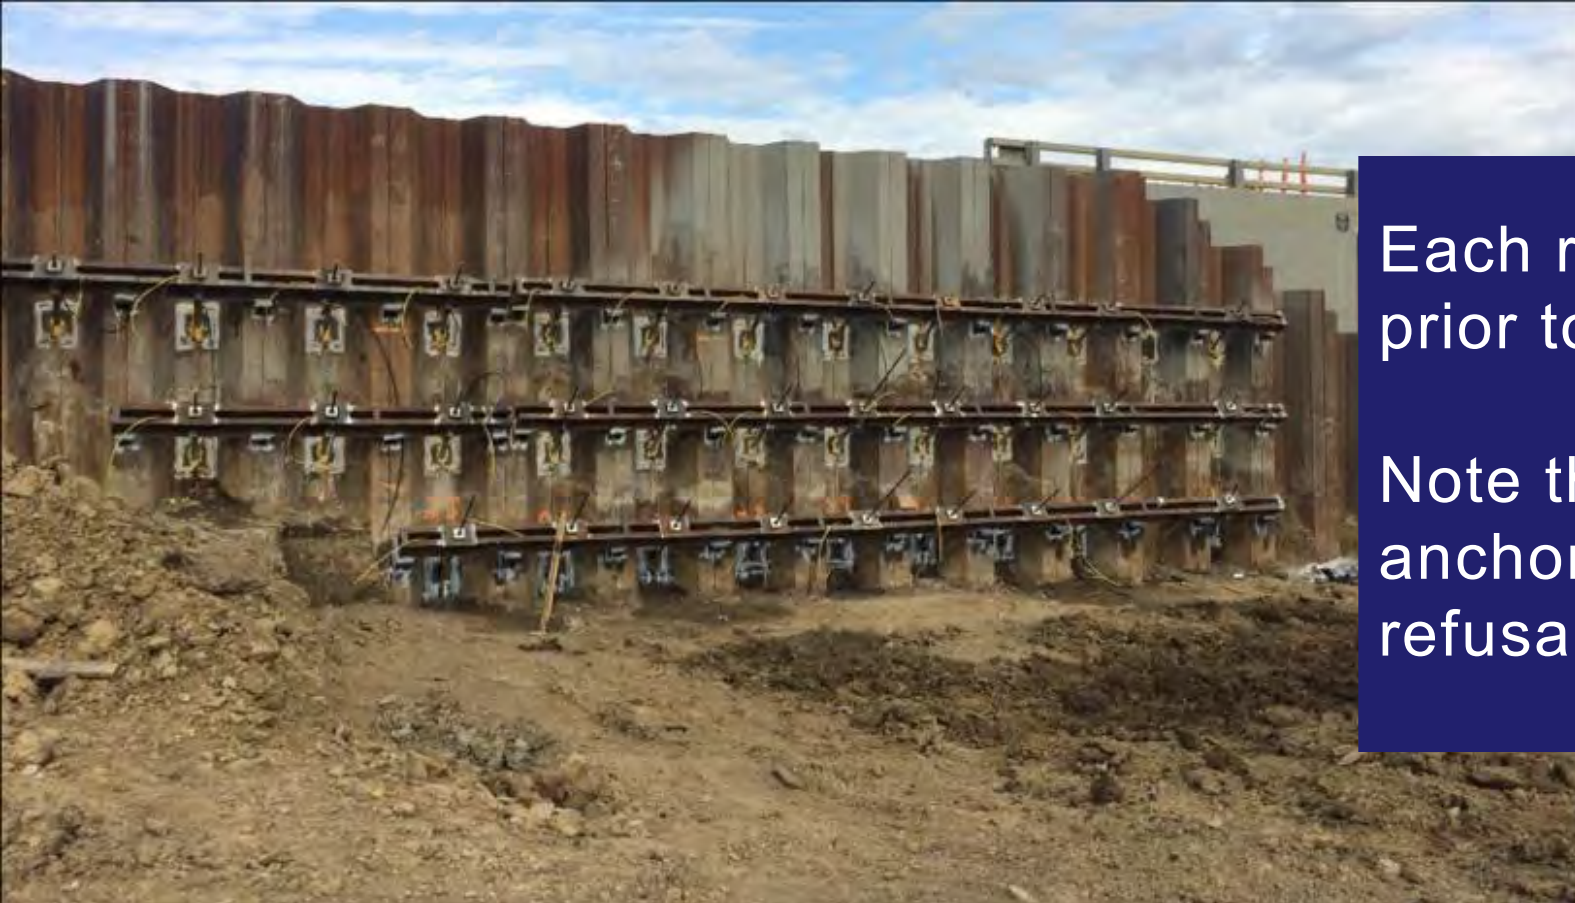
Each row of anchors was locked off prior to excavating to the next.

Note the larger spacing between anchors on the right due to drilling refusal on old bridge or shoring piles.
