Baptiste Creek Bridge Landslide

Design and Construction of Remedial Measures

THURBER ENGINEERING LTD.

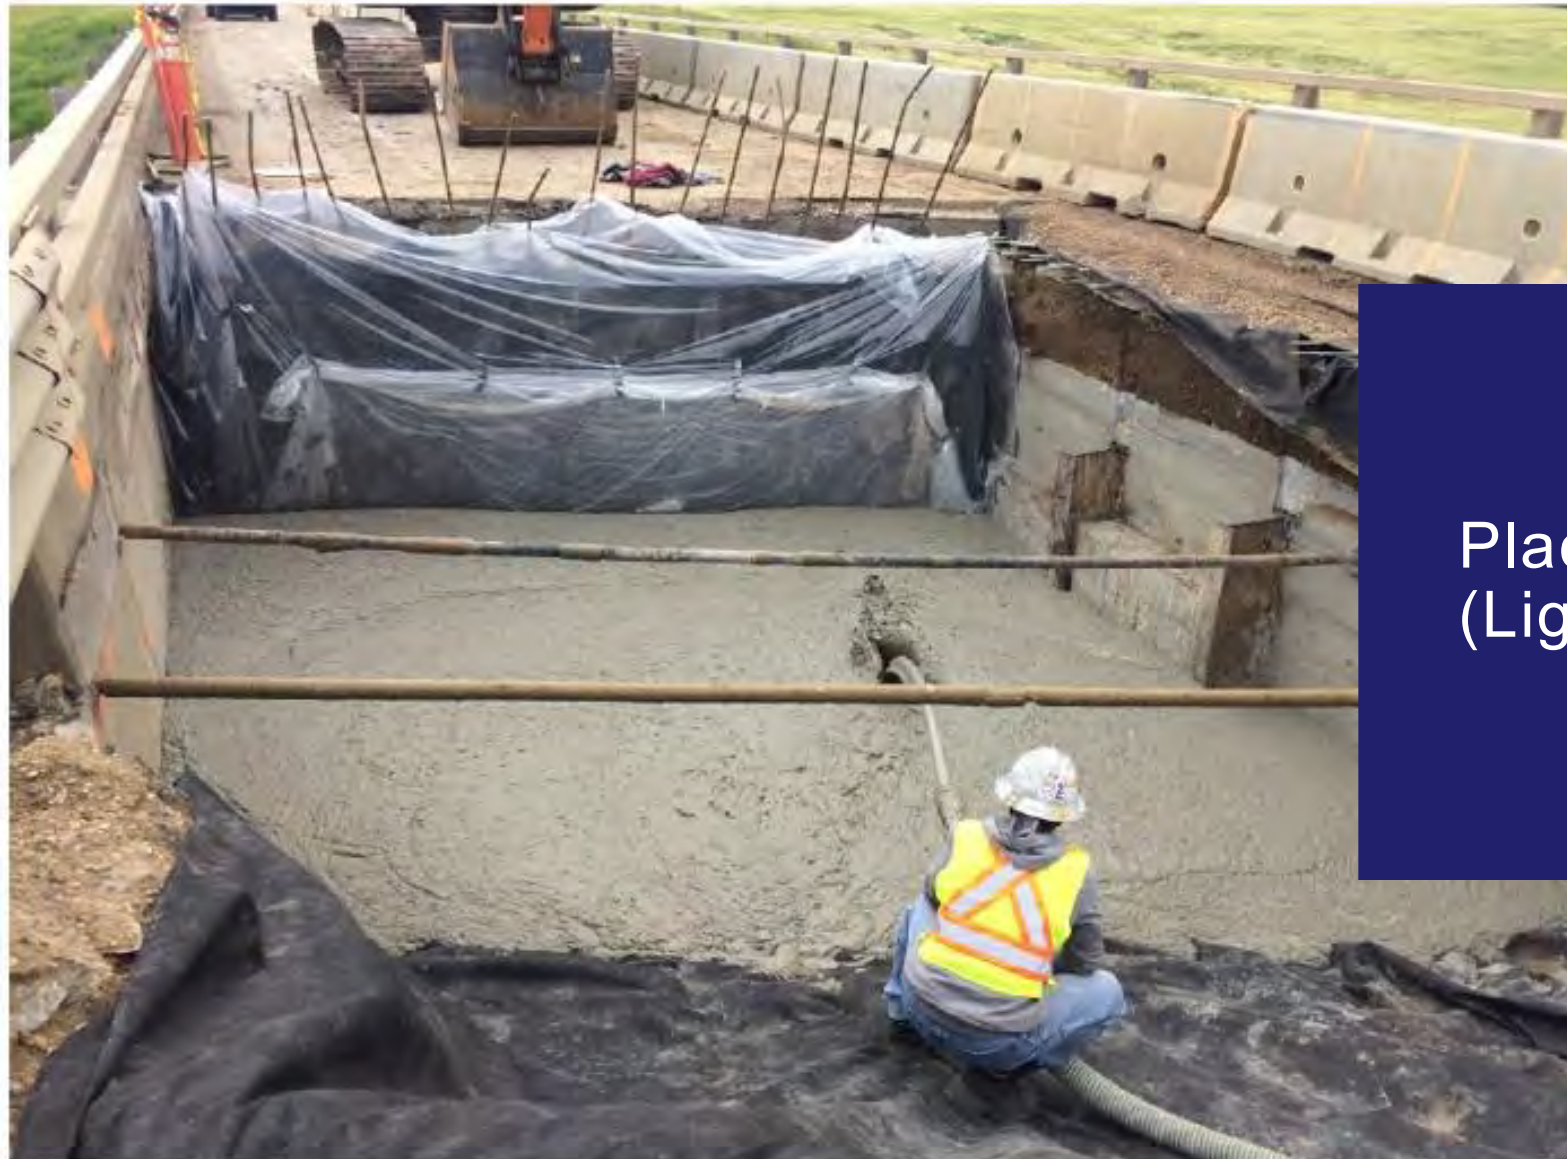
Placement of cellular concrete (Light Weight Fill)
