CEA Transportation Connects Alberta Conference

Counteracting Microbial Induced Corrosion - Reed Narrows Bridge

Reed Narrows Bridge

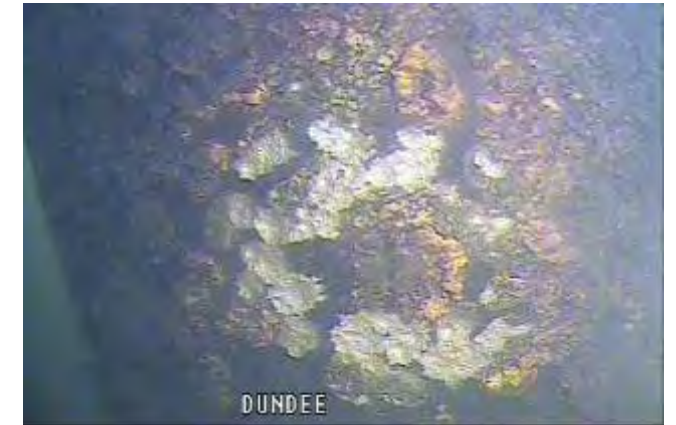
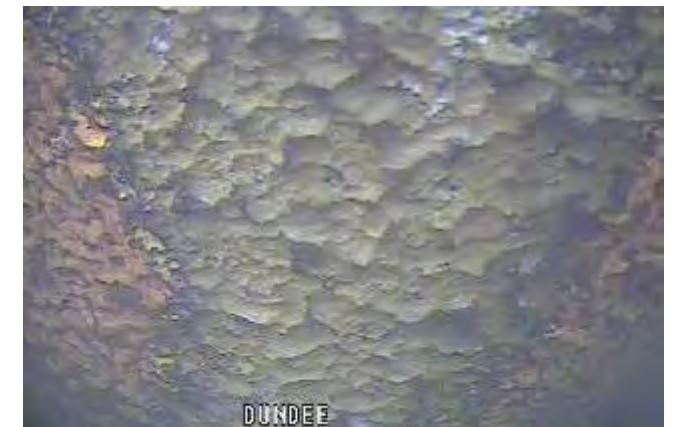
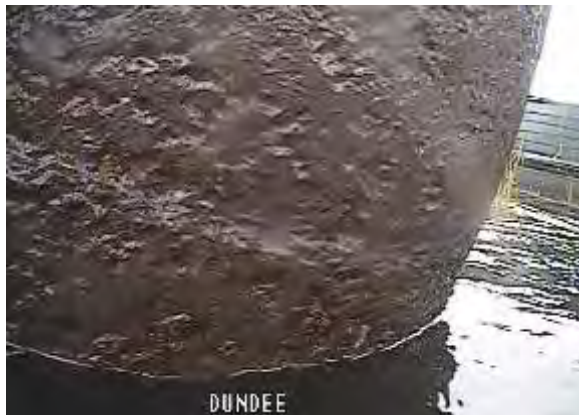
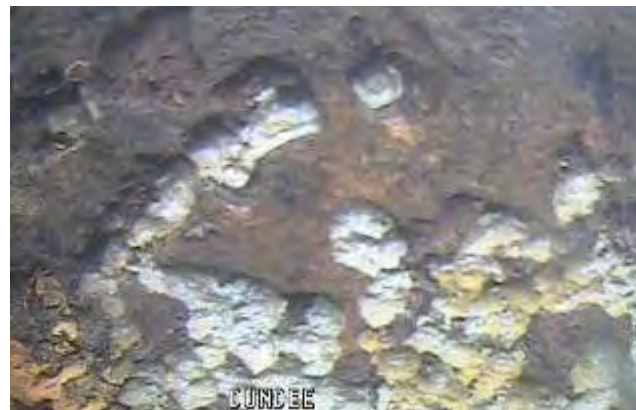
Pipe Pile Condition

- 2018 underwater investigation
 - Pile cleaned of algae below water
 - Ultrasonic testing (UT) and pit gauge utilized
- Severe MIC identified
 - Band of severe pitting located ~0.5-1.0m below waterline on all piers
 - Average 62% section loss (maximum pitting depth was 86%)
 - Shiny steel pile surface under organic scale

- **Pile Strengthening of all piles recommended**
 - Minimal cost difference between strengthening all vs. select piles
 - True composition of the piles (if concrete filled) is unknown
 - Level of certainty in localized and global section loss
