Graves Bridge High Load Damage Repair

Tao Yong M.Eng., P.Eng.

Hossein Azimi Ph.D., P.Eng., PMP

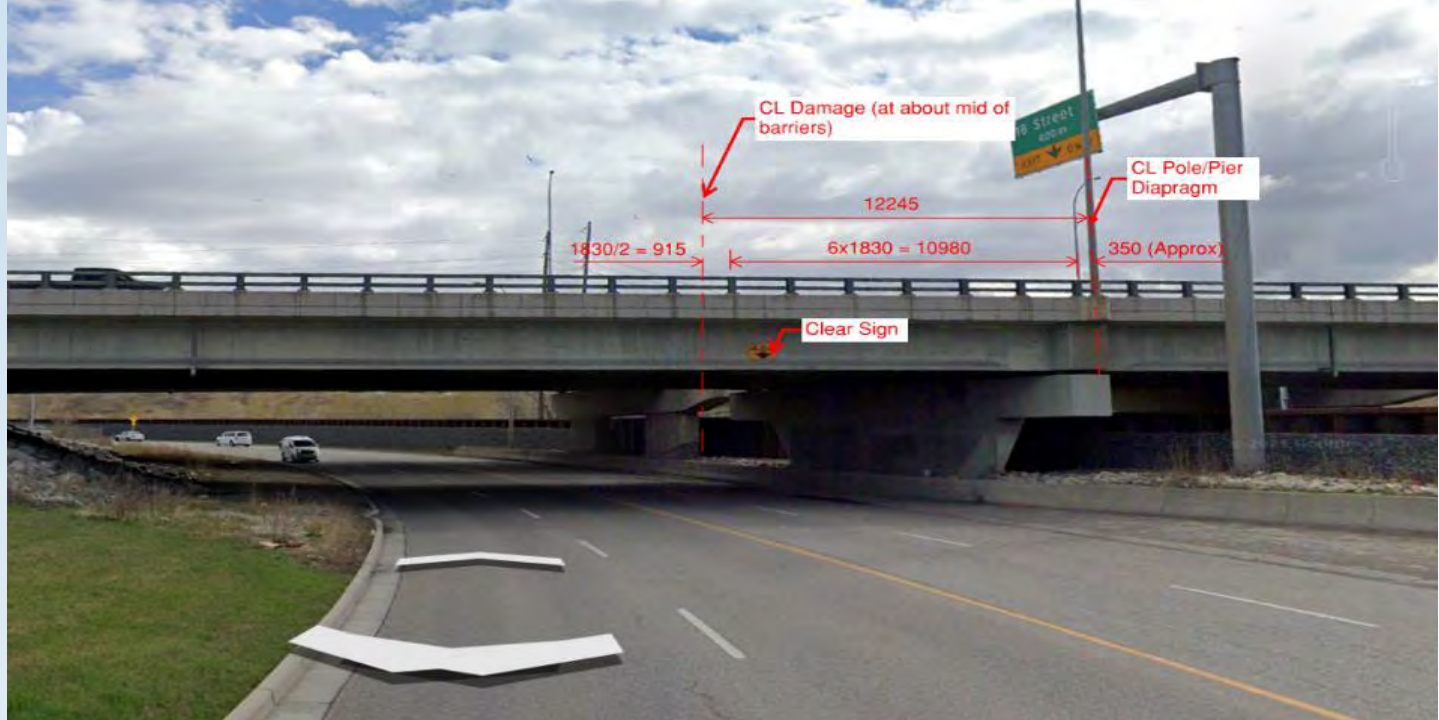
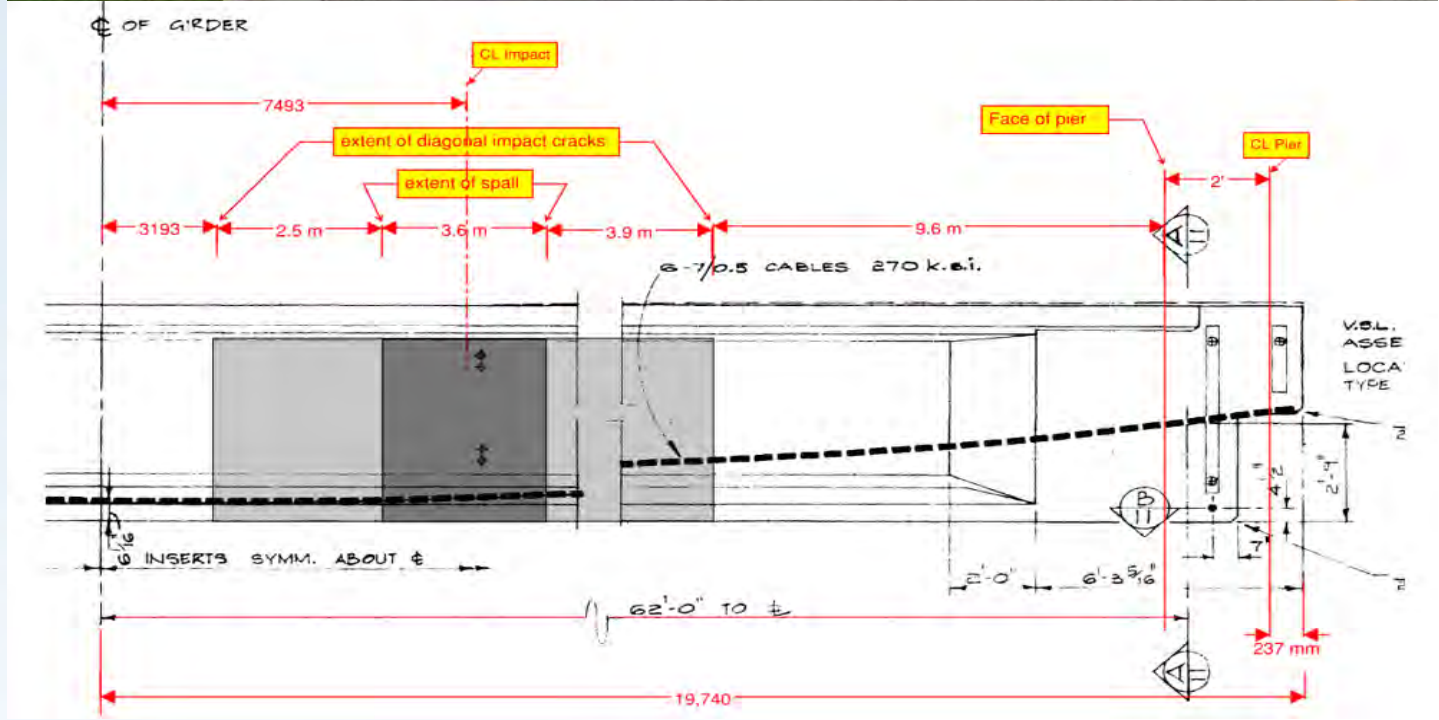
- **Date:** High load damage occurred in May 2022
- **Damage Location:** The south exterior girder of the first span was severely impacted by a dump truck at about 1/3 of the span length measured from the pier

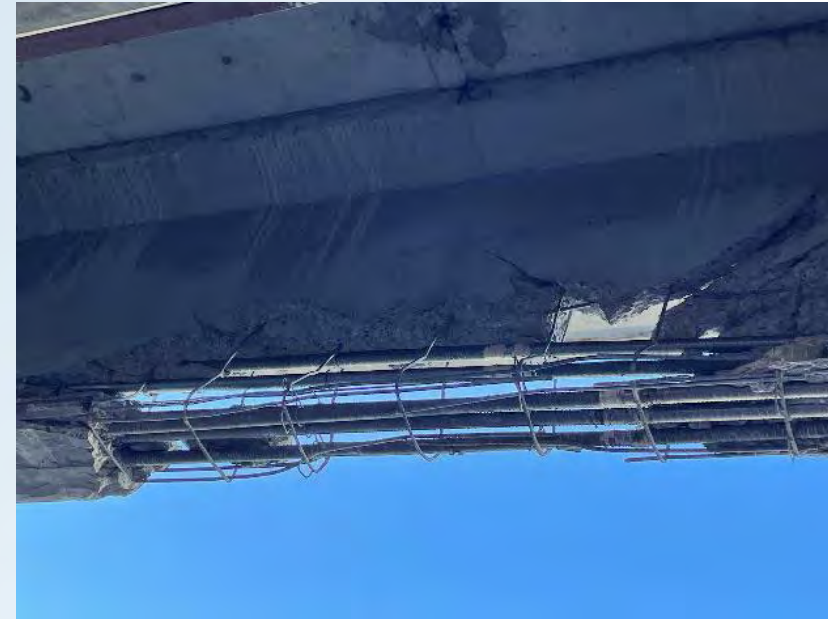
- Mass crash and breaking at bottom flange and lower portion of the girder's web
- Extensive diagonal cracks at web
- Long full depth crack between top flange and web
- Part of post-tensioned tendons, stirrups, and reinforcing steels were exposed and debonded from concrete
- Concrete spalls extend ± 3.6 m while diagonal cracks extend about 10 m
- Crack width ranges from 0.1mm up to 7 mm

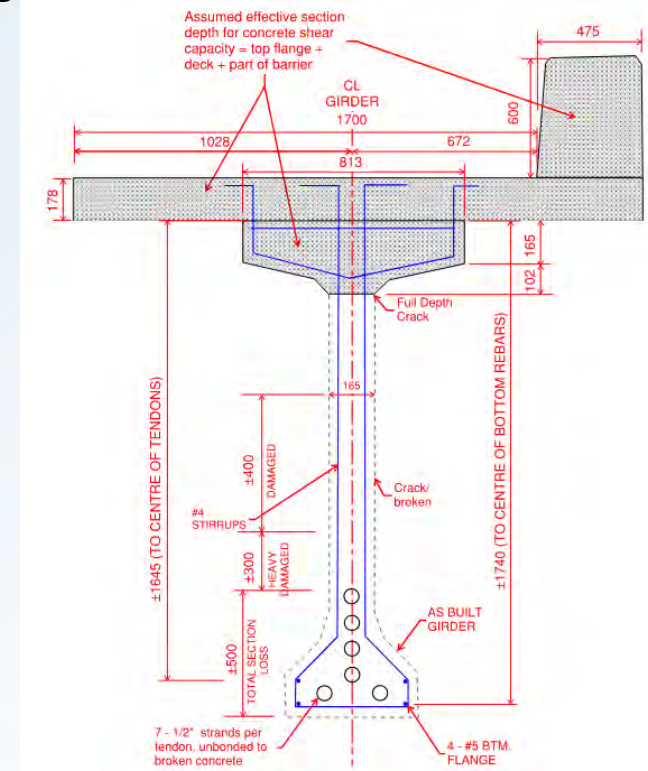
Section Considered for Load Rating Before Repair

- Assumptions:
 - The live load analysis was based on a simplified method
 - Conservatively assumed the damaged girder still attracts the same loads as before
 - Conservatively assumed only the concrete of the deck, barrier, and the girder top flange are still in function.
 - Moment Evaluation: Assumed the concrete and major steels still comply with a strain and stress relationship to simplify the evaluation analysis and calculation.
 - Shear Evaluation: Include the deck, girder top flange, and a partial section of the TL-5 barrier for the shear resistance. Conservatively ignore the vertical component of the post-tensioned forces.

- **Results and Findings:**
 - The collision did not much affect the girder's flexural capacity. The damaged girder has sufficient capacity for the positive moment
 - There is no concern about the live load caused negative moment to the damaged girder, since it is counteracted by the positive moment of the dead loads.
 - The shear capacity of the damaged girder has been significantly reduced. The damaged girder itself has no sufficient shear capacity to carry either dead loads and/or live loads.
 - After including partial contributions to the shear resistance from the TL-5 barrier, it is prudently accepted that the composite section consisting of the deck, girder top flange, and the partial barrier still provides sufficient shear capacity to the dead loads.
 - In general, the damaged girder is still safe under the permanent loads, but not under traffic loads.
