Replacement of Red Deer River Bridge near Morrin (Morrin Bridge)

Presentation prepared for Transportation Connects Alberta Conference
Edmonton, Alberta, March 2025

Azita Azarnejad, Ph.D., P.Eng., FCSCE, Jacobs

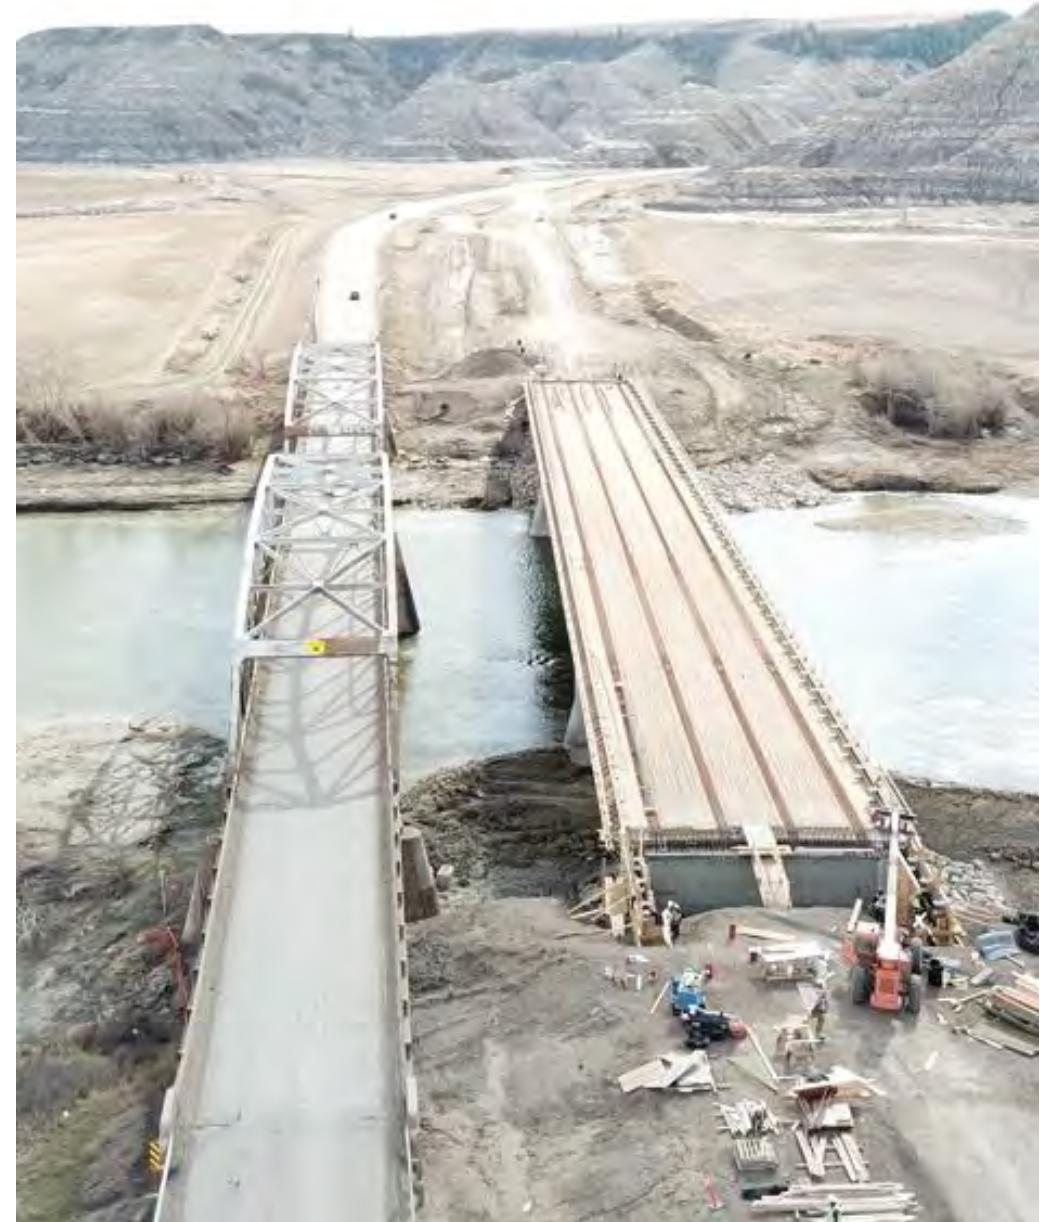
New Alignment

- New alignment with about 25 m centre to centre spacing

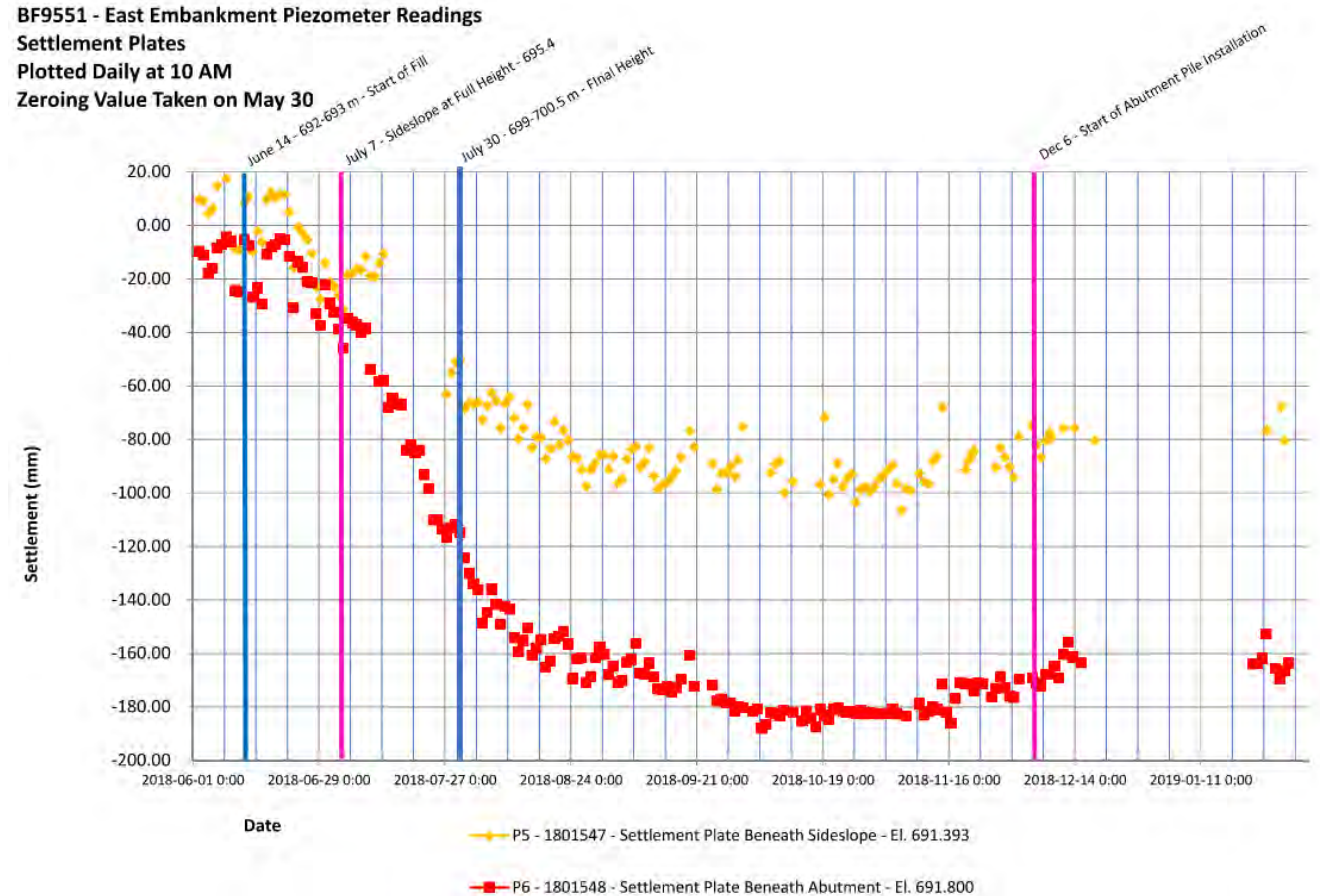
Image from Thurber

- Shear pile wall was mainly constructed in front of head slope (to reduce the cost for the ears with lower risk)
- Instrumentation installed along the flanks of approach fill at east abutment to monitor ground movement and pore pressure (to increase length of shear pile wall if results not favorable)
- Complete abutment fill to full height and let it sit for about six months before installing the abutment piles (to avoid downdrag in the piles).
- Provide instrumentation and monitor settlements

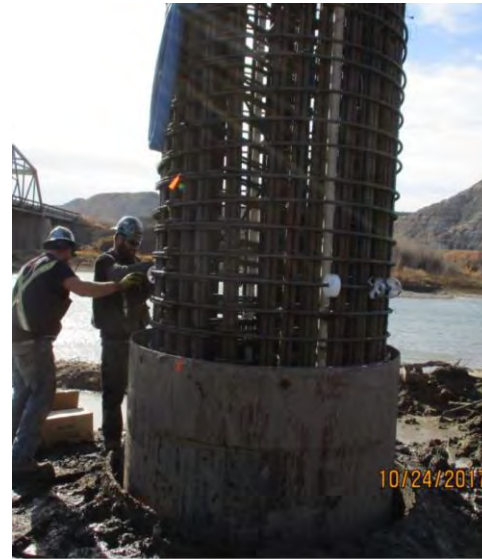
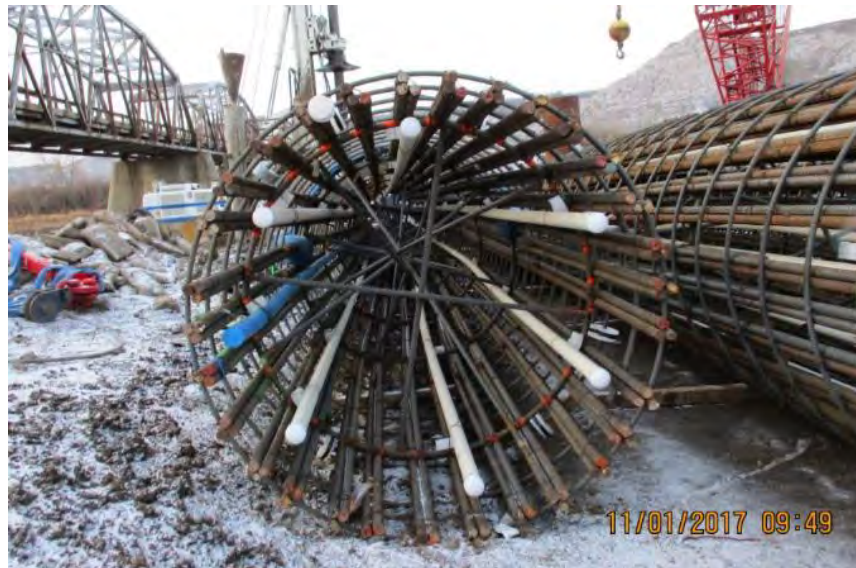
Sep. – Nov. 2017

- Mobilization – 17/09
- Shear pile wall
 - 1.8 m diameter – 24 m long – CIP Concrete piles
 - CSL tubes installed in all of the piles
 - Challenges with unfavorable CSL results
 - Coring and Pile Integrity Testing (PIT) conducted before accepting the piles

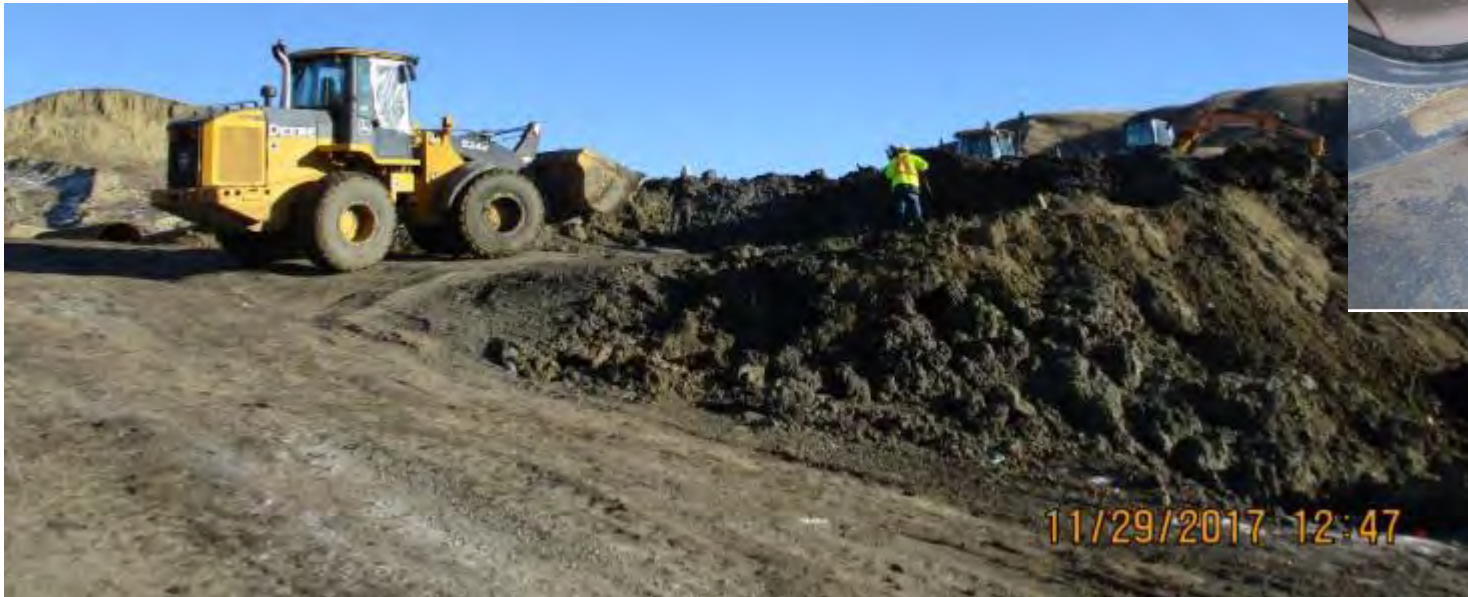
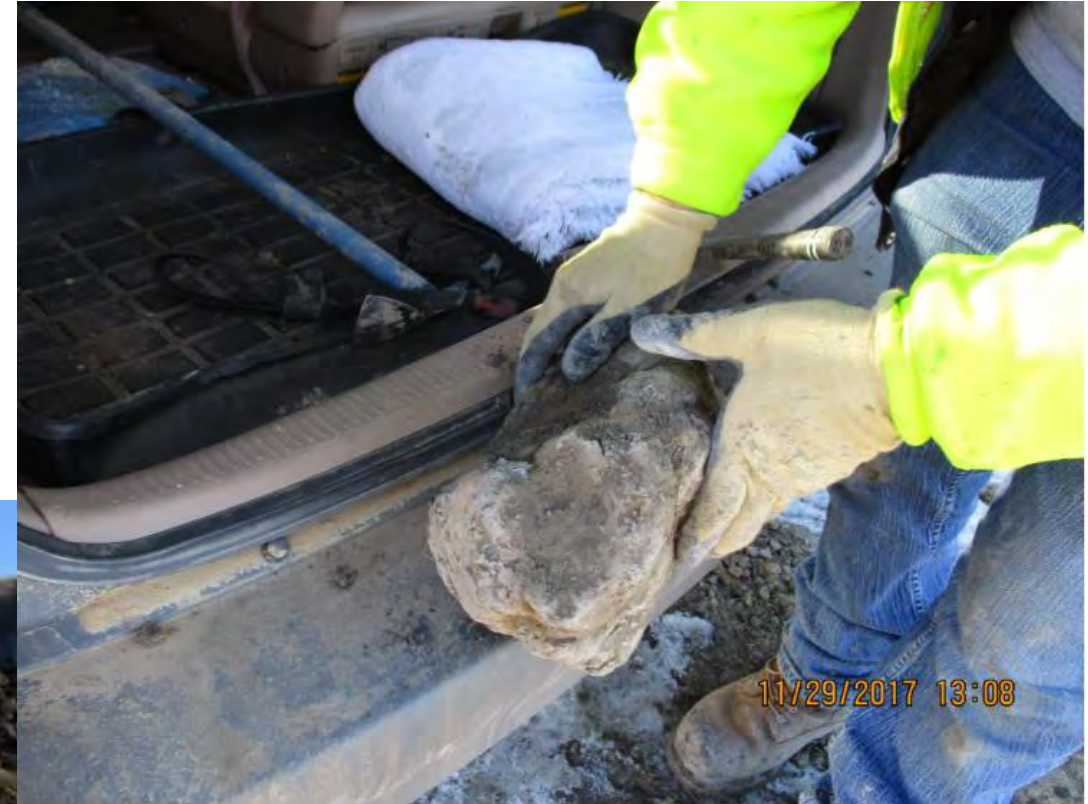
Paleontological Monitoring

- Paleontological monitoring required for major excavations including excavated material from shear pile wall
- Dinosaur bone fossil excavated from P-12

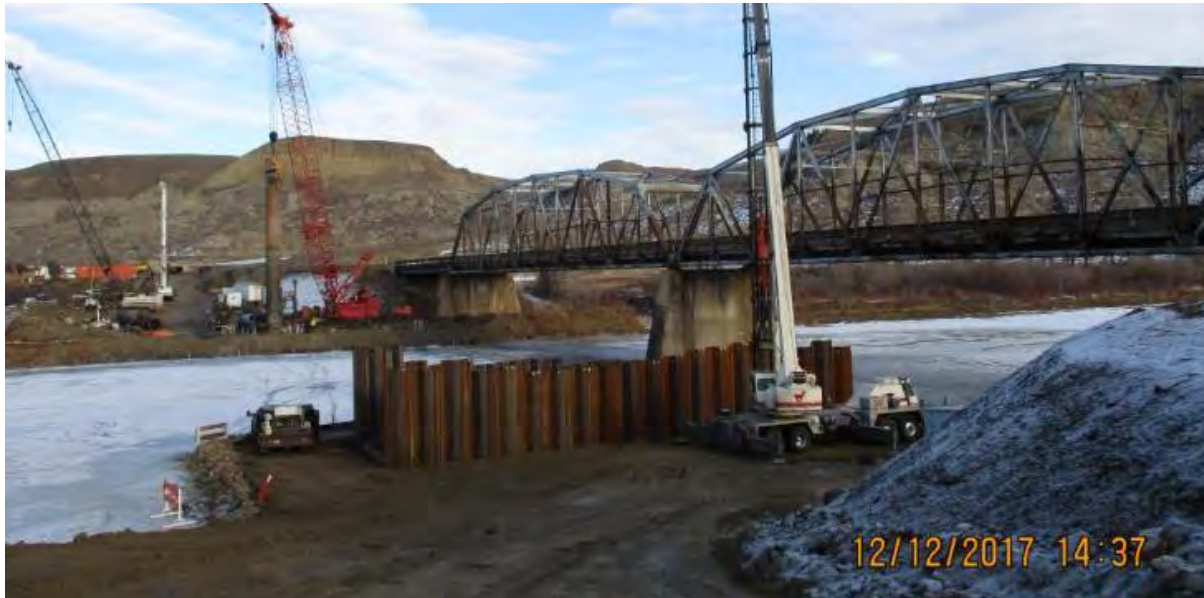
Dec. 2017 to Feb. 2018

- West berm and piling for pier 1
- West Berm installation and removal – 17/12 to 18/04

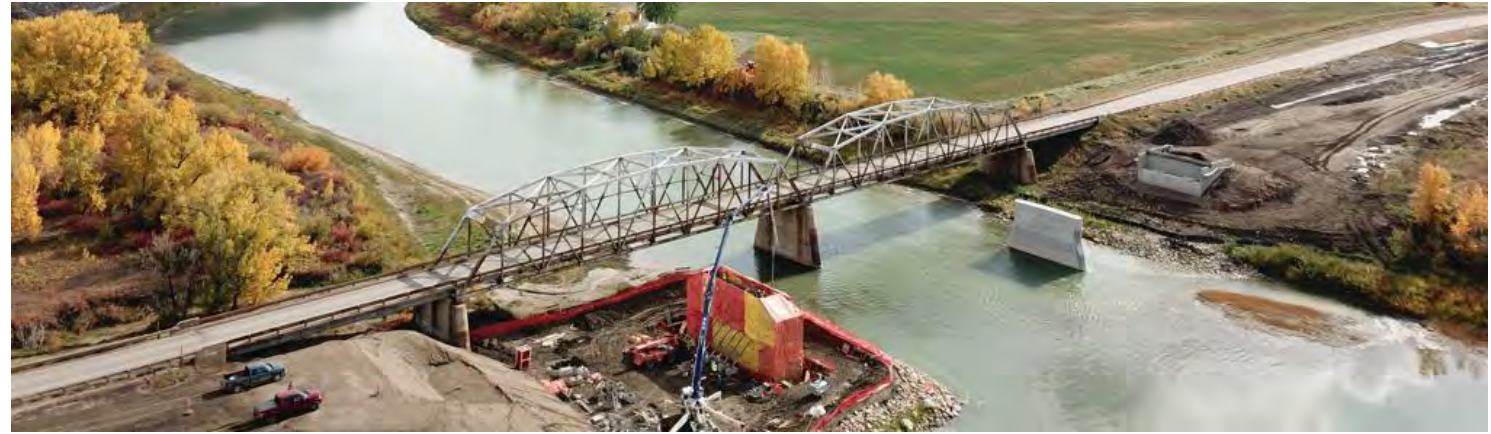
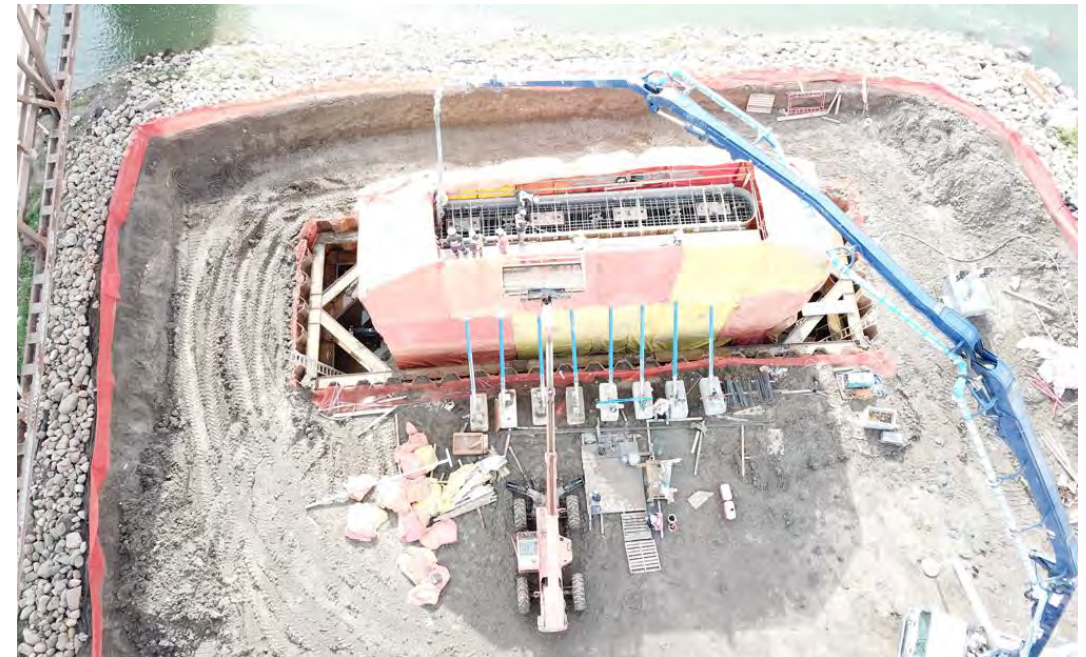
May – Oct. 2018

- Completing west abutment
- Bearings on site
- Completing shear pile wall
- Working on pier 2
- Grading, backfilling, and erosion control work on ditches.

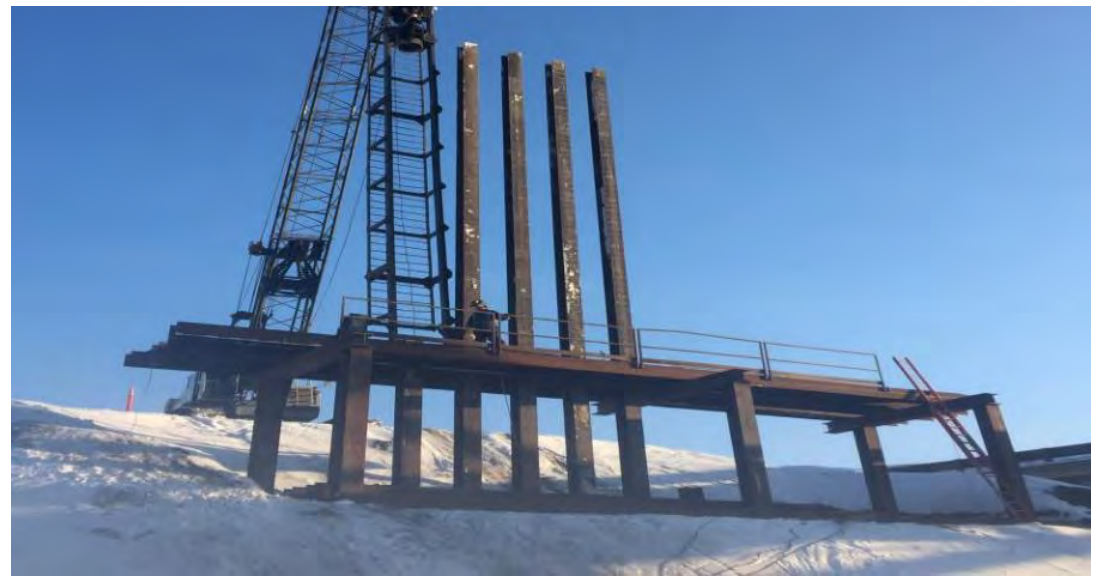
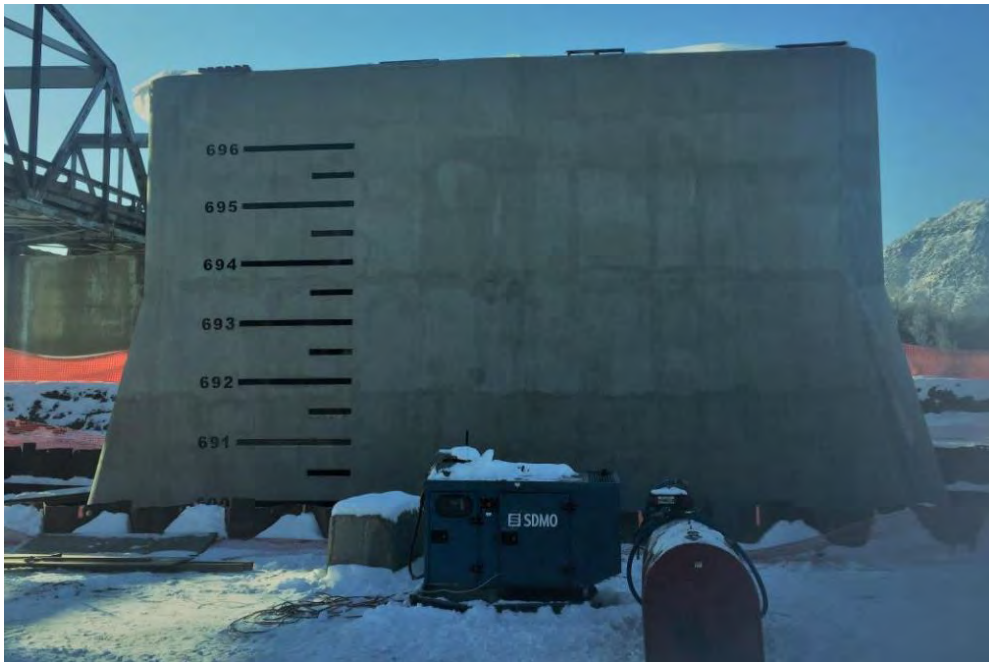
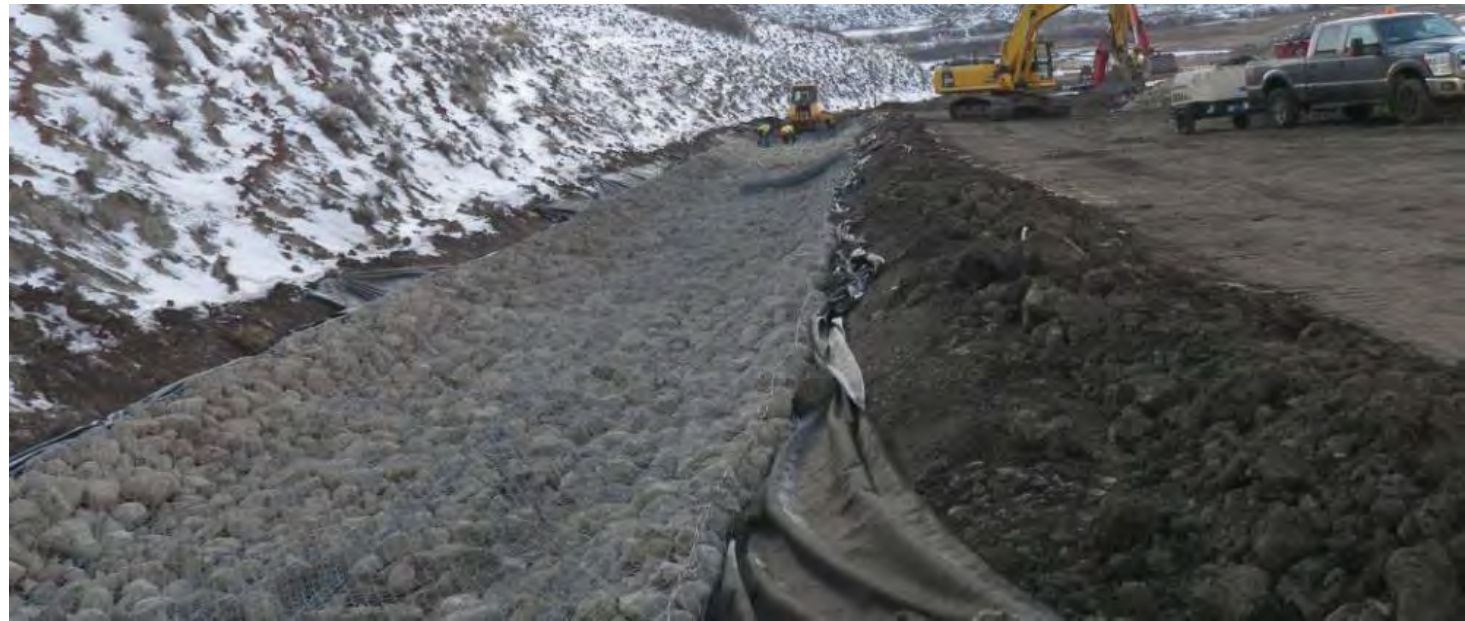
Nov. – Dec. 2018

- Finishing Pier 2
- Working on Abutment 2
- Erosion Control work in the ditches

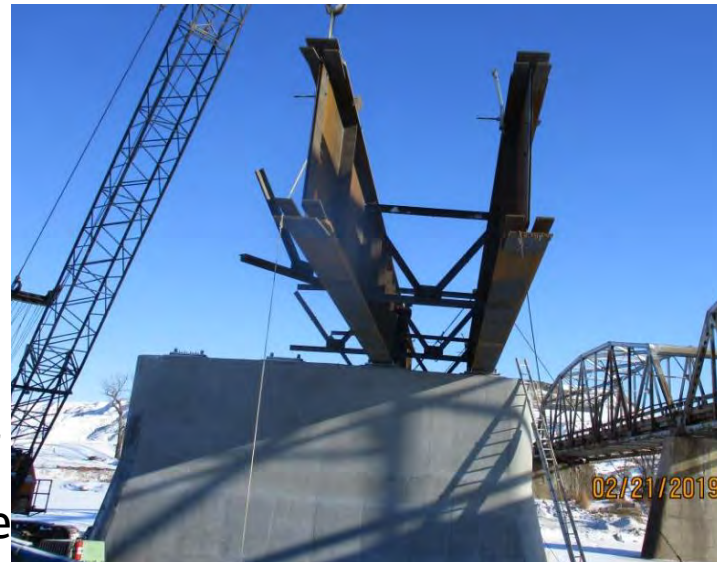
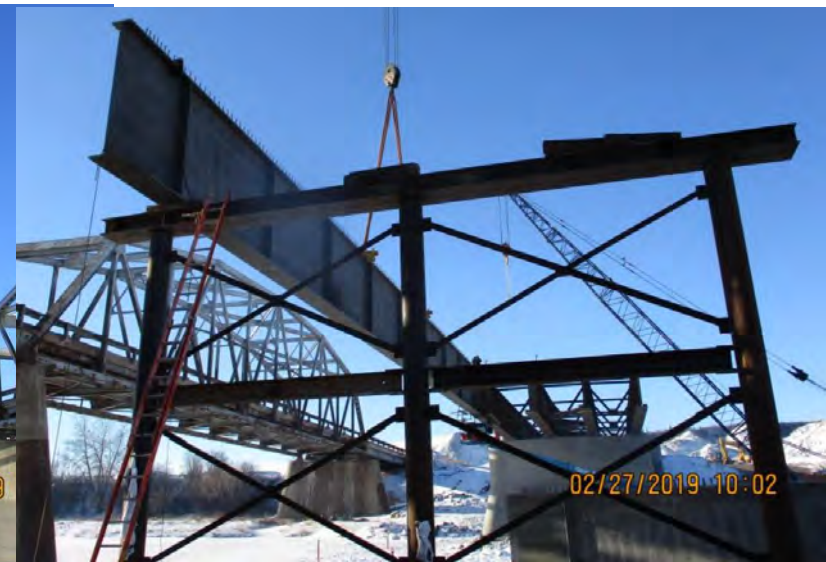
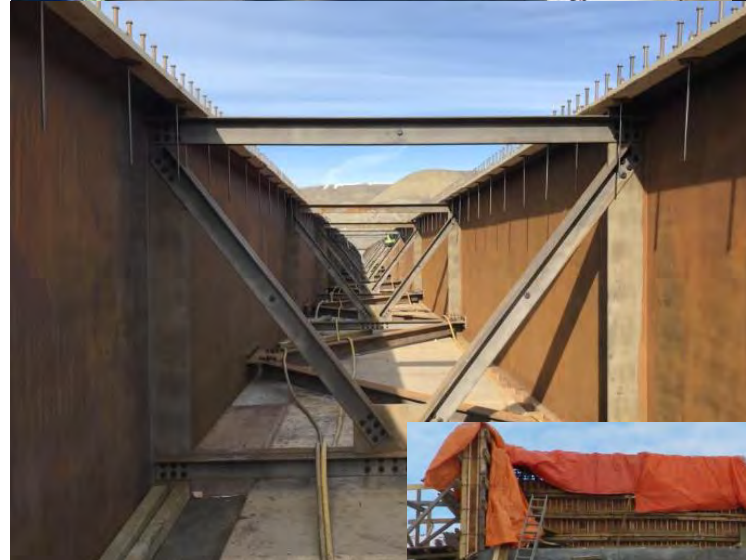
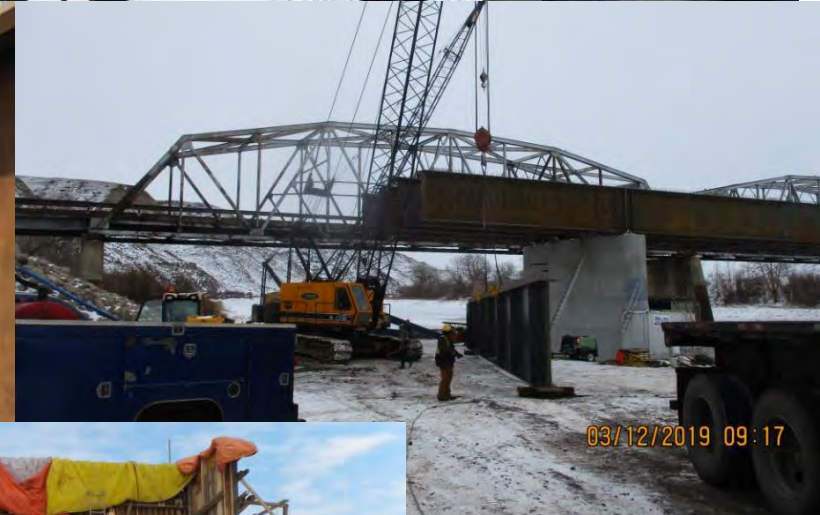
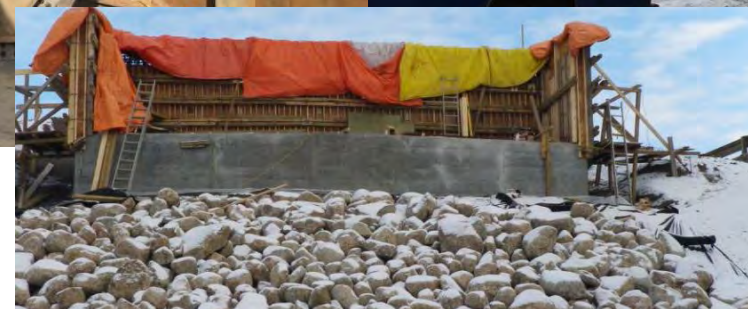
Jan. – Mar. 2019

- Finishing abutment 2
- Placing rip-rap in abutment headslopes
- Installing bearings
- Installing berm at west and shoring tower
- Girder erection from berms and ice bridge
 1. Segment on west pier and shoring tower
 2. Segment between pier and abutment
 3. Move shoring tower to east berm and install middle segment
 4. Segment on east pier
 5. Segment between east pier and abutment
- Working on connections
- Erosion Control work in the ditches

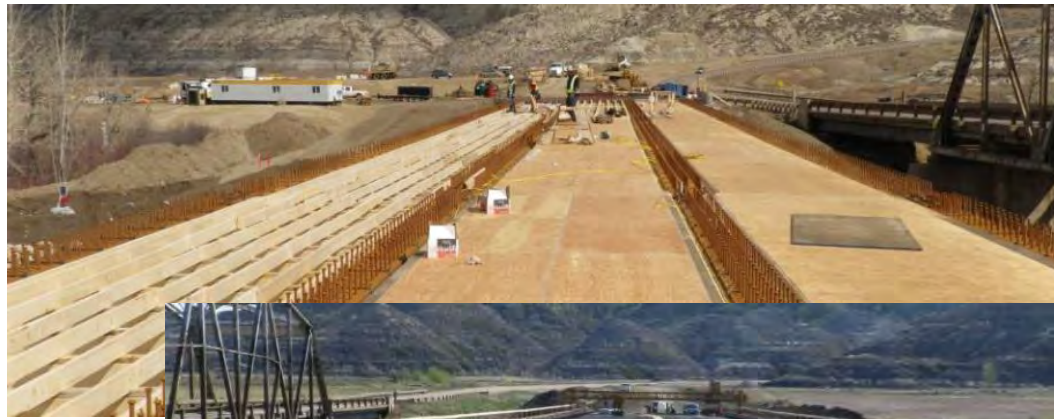
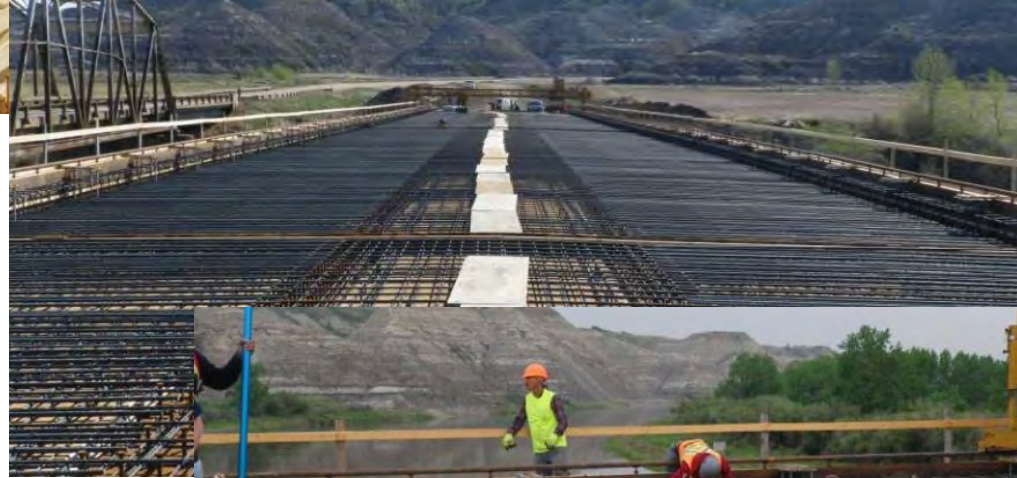
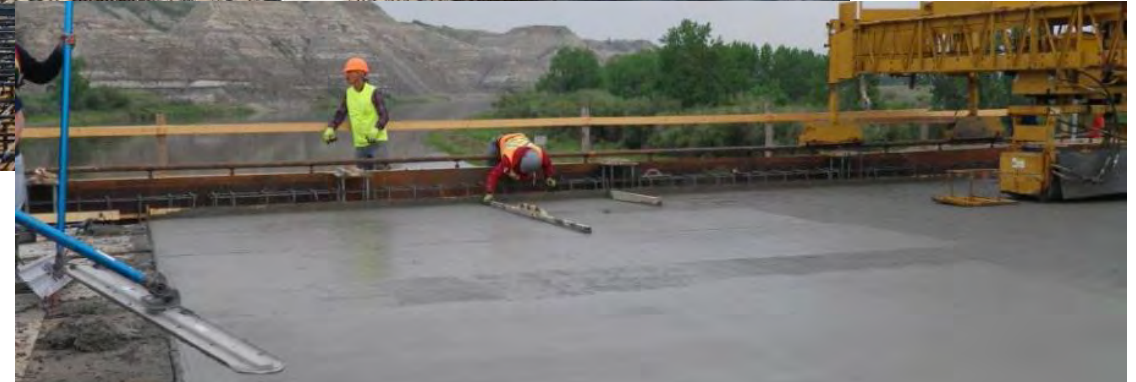
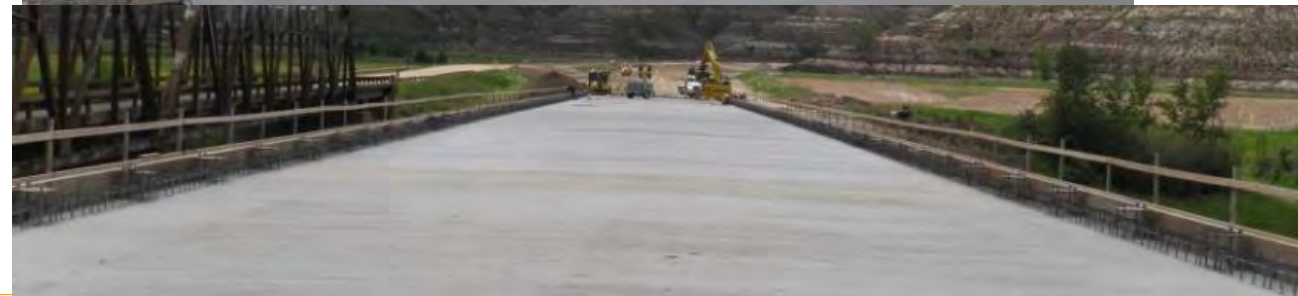
Apr. – Jun. 2019

- Deck formwork and rebar
- Casting deck and curing
- V-Seal Deck joint at west abutment

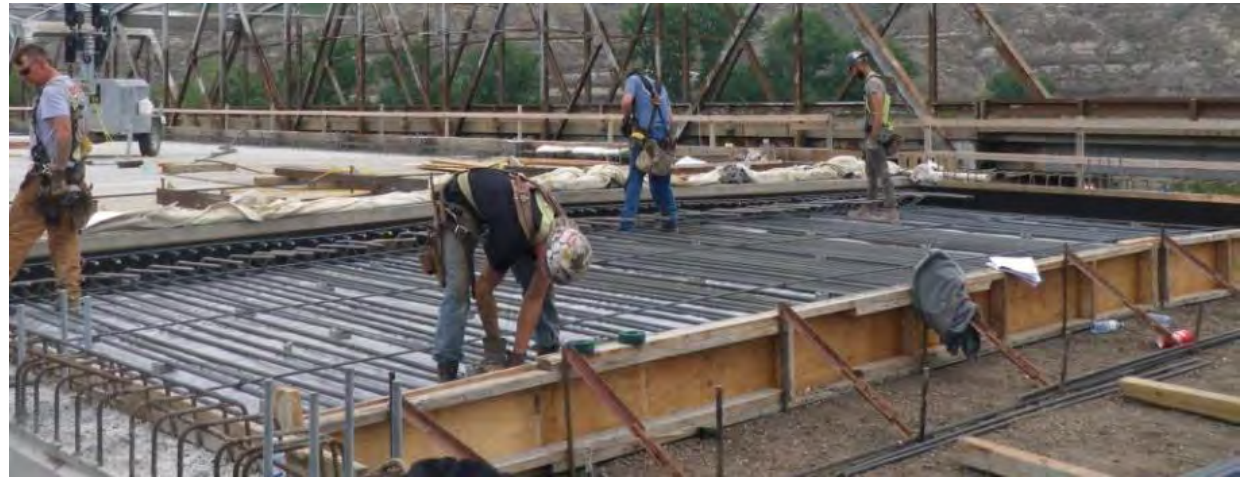
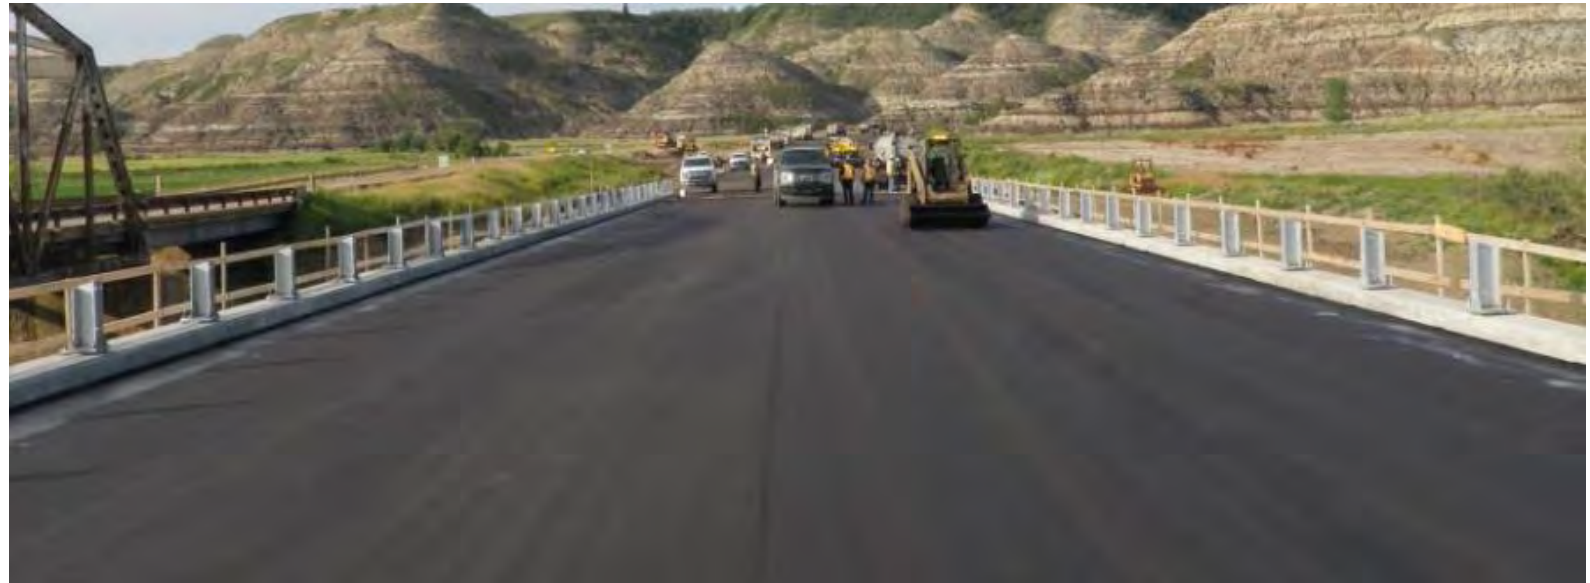
Jul. – Aug. 2019

- Casting approach slabs and bridge curbs
- Deck waterproofing and asphalt
- Approach roads and boat Launch access

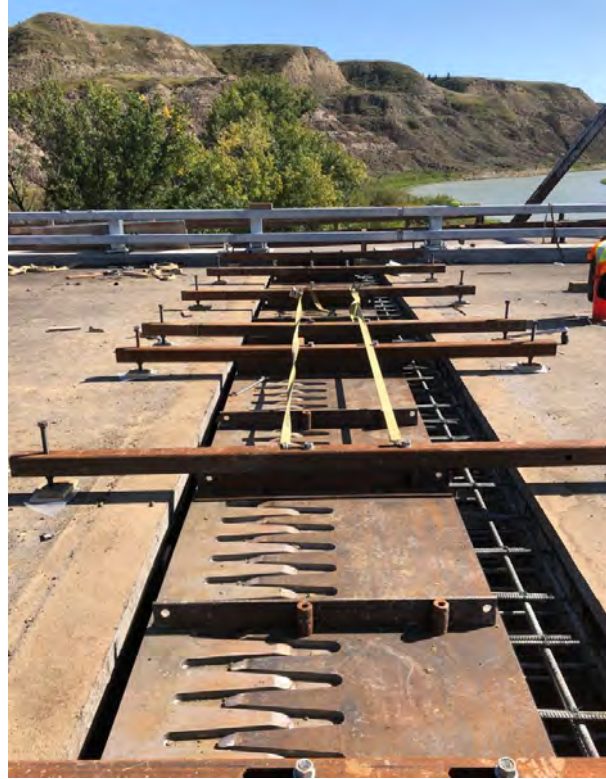
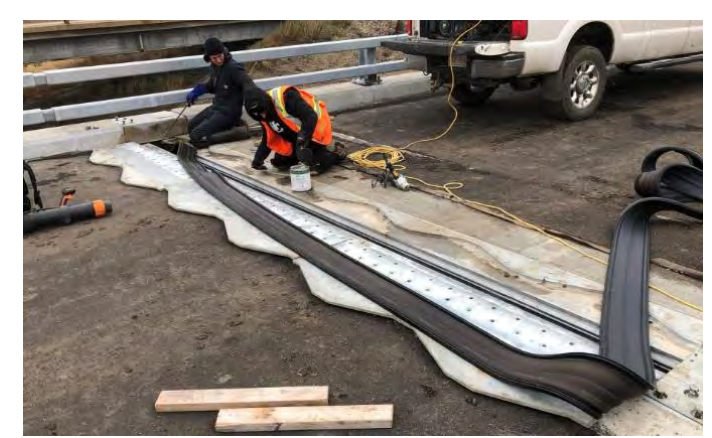
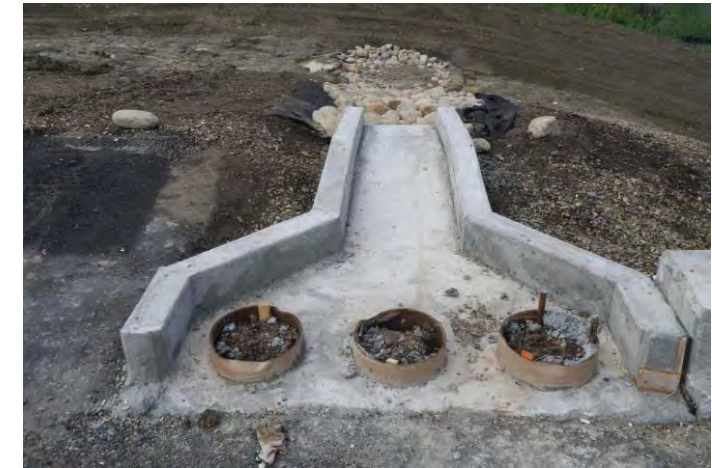
Sep. – Oct. 2019

- Finger joint in east abutment
 - First finger joint to be installed per TEC bulletin 96 (after application of all superimposed dead loads)
- Seals for west abutment joint
- Drain troughs
- Boat launch access near east abutment
- Paving and finishing details

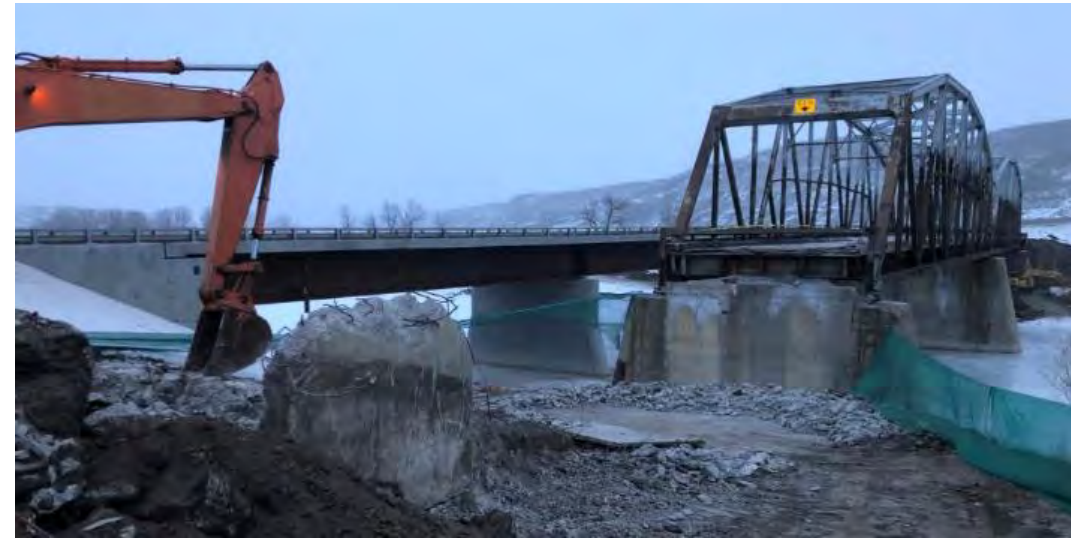
Existing Bridge Demolition, Jan. – Mar. 2020

- Flooded the ice to build ice bridge
- Removed west approach and demolished west abutment
- Removed east approach and demolished east abutment
- Phase break Jan. 27 to Feb. 17
- Demolished the deck
- Demolished the west pier starting from top

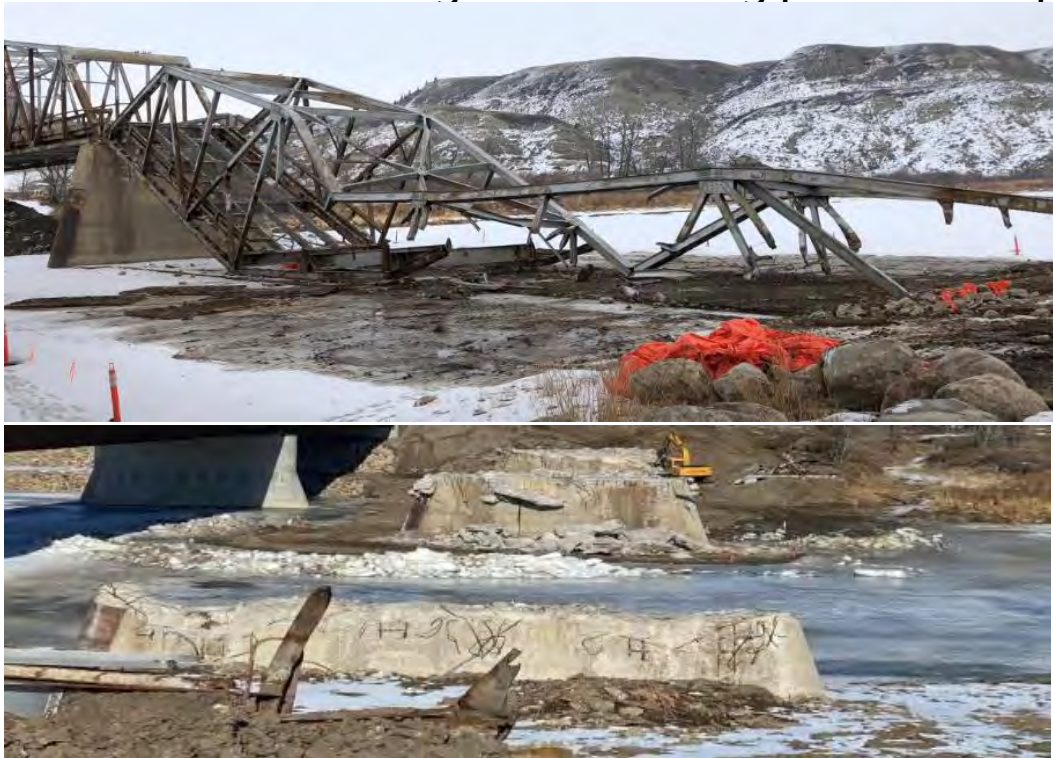
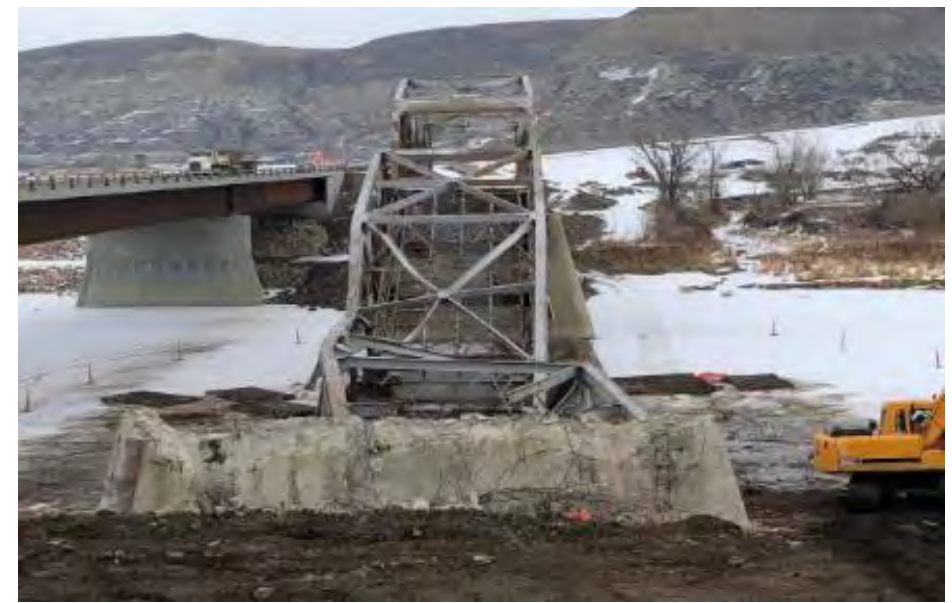
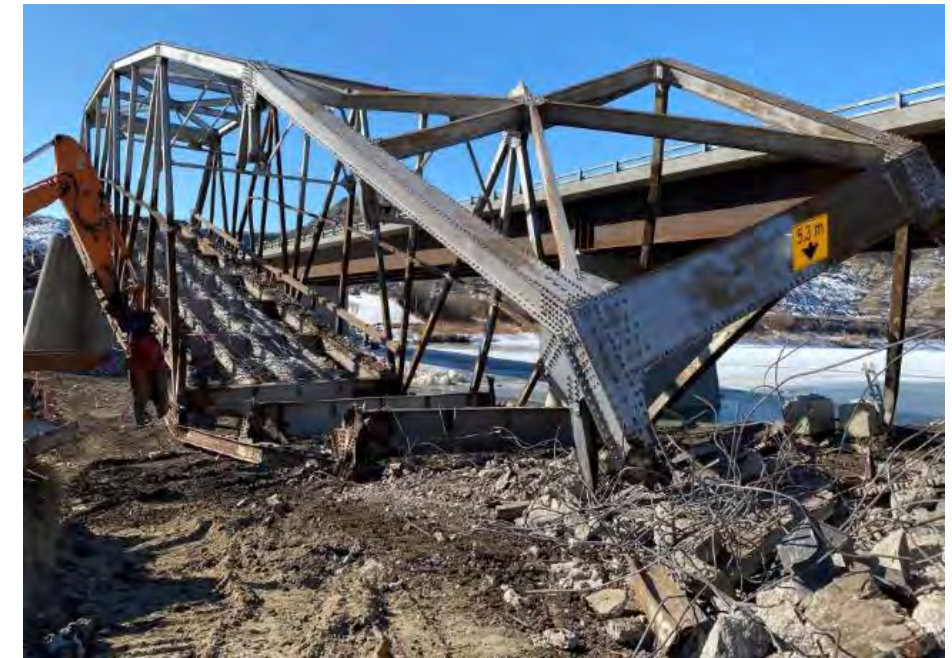
Existing Bridge Demolition, Cont.

- Continued with demolishing west pier to allow the truss to fall on the ice from one end
- Dismantled the truss
- Similar process with the second truss
- Finished with demolishing the remaining parts of the piers

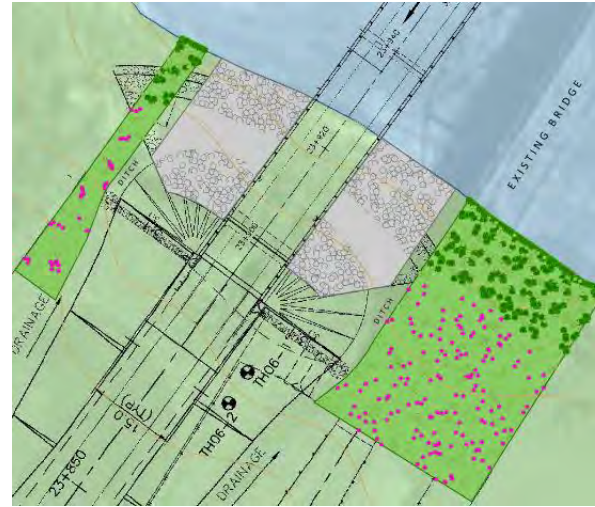
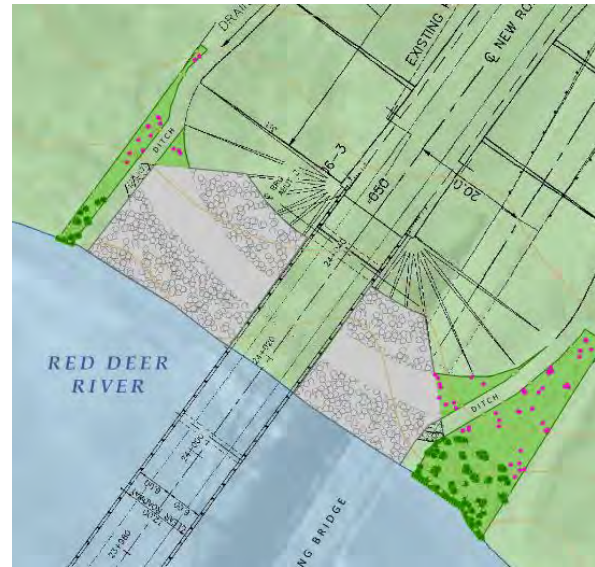
Offsetting Plan

- Authorization required for permanent instream work under Fisheries Act
- Permanent instream work:
 - Piers in the river (footprint smaller than existing bridge)
 - Protection rip-rap
- Offsetting Plan provided to propose measures to counterbalance any possible serious harm to fish and maintain or improve fisheries productivity
- Proposed Offsetting Plan
 - Instream habitat: Extended keyed in class 3 rip-rap toe to form scalloped shoreline with short spurs
 - Riparian offsets: Riparian area planting including weed removal, seeding, planting, irrigation, and applying deterrent
 - Offsite replacement of a hanging culvert (not in Jacobs scope)

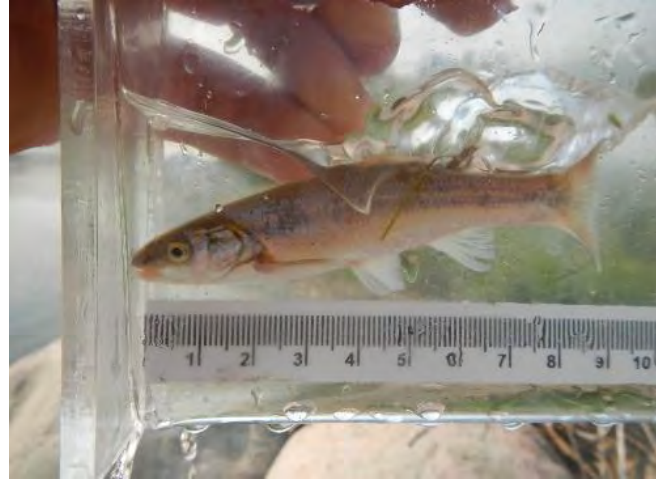
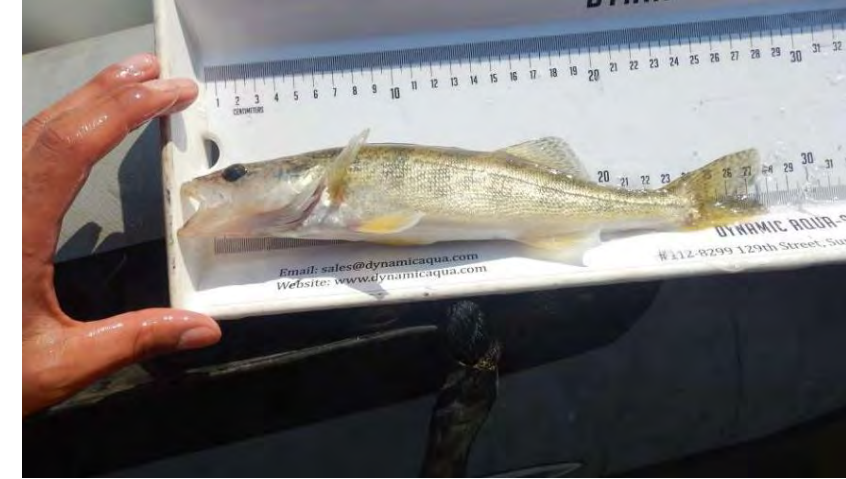
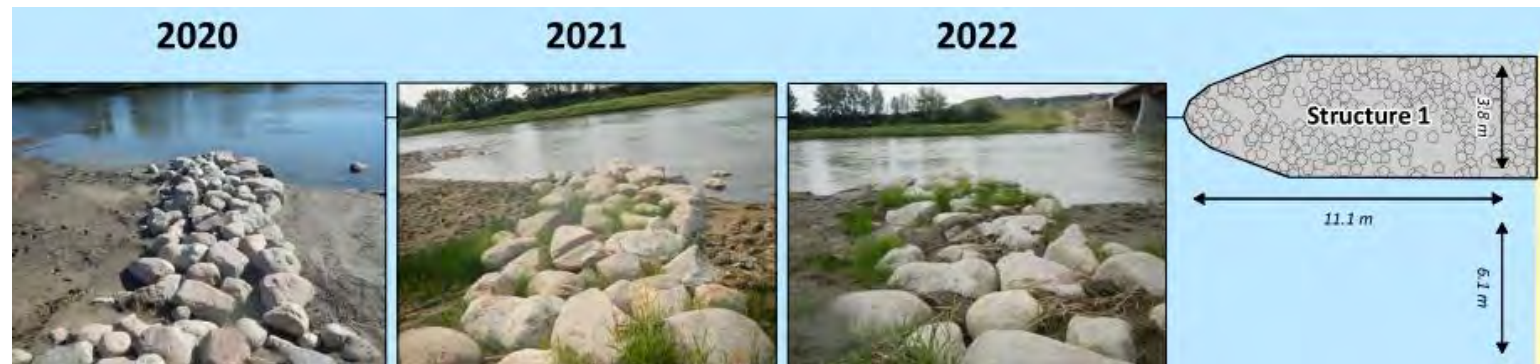
Post Construction IM – Aquatics – 2021 and 2022

- Fish sampling to compare scalloped shoreline and spurs with adjacent unenhanced areas to confirm presence/absence and relative abundance
 - Documenting site conditions for comparison with the as-built design and for year to year comparison of structural integrity
- Fish sampling conducted using a float electrofisher (FLEF) or a backpack electrofisher (BPEF)
- The new instream habitat offsetting was determined to be effective in providing flow breaks, with some small pool creation, and providing complexity that would be of better use to several fish species.

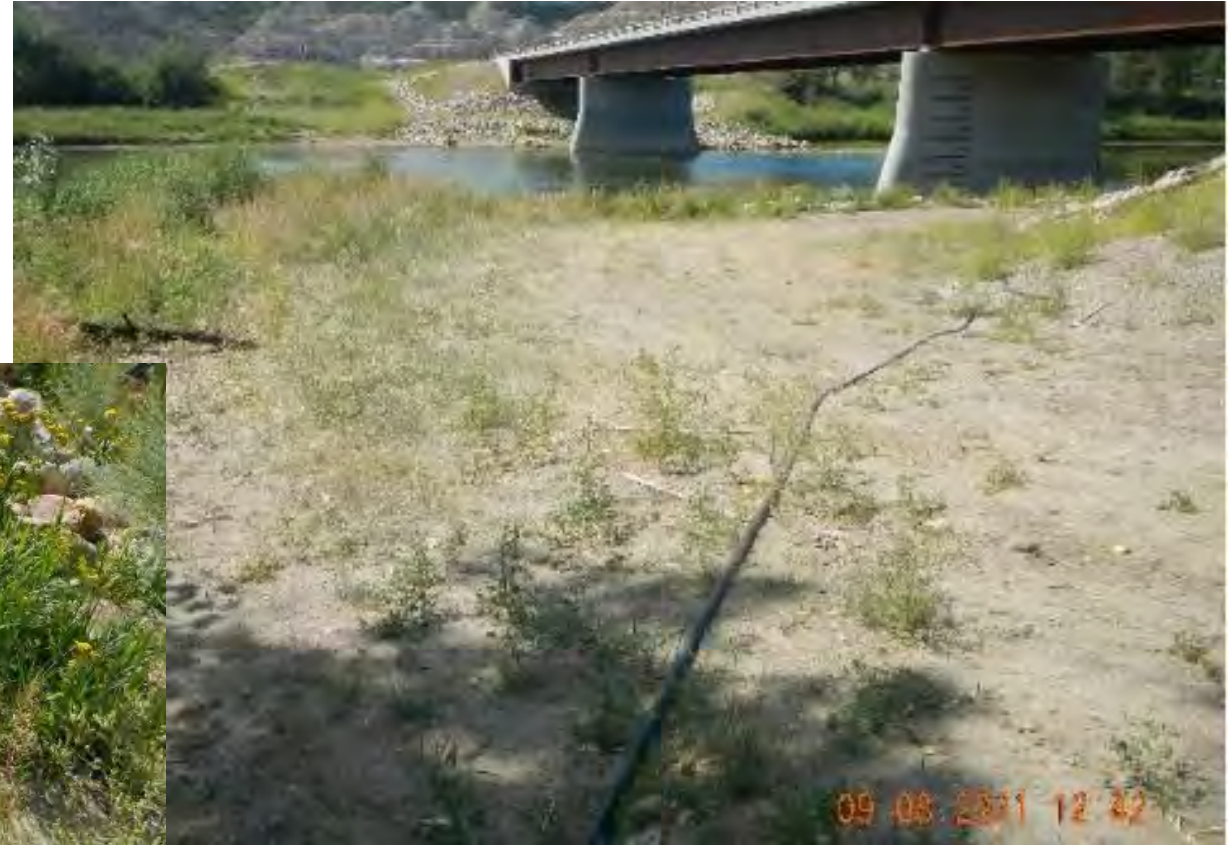
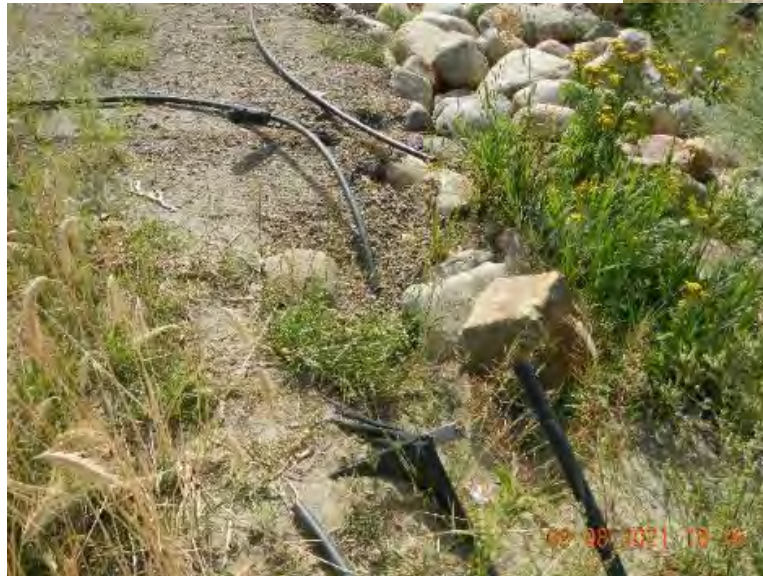
Post Construction IM – Vegetation– 2021 to 2023

- Assess plant survival using the ratio of number of live plants to number of those installed in 2020 (survivability) – target of 80%
- Low survivability observed in 2021 inspection (27%)
 - Damages due to public access (Vehicles driving through the site, dragging canoes, fire pit under the bridge, irrigation lines cut)
 - Hot and dry season
 - Noxious weeds
