Replacement of Red Deer River Bridge near Morrin (Morrin Bridge)

Presentation prepared for Transportation Connects Alberta Conference
Edmonton, Alberta, March 2025

Azita Azarnejad, Ph.D., P.Eng., FCSCE, Jacobs

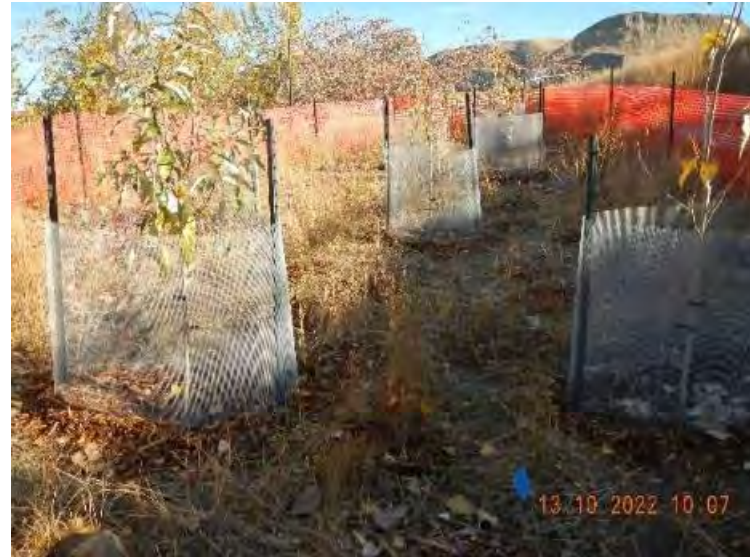
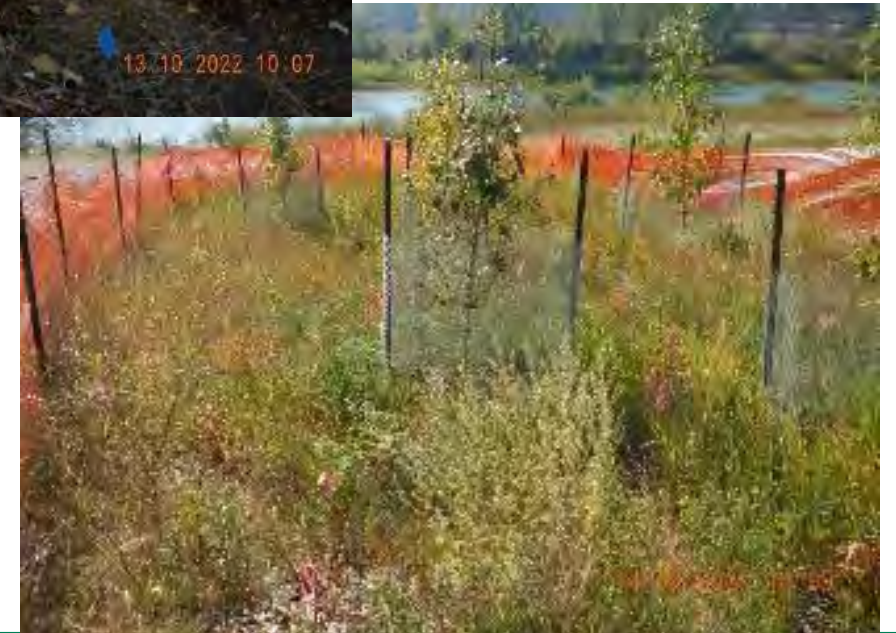
Post Construction IM – Vegetation– 2021 to 2023 – Cont.

- Contingency planting offset plan submitted and approved in 2022 and planting conducted Sep. 2022
 - Planting outside the areas accessed by public
 - Planting larger plants in clusters with bark mulch and fencing
 - Emulating the adjacent native vegetation
 - Touching up seeding
- Removed weeds and watered plants in 2022 and 2023
- Healthy growth was observed in 2023 and target was met
- All conditions of authorization were satisfied

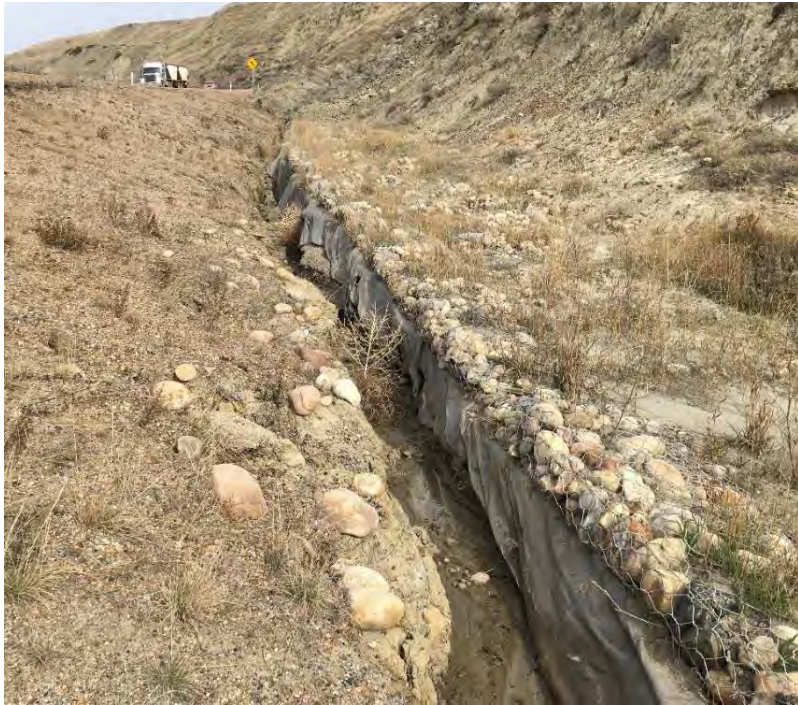
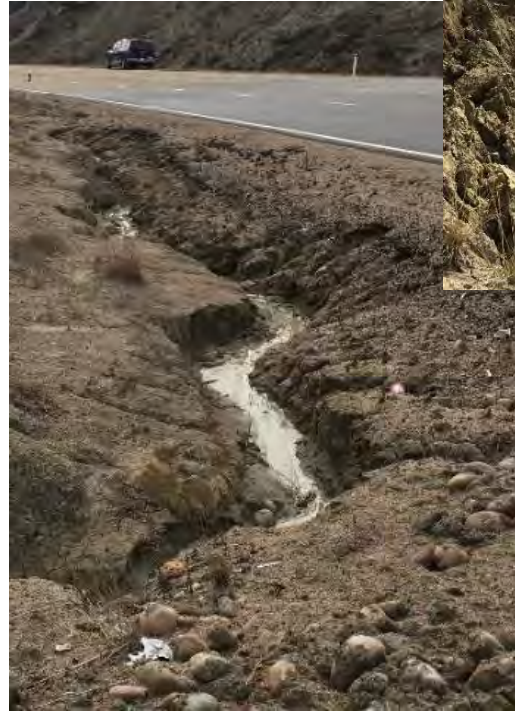
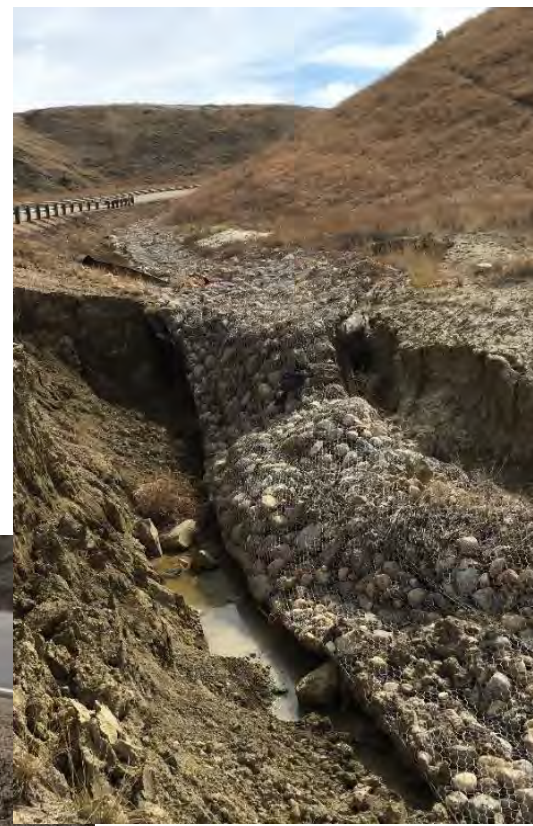
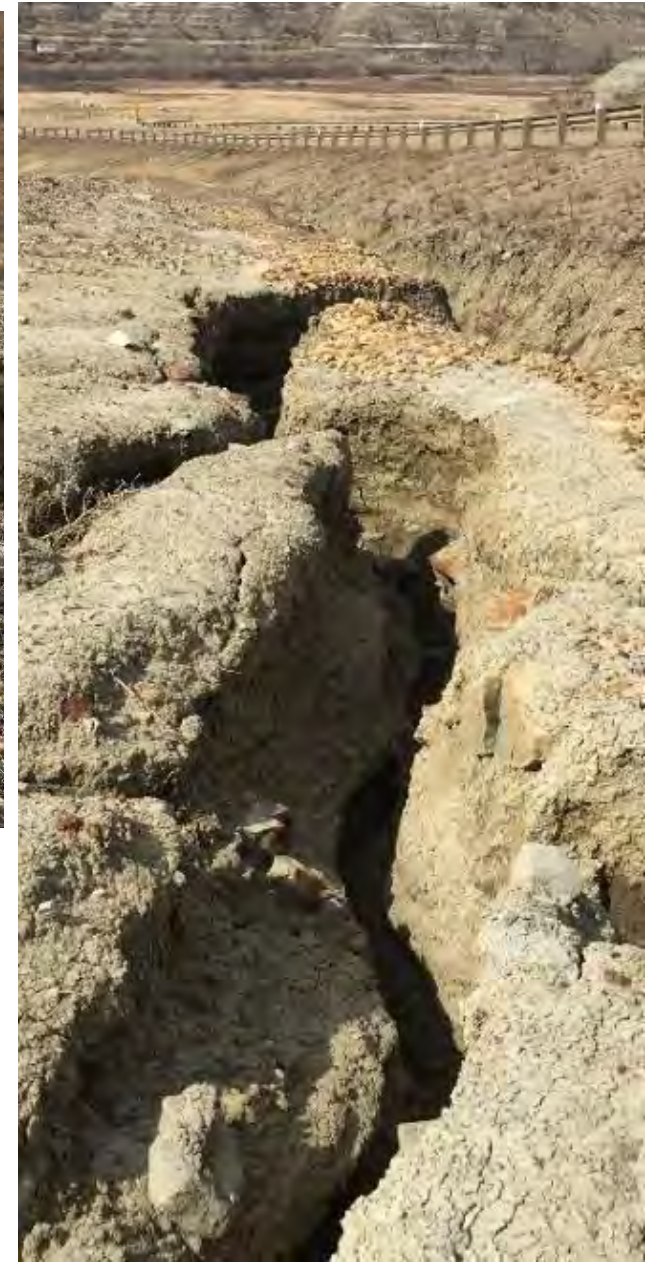
Erosion Control - Preconstruction

- On-going erosion on site due to soil condition
- Redesign of erosion control required during tender due to changes in site condition

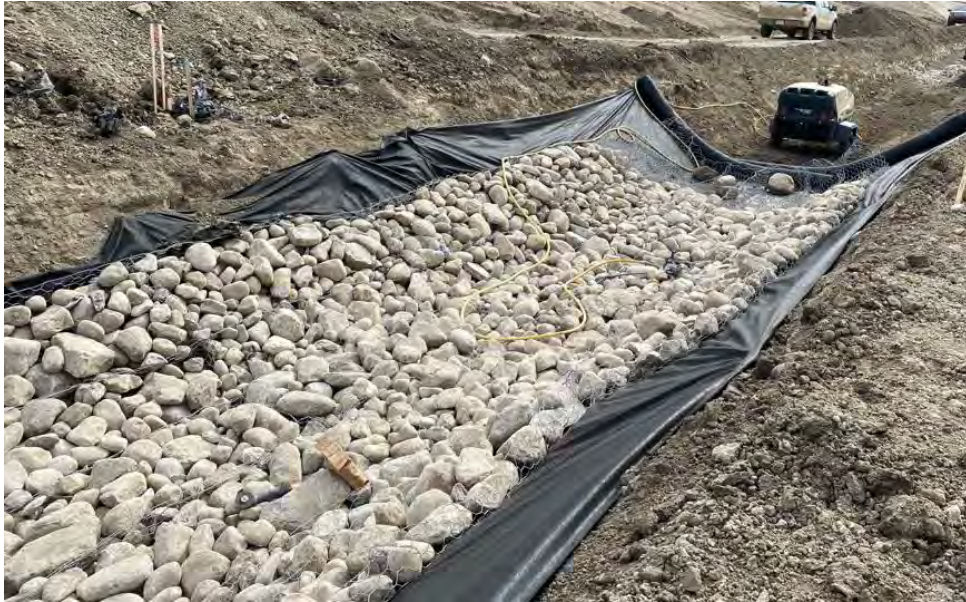
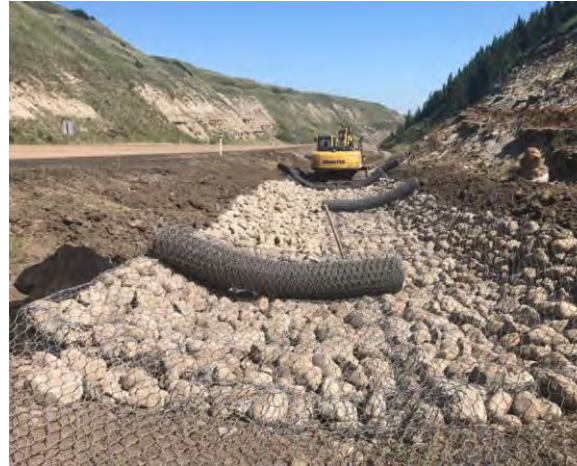
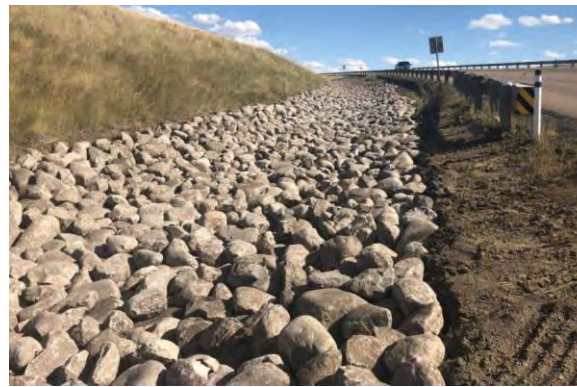
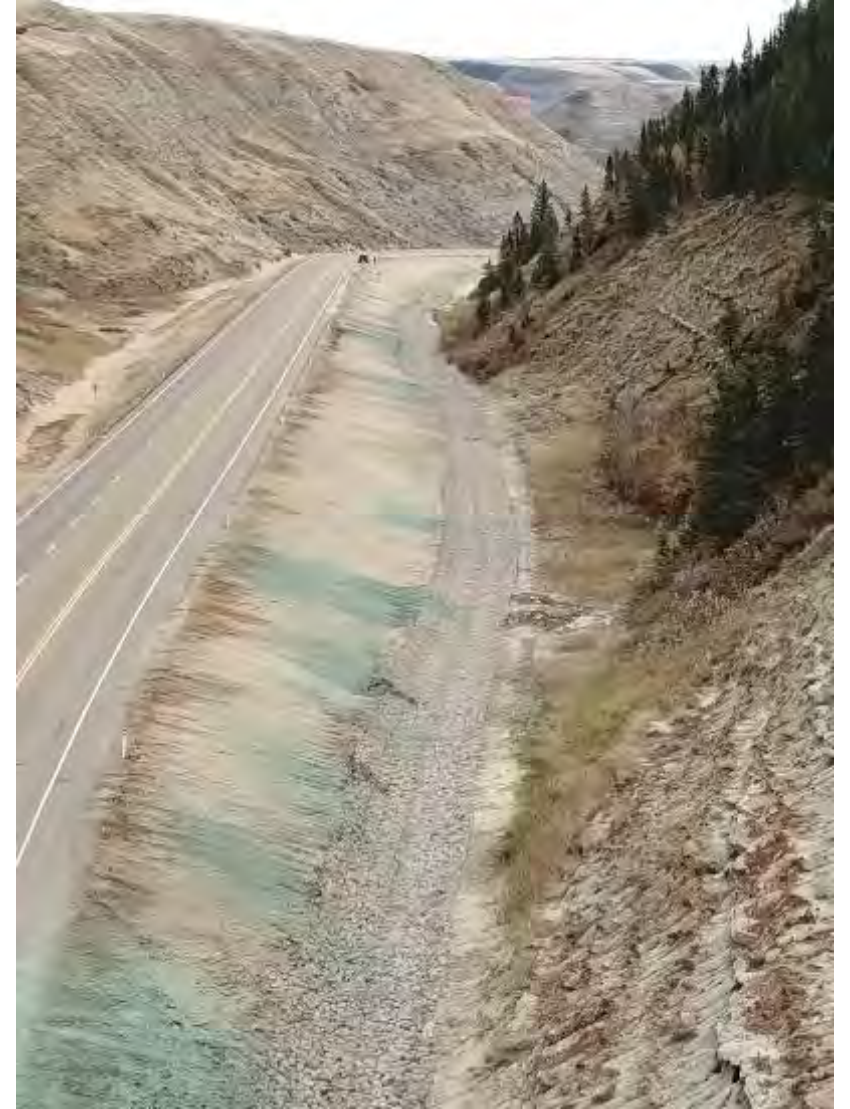
Erosion Control

- Extensive erosion control work included in the project

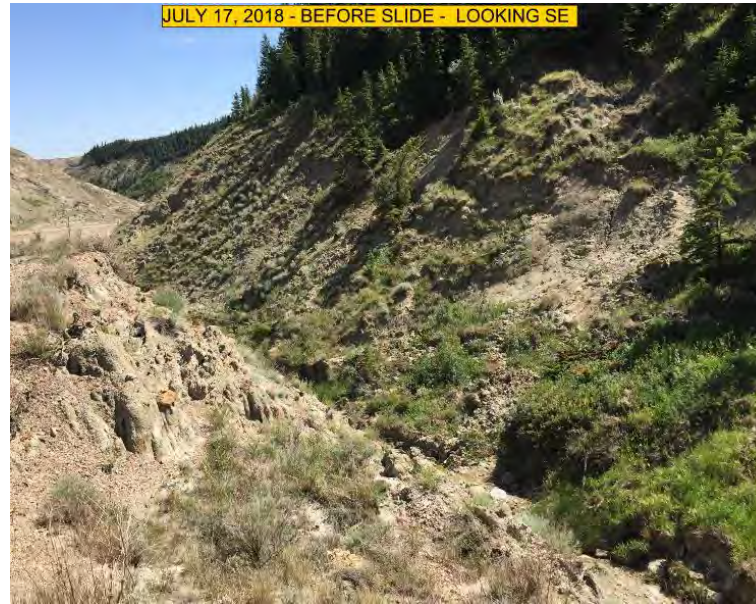
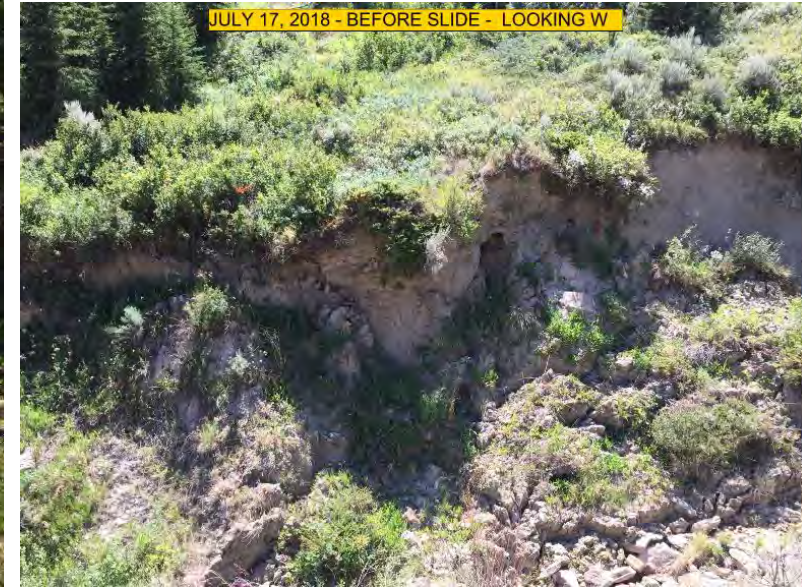
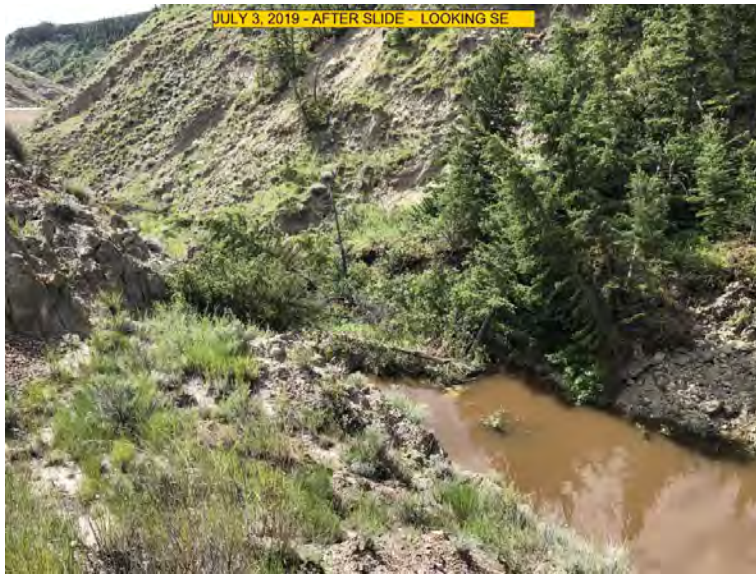
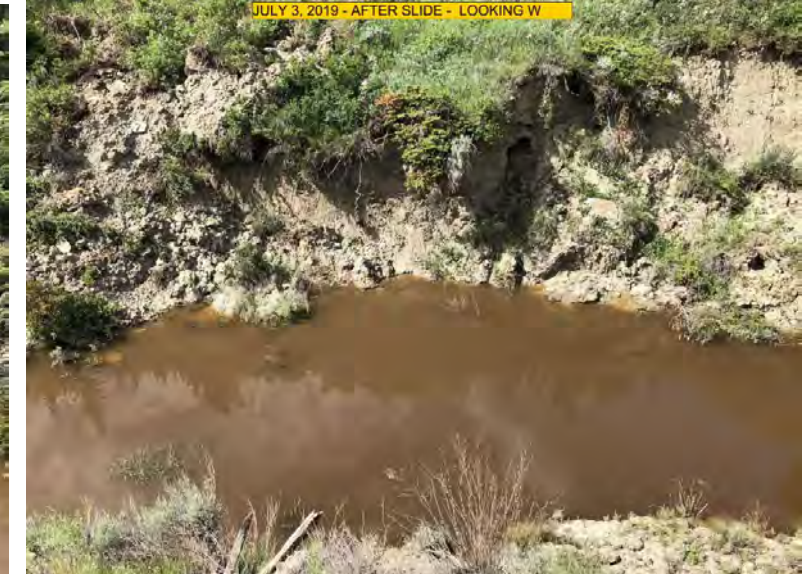
Erosion Control - Landslide

- Landslide in SW in 2019
- Water ponding after landslide

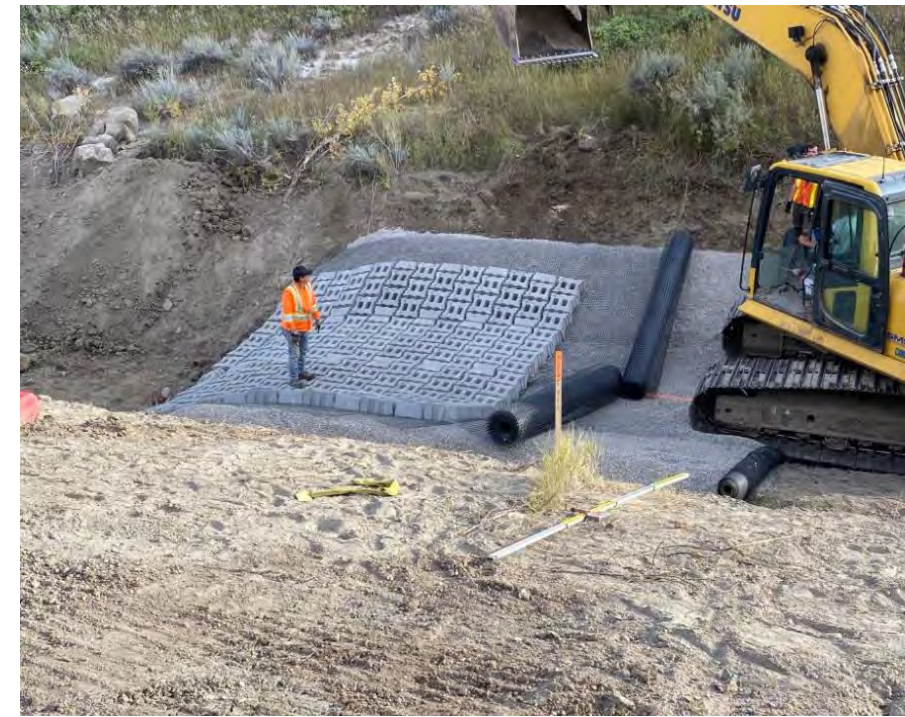
Erosion Control – SW After Land Slide

- Redesign of erosion control in SW ditch after landslide
- Design included stilling basins

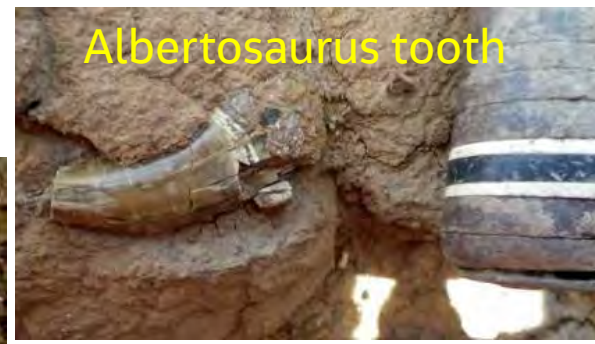
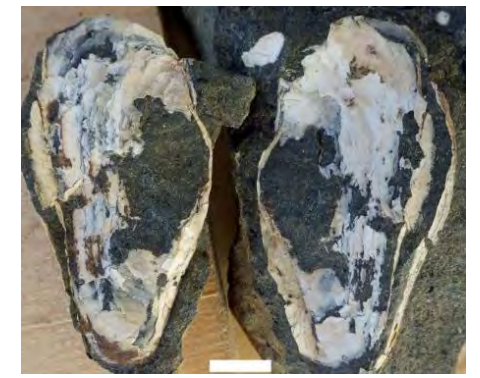
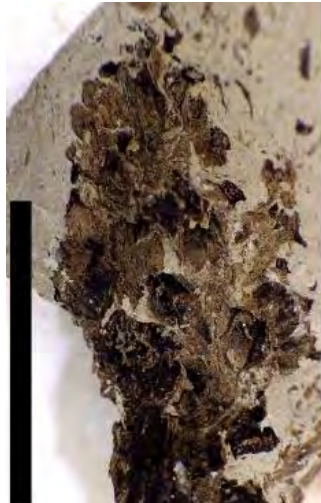
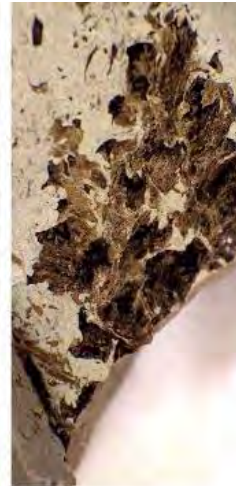
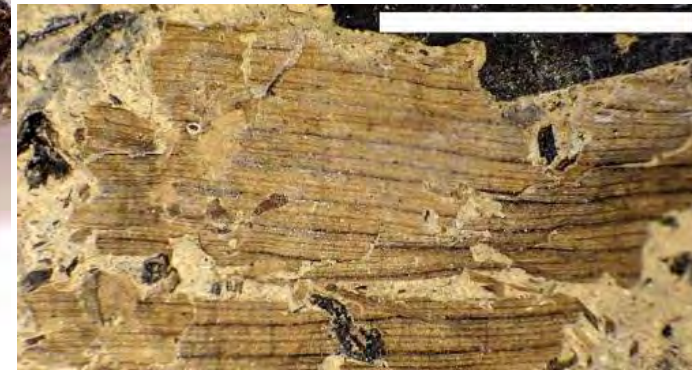
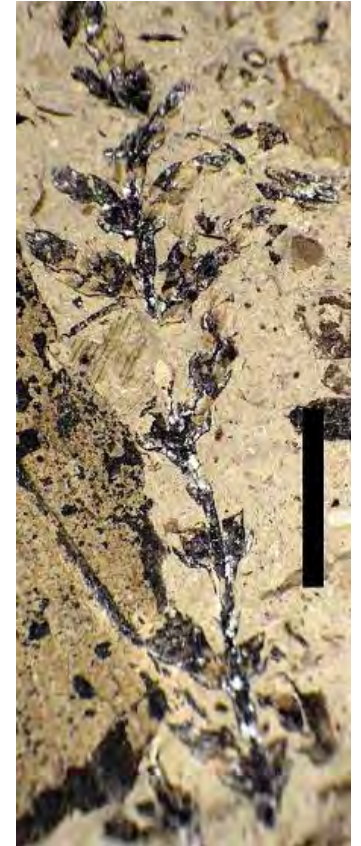
Paleontological Monitoring

- Extensive stage I and stage II archeological investigation at design phase
- Concern: Potential to encounter significant fossil material
- Objective: Document and salvage any significant fossil material and recommend subsequent mitigative measures, if needed
- Areas warranted exploration:
 - Concrete pile and bridge pier excavations
 - Roadbed and ditch repair work
 - Coring excavation under the highway
 - Upper east side borrow pit
- Fossils observed on site
 - Dinosaur bones fossils
 - Plant remain fossils
 - Invertebrates fossils
