# Highway 14 Grade Raise at Range Road 30

# Project Background

- Highway 14:16 rehabilitation from Highway 41 (Wainwright) to Saskatchewan Border (55.562 km);
- Grading work included:
  - Grade raise at Range Road 30;
  - Two intersection upgrades;
  - Approach removals, construction and sideslope improvements.
- Total surfacing quantities included approximately:
  - 168,000 tonnes of ACP;
  - 28,000 tonnes of Granular Fill;
  - 15,000 tonnes of GBC.

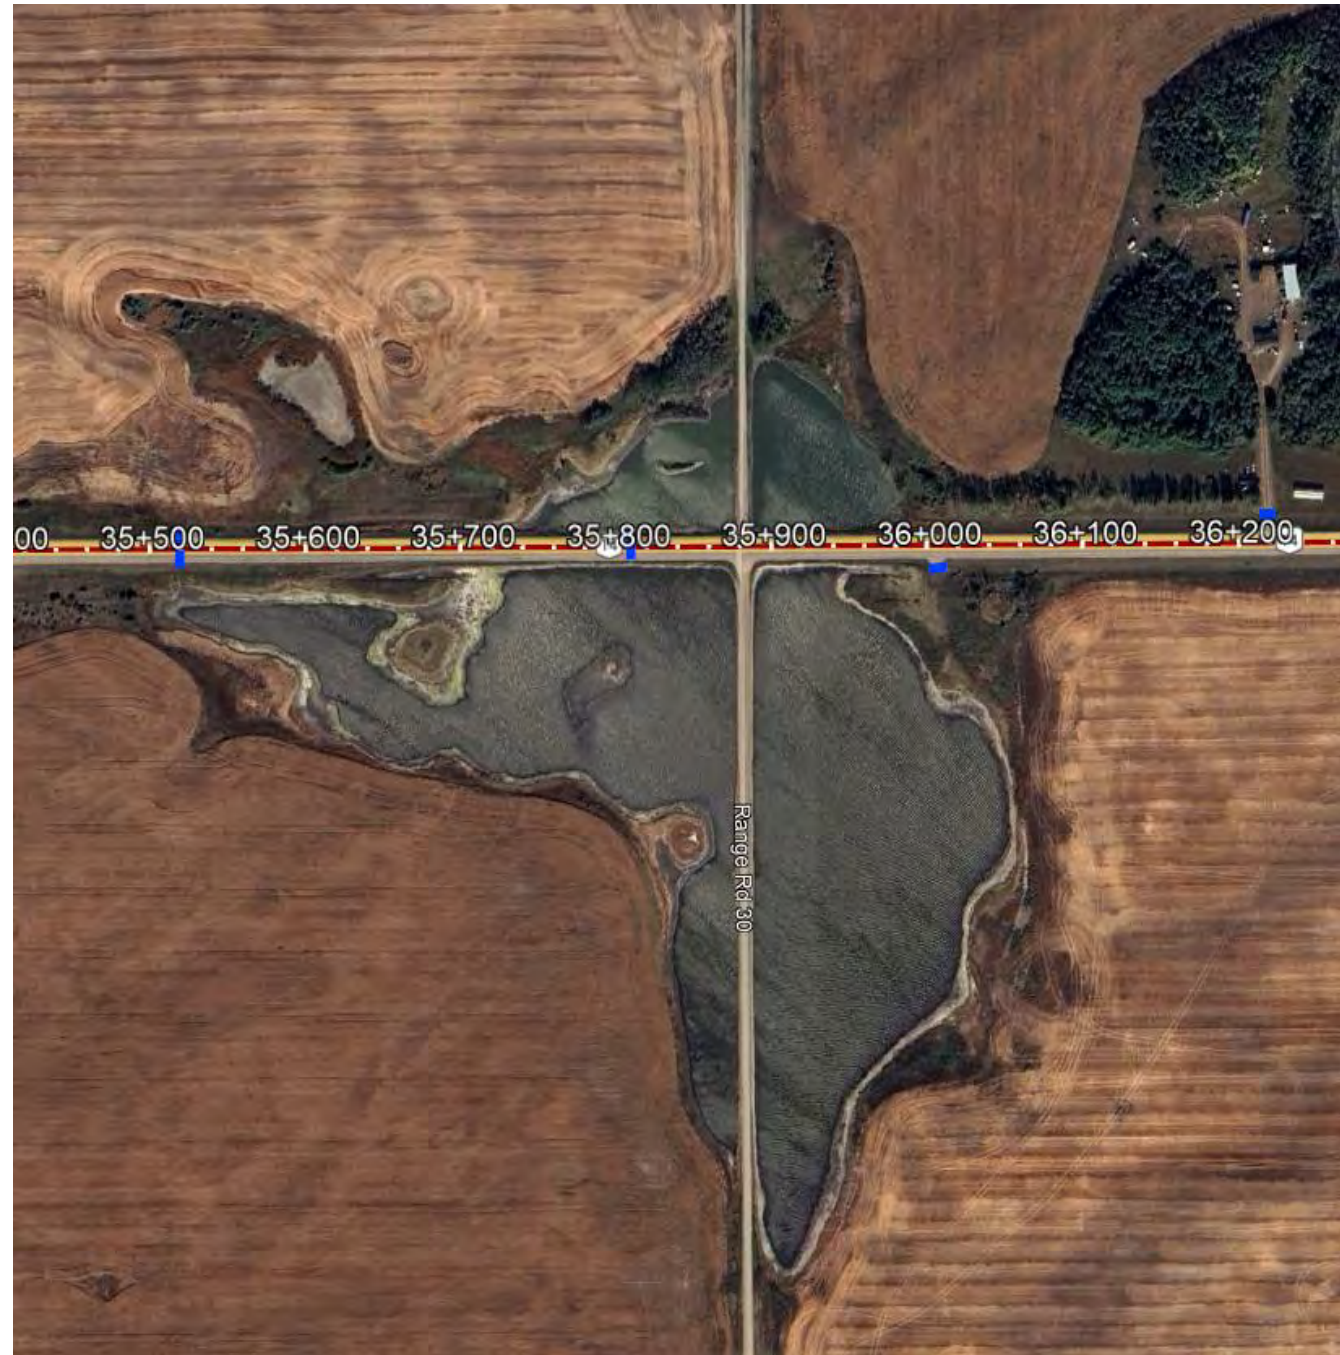
- Grade Raise at Range Road 30:
  - Intersection in a low-lying area and has experienced historical flooding and overtopping of the range road;
  - TEC maintenance forces often had to pump water away in the spring to mitigate risk of overtopping the highway;
  - TEC wished to permanently solve the issue by raising the grade of Highway 14 and physically removing portions of Range Road 30.

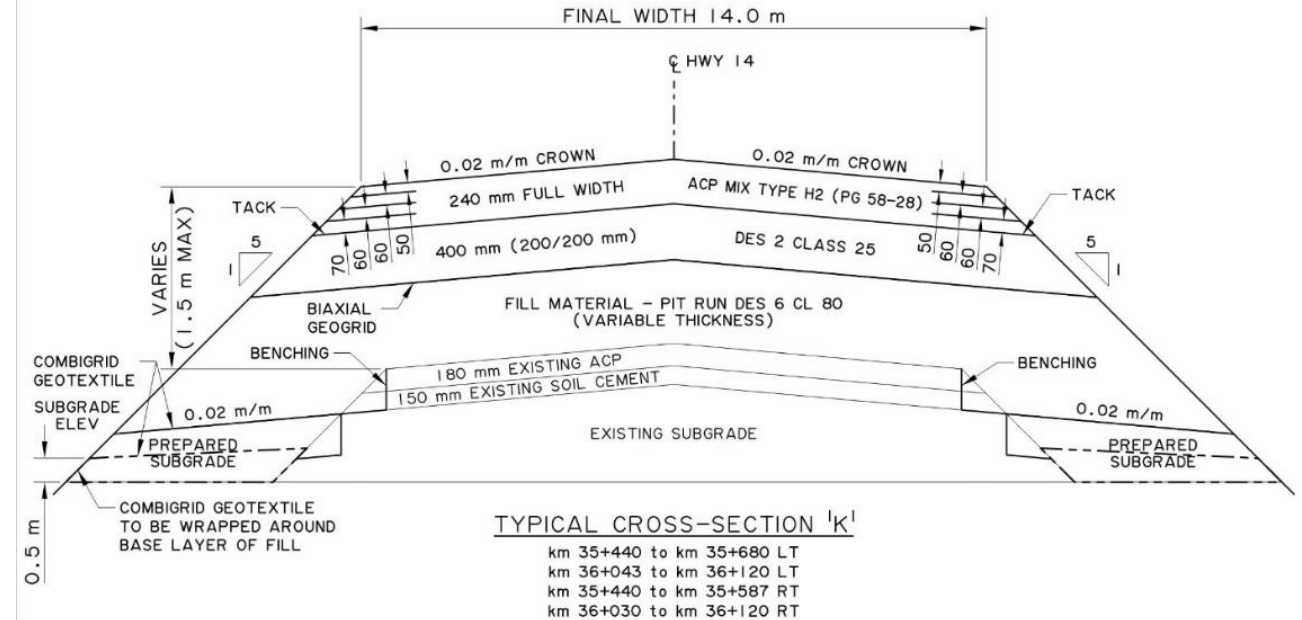
- Surfacing design by Tetra Tech
  - 240 mm ACP/400 mm GBC/variable thickness Pit Run to elevation of Hwy 14 existing subgrade;
  - Biaxial geogrid on top of pit run, non-woven geotextile on top of subgrade;
  - Stantec replaced non-woven geotextile with combi-grid product and added layers in subgrade.
- Geotechnical site investigation by Hoggan Engineering
  - Drilled along Hwy 14 to confirm existing conditions;
  - Drilled existing Range Road 30 to determine suitability of existing material for use in grade raise;
    - Decent material for top ~1 m below existing elevation of Range Road 30.
  - Hand auger investigation for existing organic depths along Highway 14.
    - Found up to 1 m of organics.

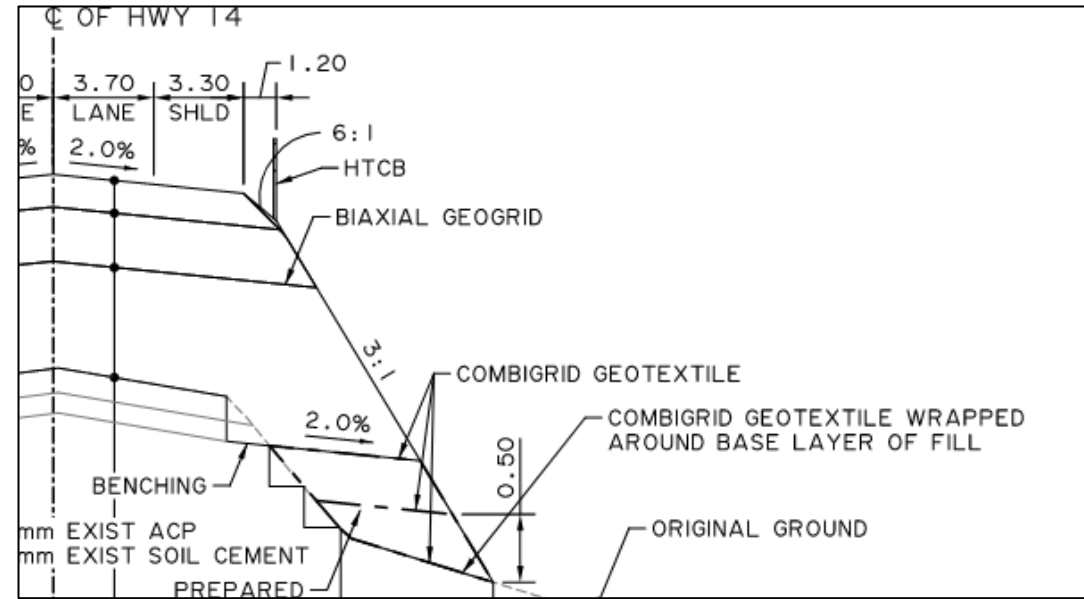
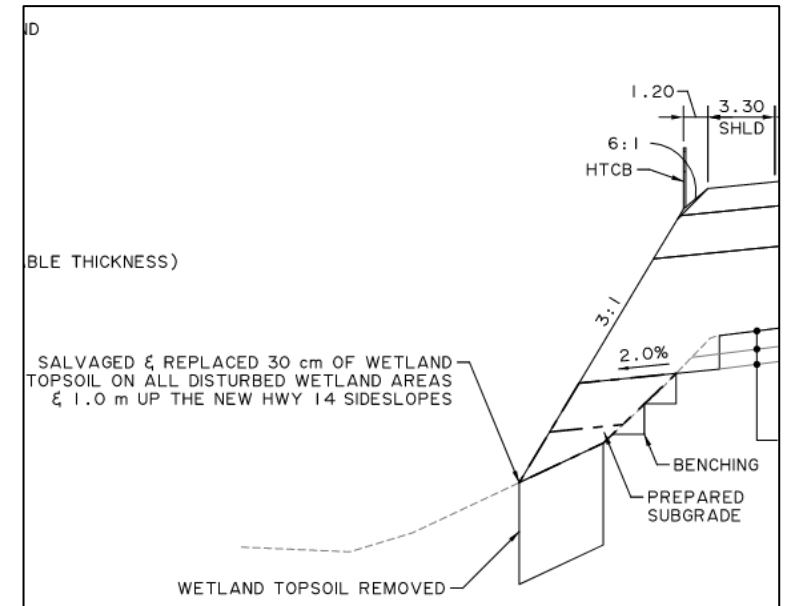
- Traffic Accommodation
  - No closure of Highway 14 or detours on local roads;
  - Highway 14 on OSOW (High Load) corridor.
- Base layer of subgrade
  - 0.5 m base layer with as much compaction as possible to support construction equipment;
  - Base layer to be wrapped with combigrid for strength and containment of layer;
  - Naue 60/60 combigrid selected.
- Isolation/Dewatering
  - Specified that water had to be managed along Highway 14 – construction could not occur in the wet;
  - Range Road 30 removal could occur in wet.
- Wetland organics
  - Needed to be salvaged and spread up toe of new slope per environmental requirements.

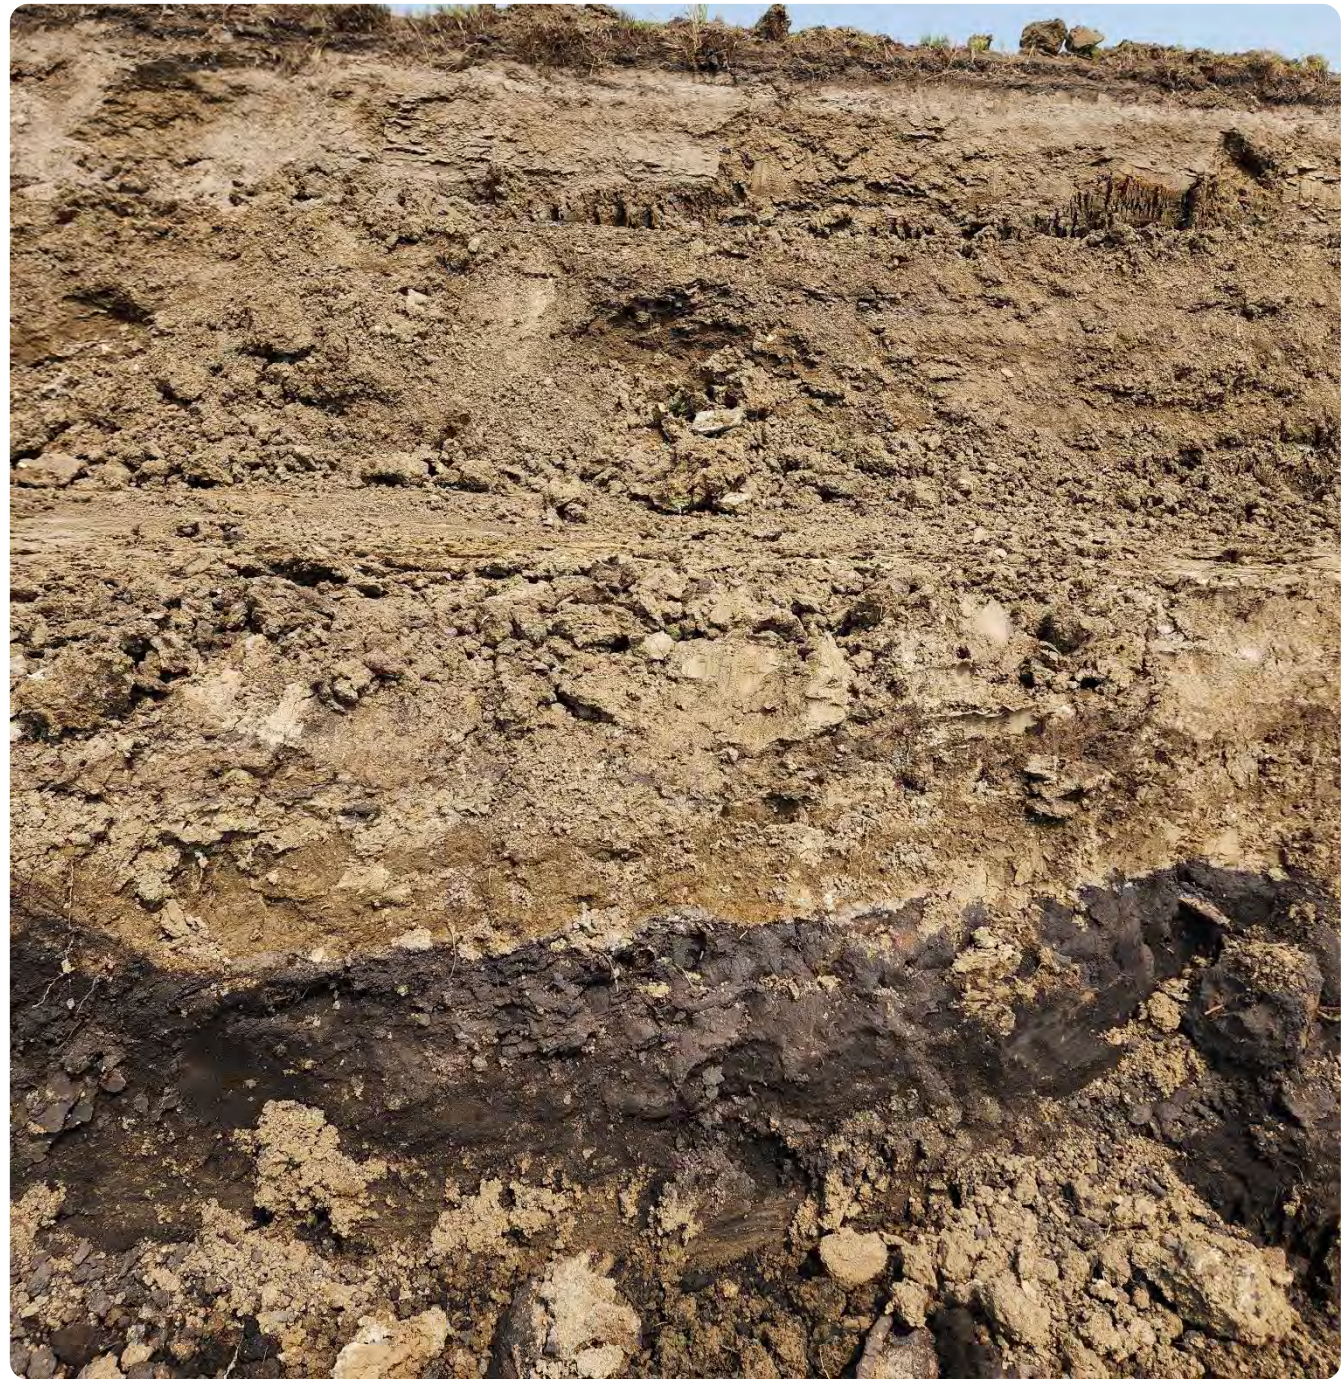
- Organic layer discovered in undercuts along Highway 14;
- Discussions in early stages about benching vs removal of organic layer;
- TEC Grade Widening spec – Sideslopes shall be benched; vertical cuts for full depth of embankment not permitted;
- **Solutions**
  - Hoggan recommended benching depth of 1 m.
  - Top layer of cut (above organics) suitable for embankment construction.
  - Unsuitable material can be used at toes of fill.
- **Lessons Learned**
  - Address benching expectations in tender. Specify benching depth in tender and/or on drawings (Specs say Consultant specifies depth of benches).

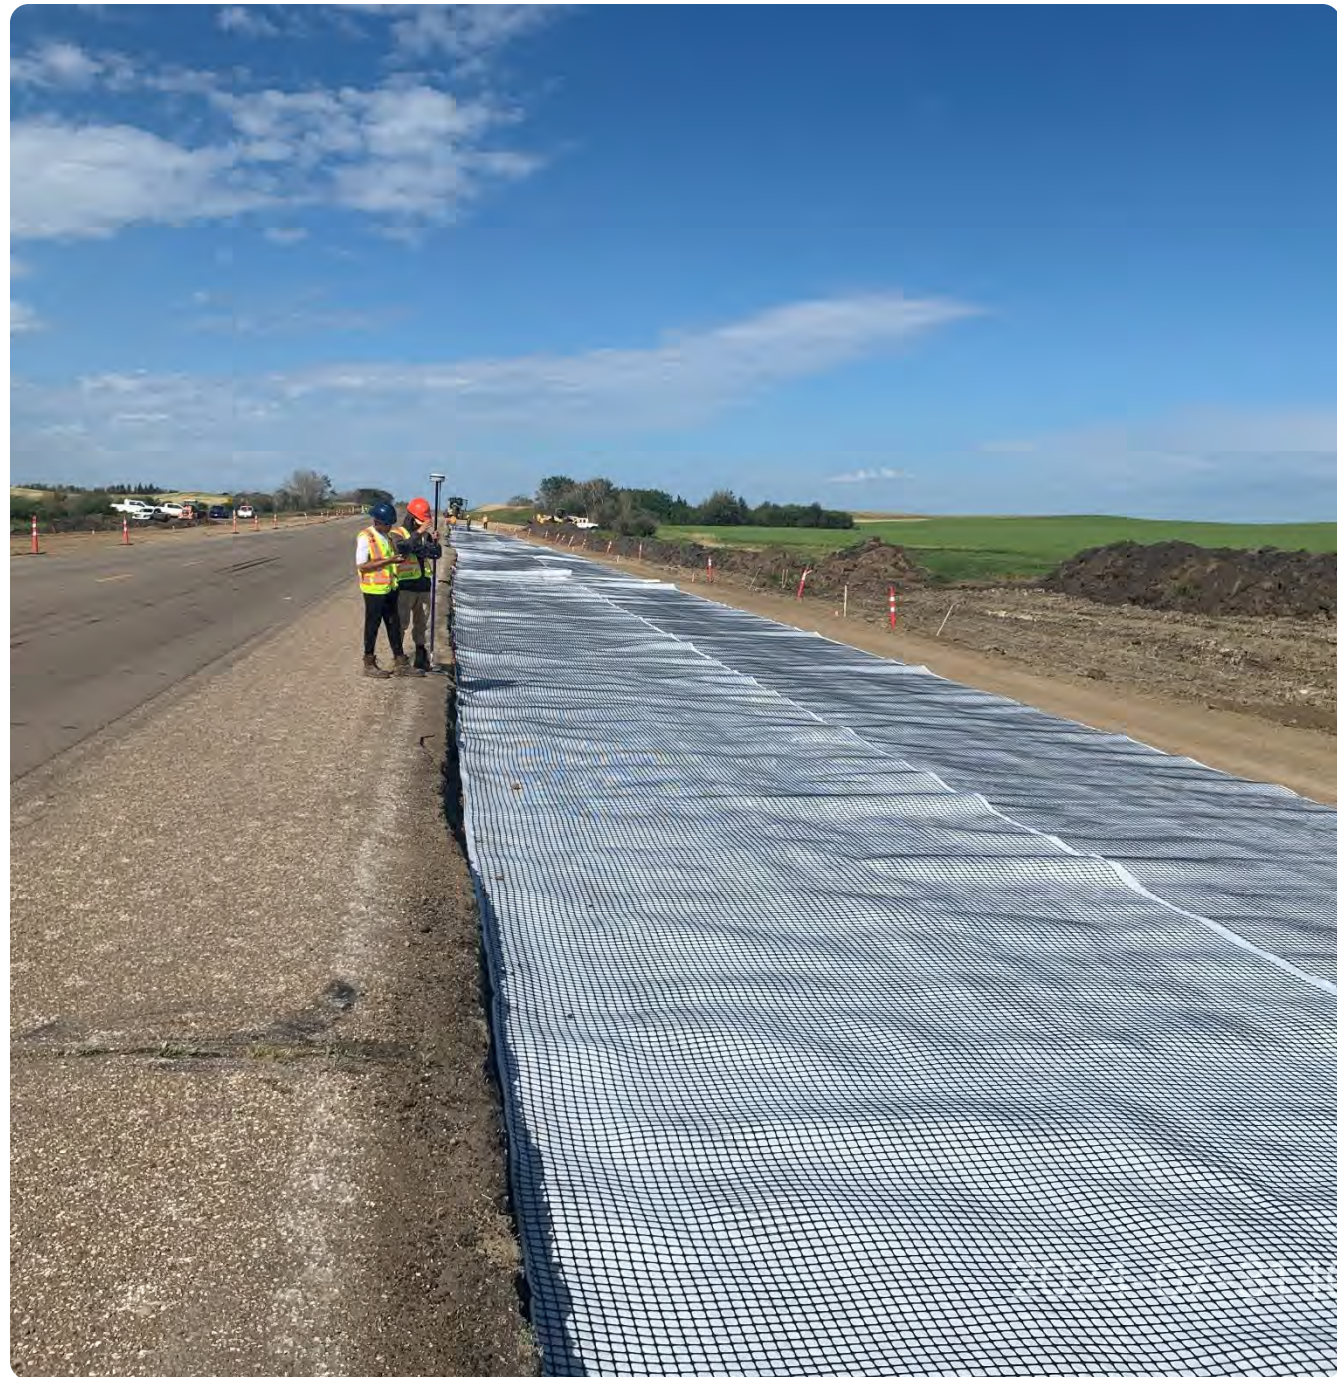
- Naue 60/60 (ie 60 KN strength) specified in design
  - Specialized product, not readily available in Canada
- CG 3131 (ie 31 KN strength) brought to site and installed in base layers west of wetland area
- Issue identified by Stantec prior to work commencing in wetland area
- **Solutions**
  - Product performing well in dry areas away from water. Keep monitoring site conditions and increase layers of combi-grid as required.
- **Lessons Learned**
  - When specifying non-typical products, check on availability prior to tendering.
  - Confirm with Contractors prior to work commencing that they are ordering correct product.

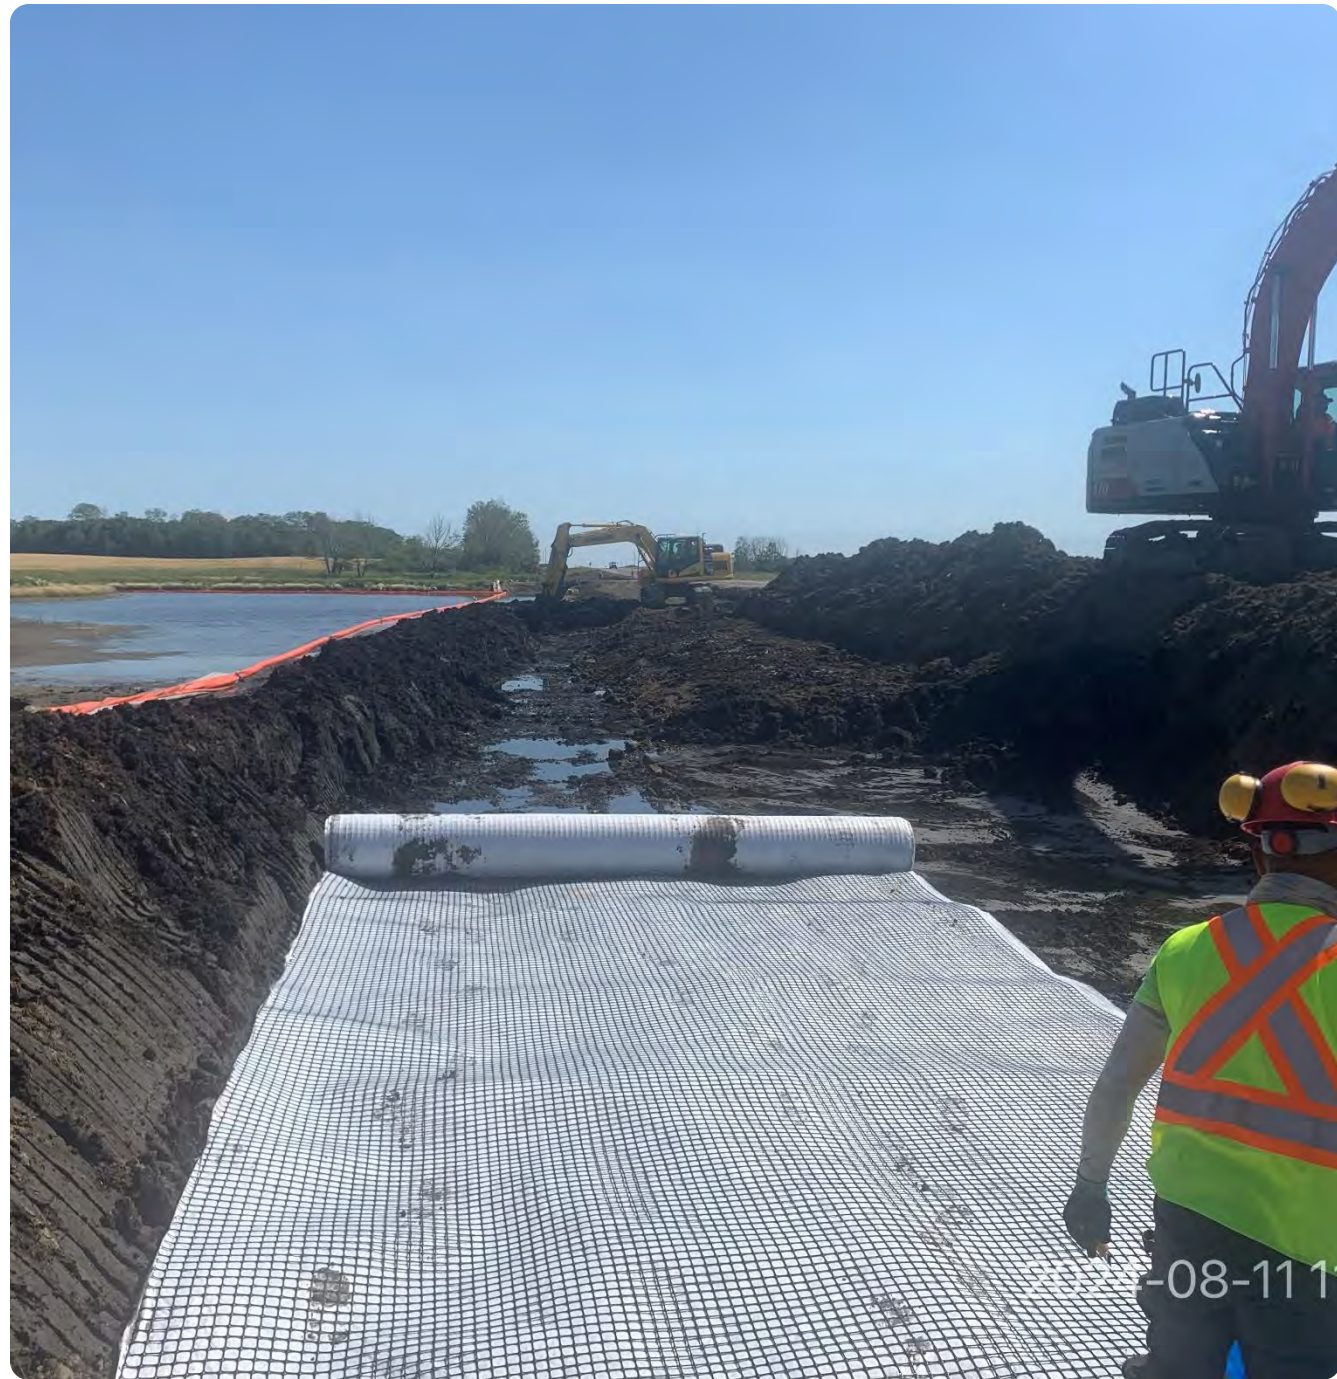
- 0.5 m base layer with combi-grid on bottom and wrapped around sides to support weight of construction equipment;
- Constructability concerns raised with wrapping of grid;
- Single layer seemed sufficient in dry areas;
- **Solutions**
  - Hoggan recommended not to wrap grid around outside of base layer. Grid can be extended up inside of bench.
  - Containment of base layer on outside achieved by not excavating all the way to design toe (leaving existing materials).
  - Number of layers of combi-grid to be determined on site. Expectation was that more layers would be needed once work began in wetland area.

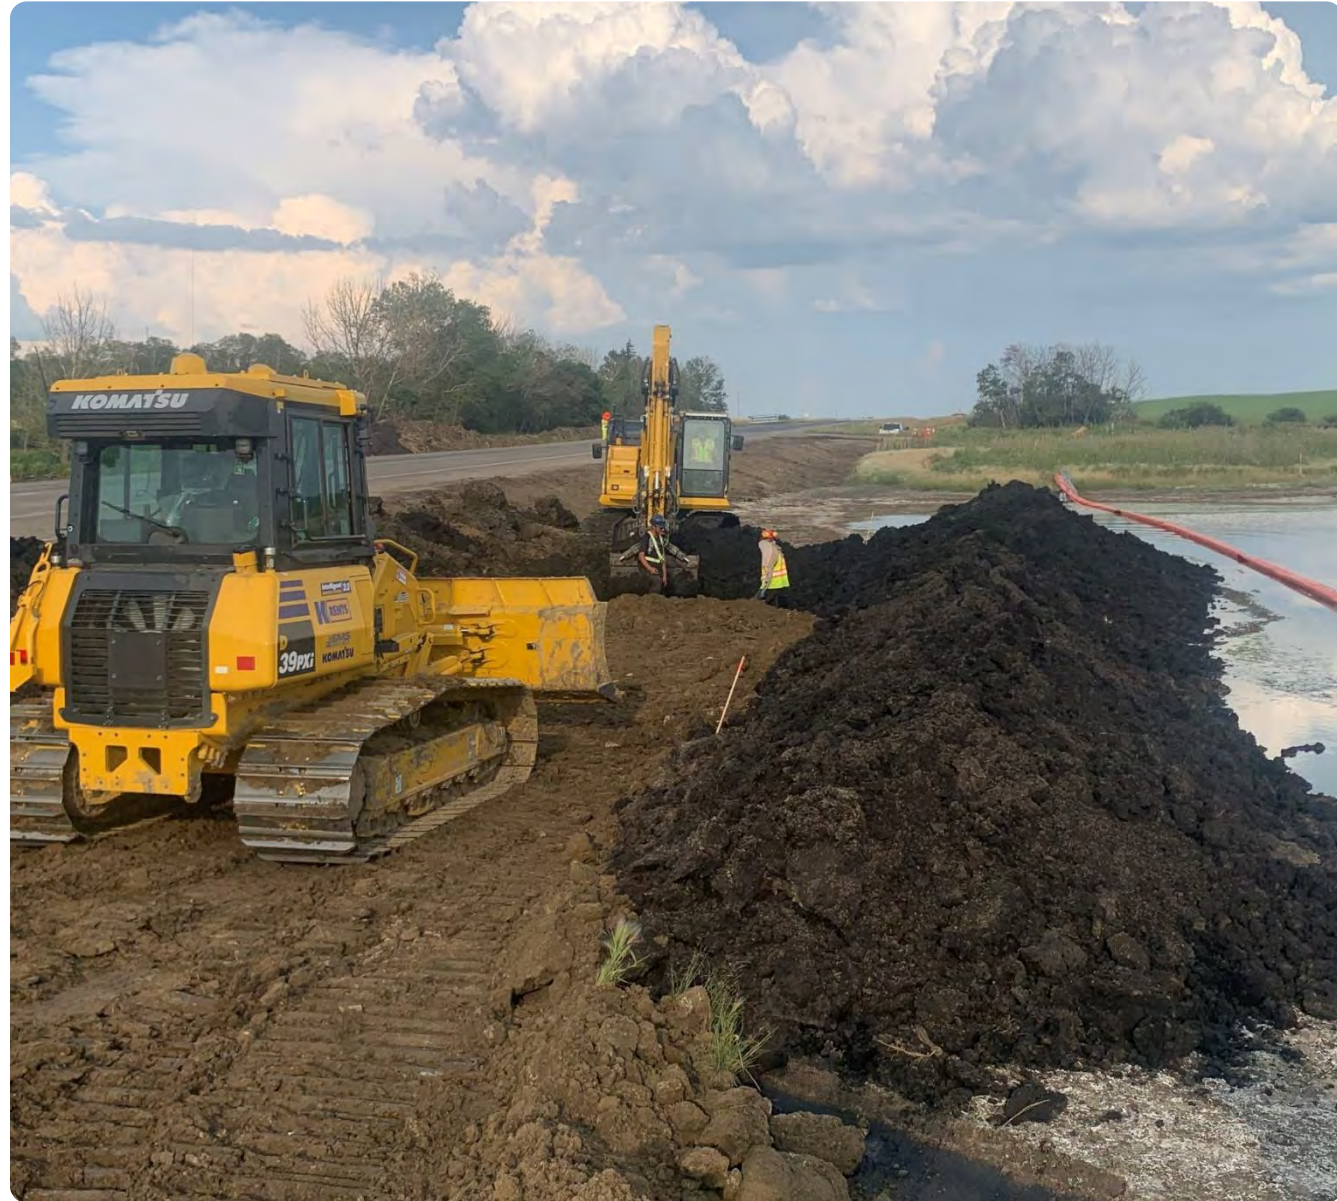
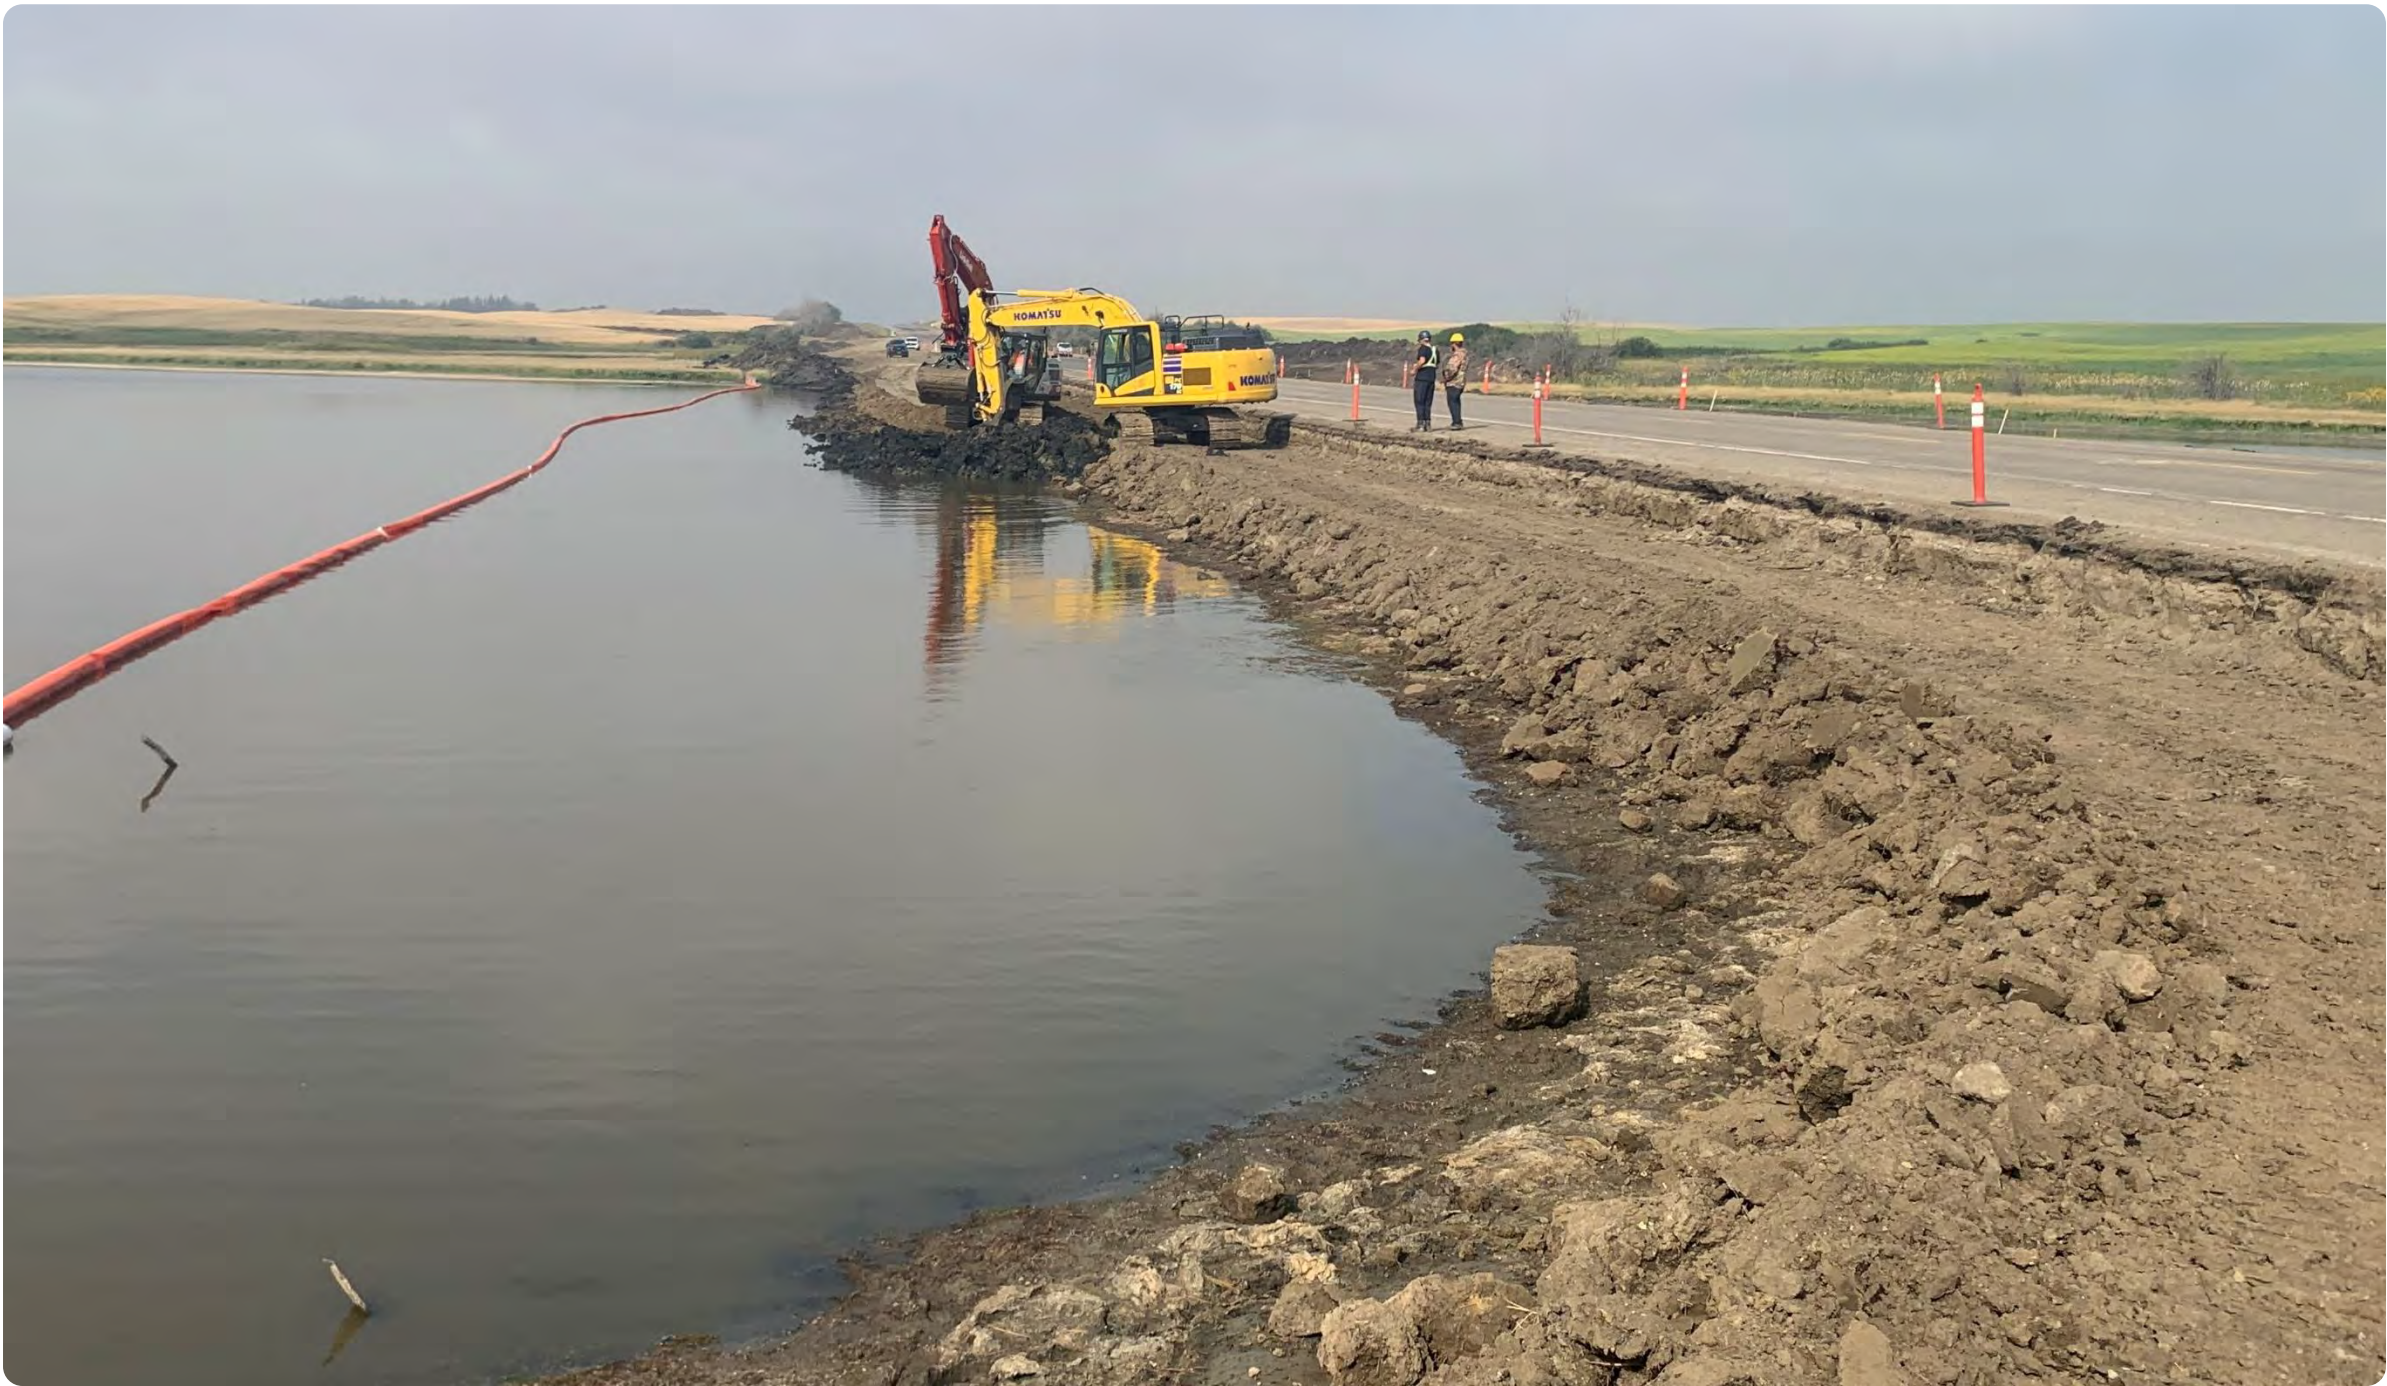
- Method of isolation proposed was to use earth material to hold water back;
- Wetland organics required to buffer clays (environmental requirement);
- Water levels lower during construction than observed in prior years;
- Base layer construction required 3-4 layers of combigrid, which ultimately worked in bridging soft/wet underlying materials.

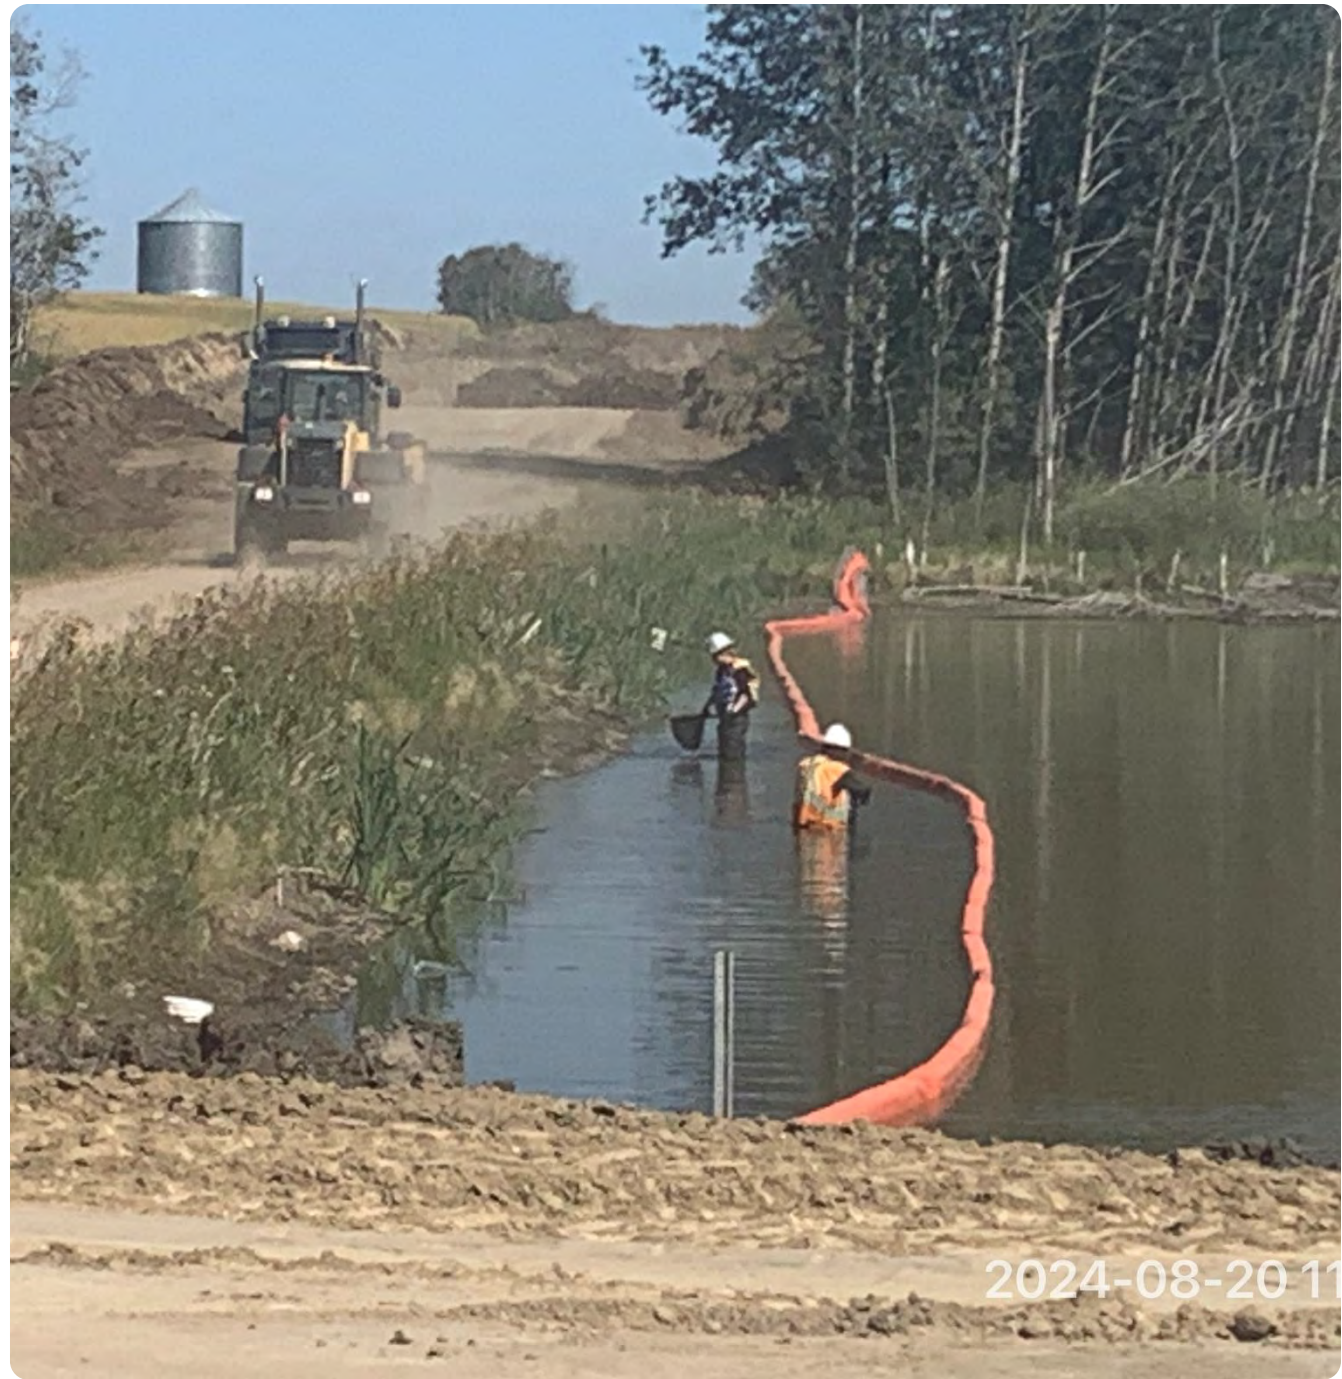
- Isolation of areas required for each quadrant/work zone;
- Capture and translocation of amphibians required until certain thresholds hit (<10% of max catch or several days of 0);
- Paid for in bid item per day that translocation occurred;
- Some ambiguity on Special Provision requirements and protected status of only species found (Barred Tiger Salamander);
- Much higher level of effort incurred than anticipated during tendering.
- **Lessons Learned**
  - Tender SP wording should not be ambiguous and should clearly state expectations around amphibian salvage;
  - Protected status of species found and criteria for stopping amphibian capture/translocation should be more explicitly stated by the Contractor's biologist and agreed to by all parties.

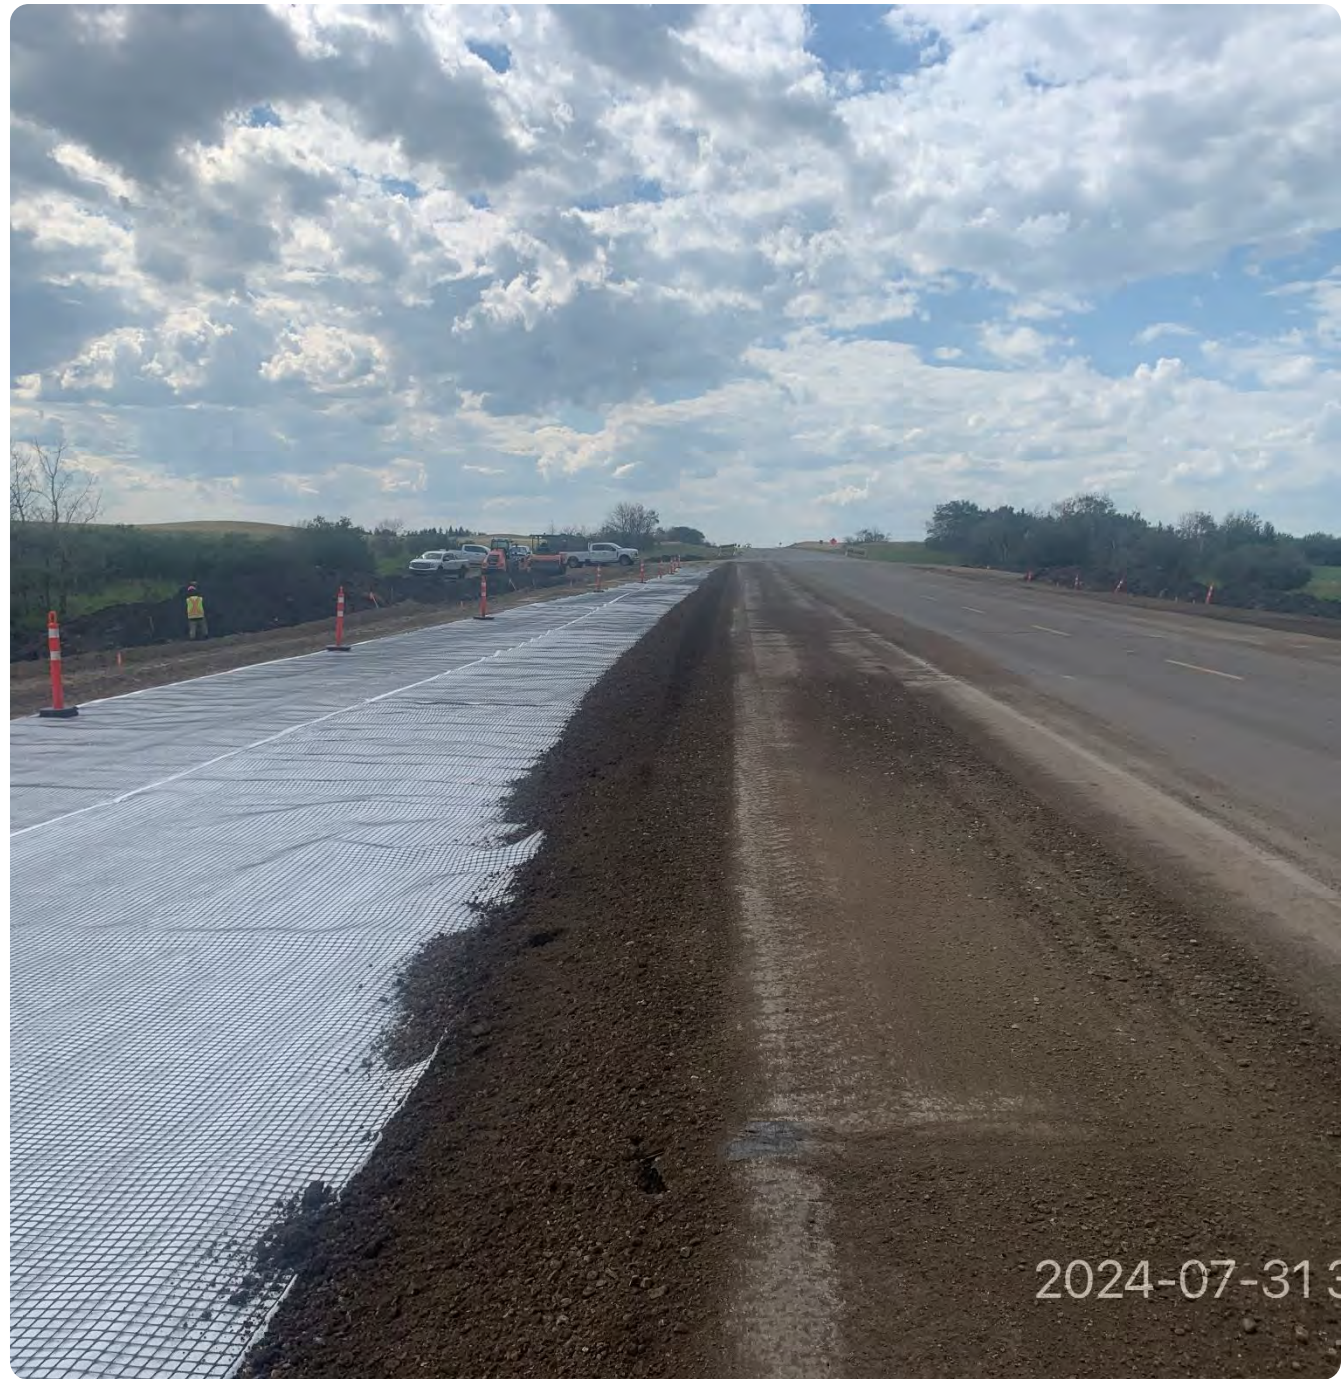
- Material substitution proposed by Contractor to utilize Des 2 CI 25 material for granular fill (rather than Des 6 CI 80);
- Layers kept separate and paid separate even though material was the same;
- Substitution aided in traffic accommodation once gravel was placed on existing Highway 14 surface.
