# Highway 14 Grade Raise at Range Road 30

# Project Background

- Highway 14:16 rehabilitation from Highway 41 (Wainwright) to Saskatchewan Border (55.562 km);
- Grading work included:
  - Grade raise at Range Road 30;
  - Two intersection upgrades;
  - Approach removals, construction and sideslope improvements.
- Total surfacing quantities included approximately:
  - 168,000 tonnes of ACP;
  - 28,000 tonnes of Granular Fill;
  - 15,000 tonnes of GBC.

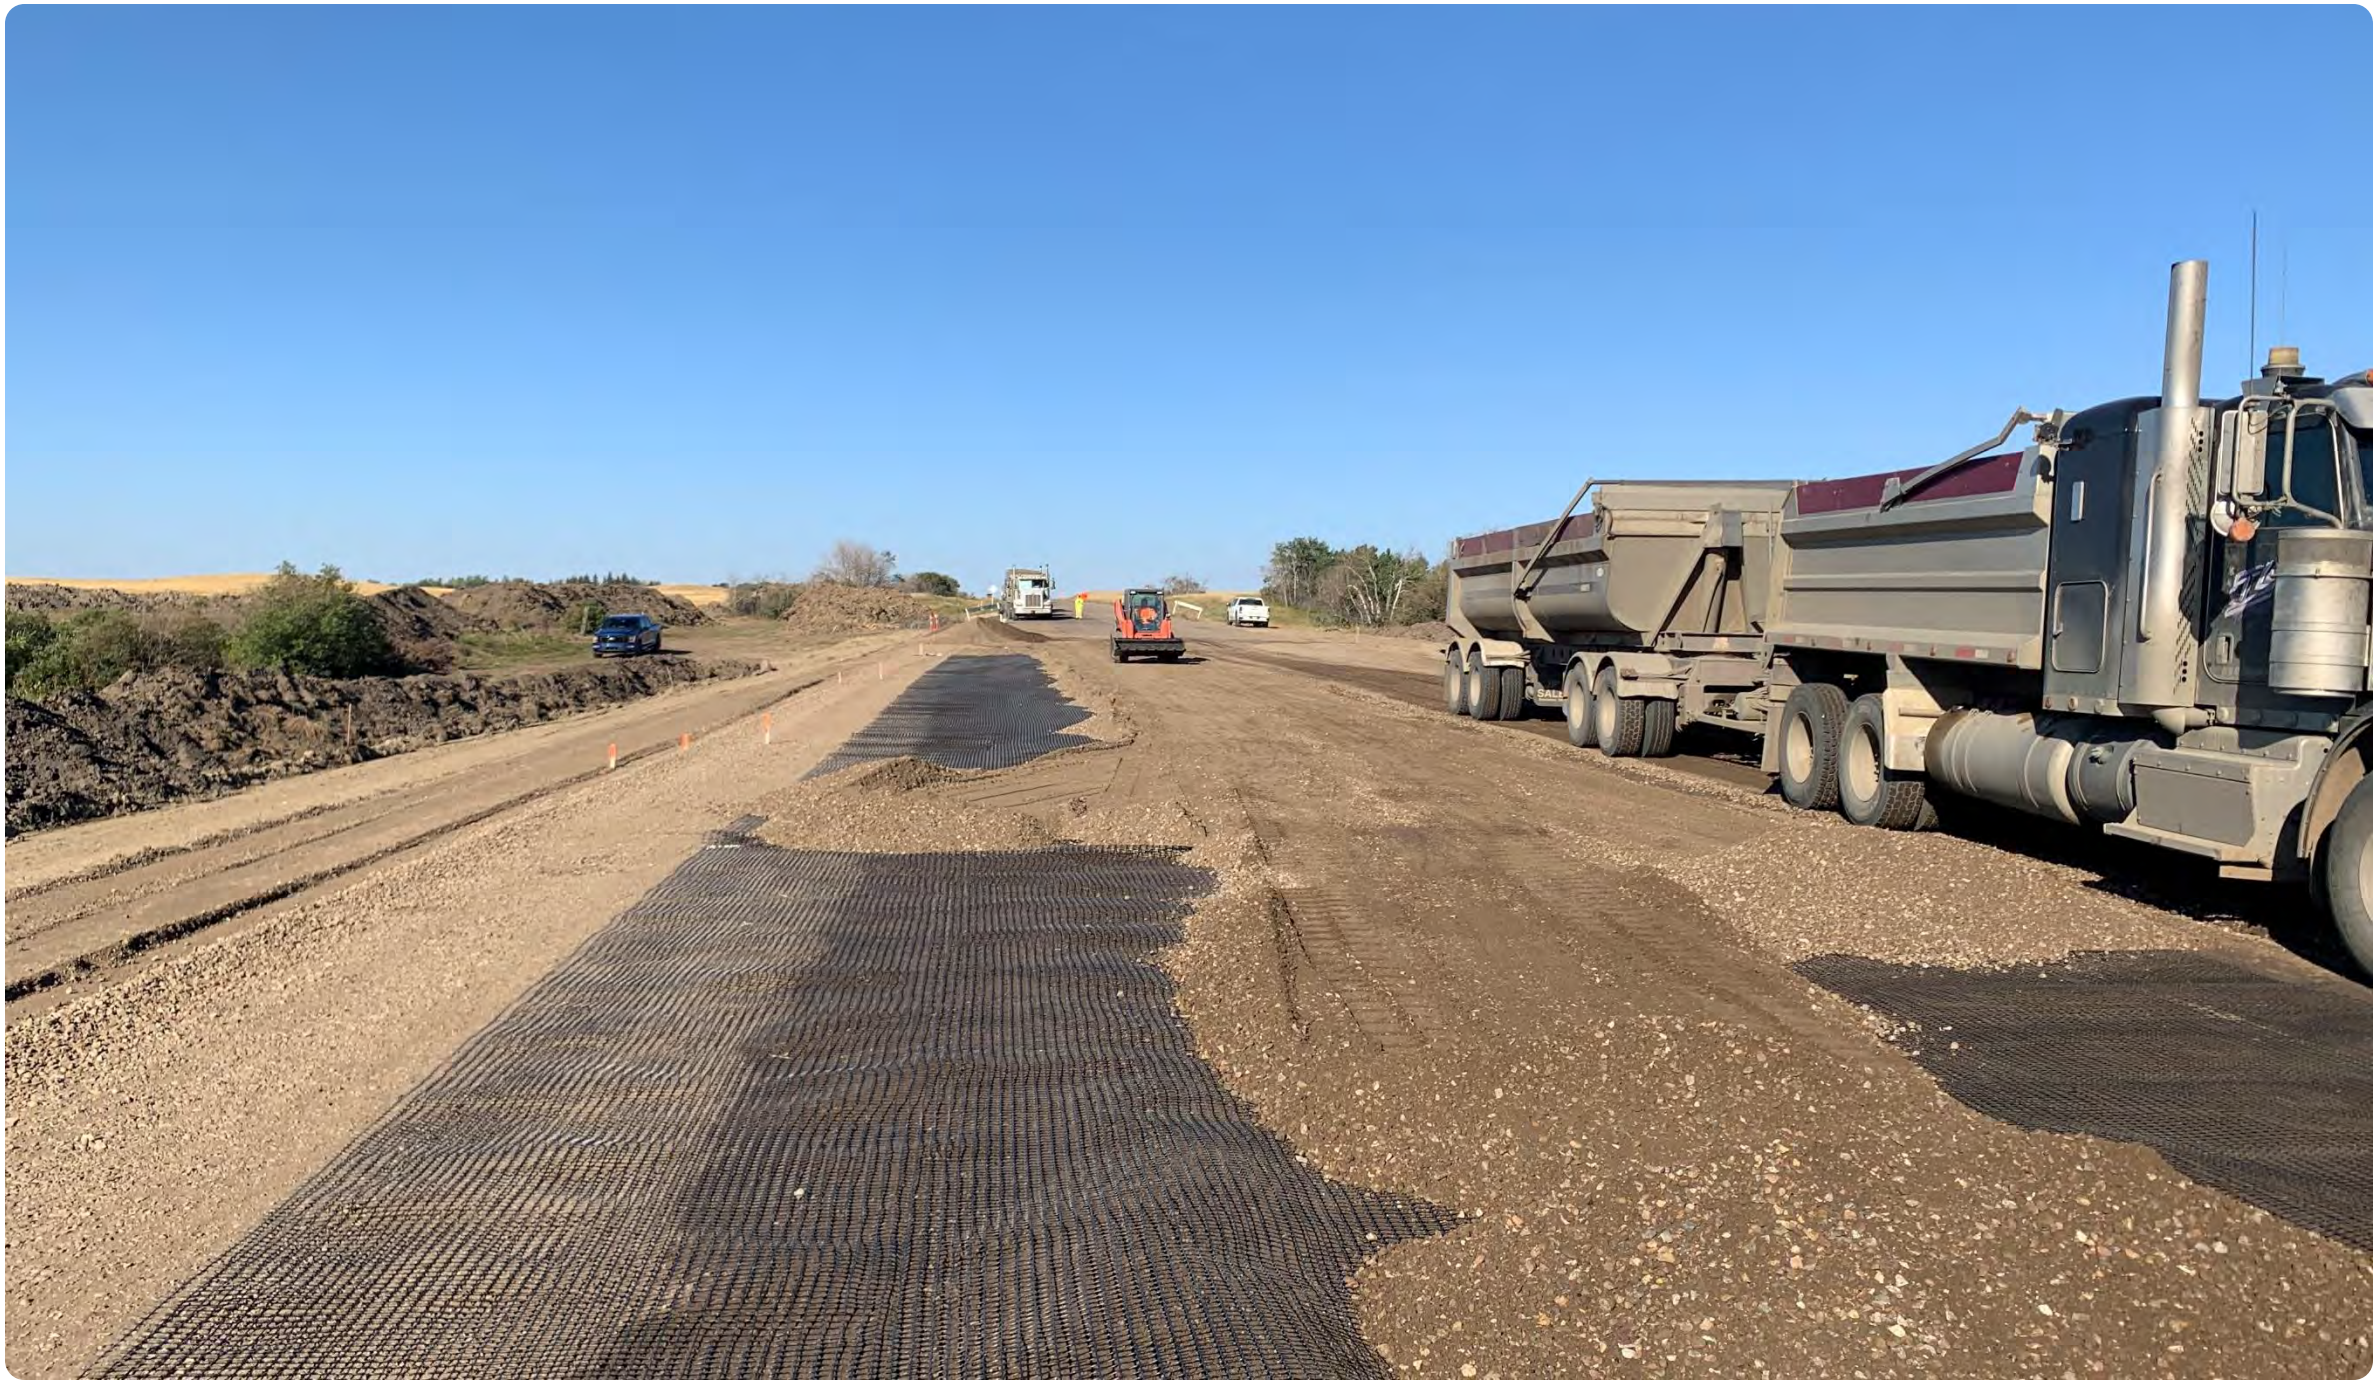
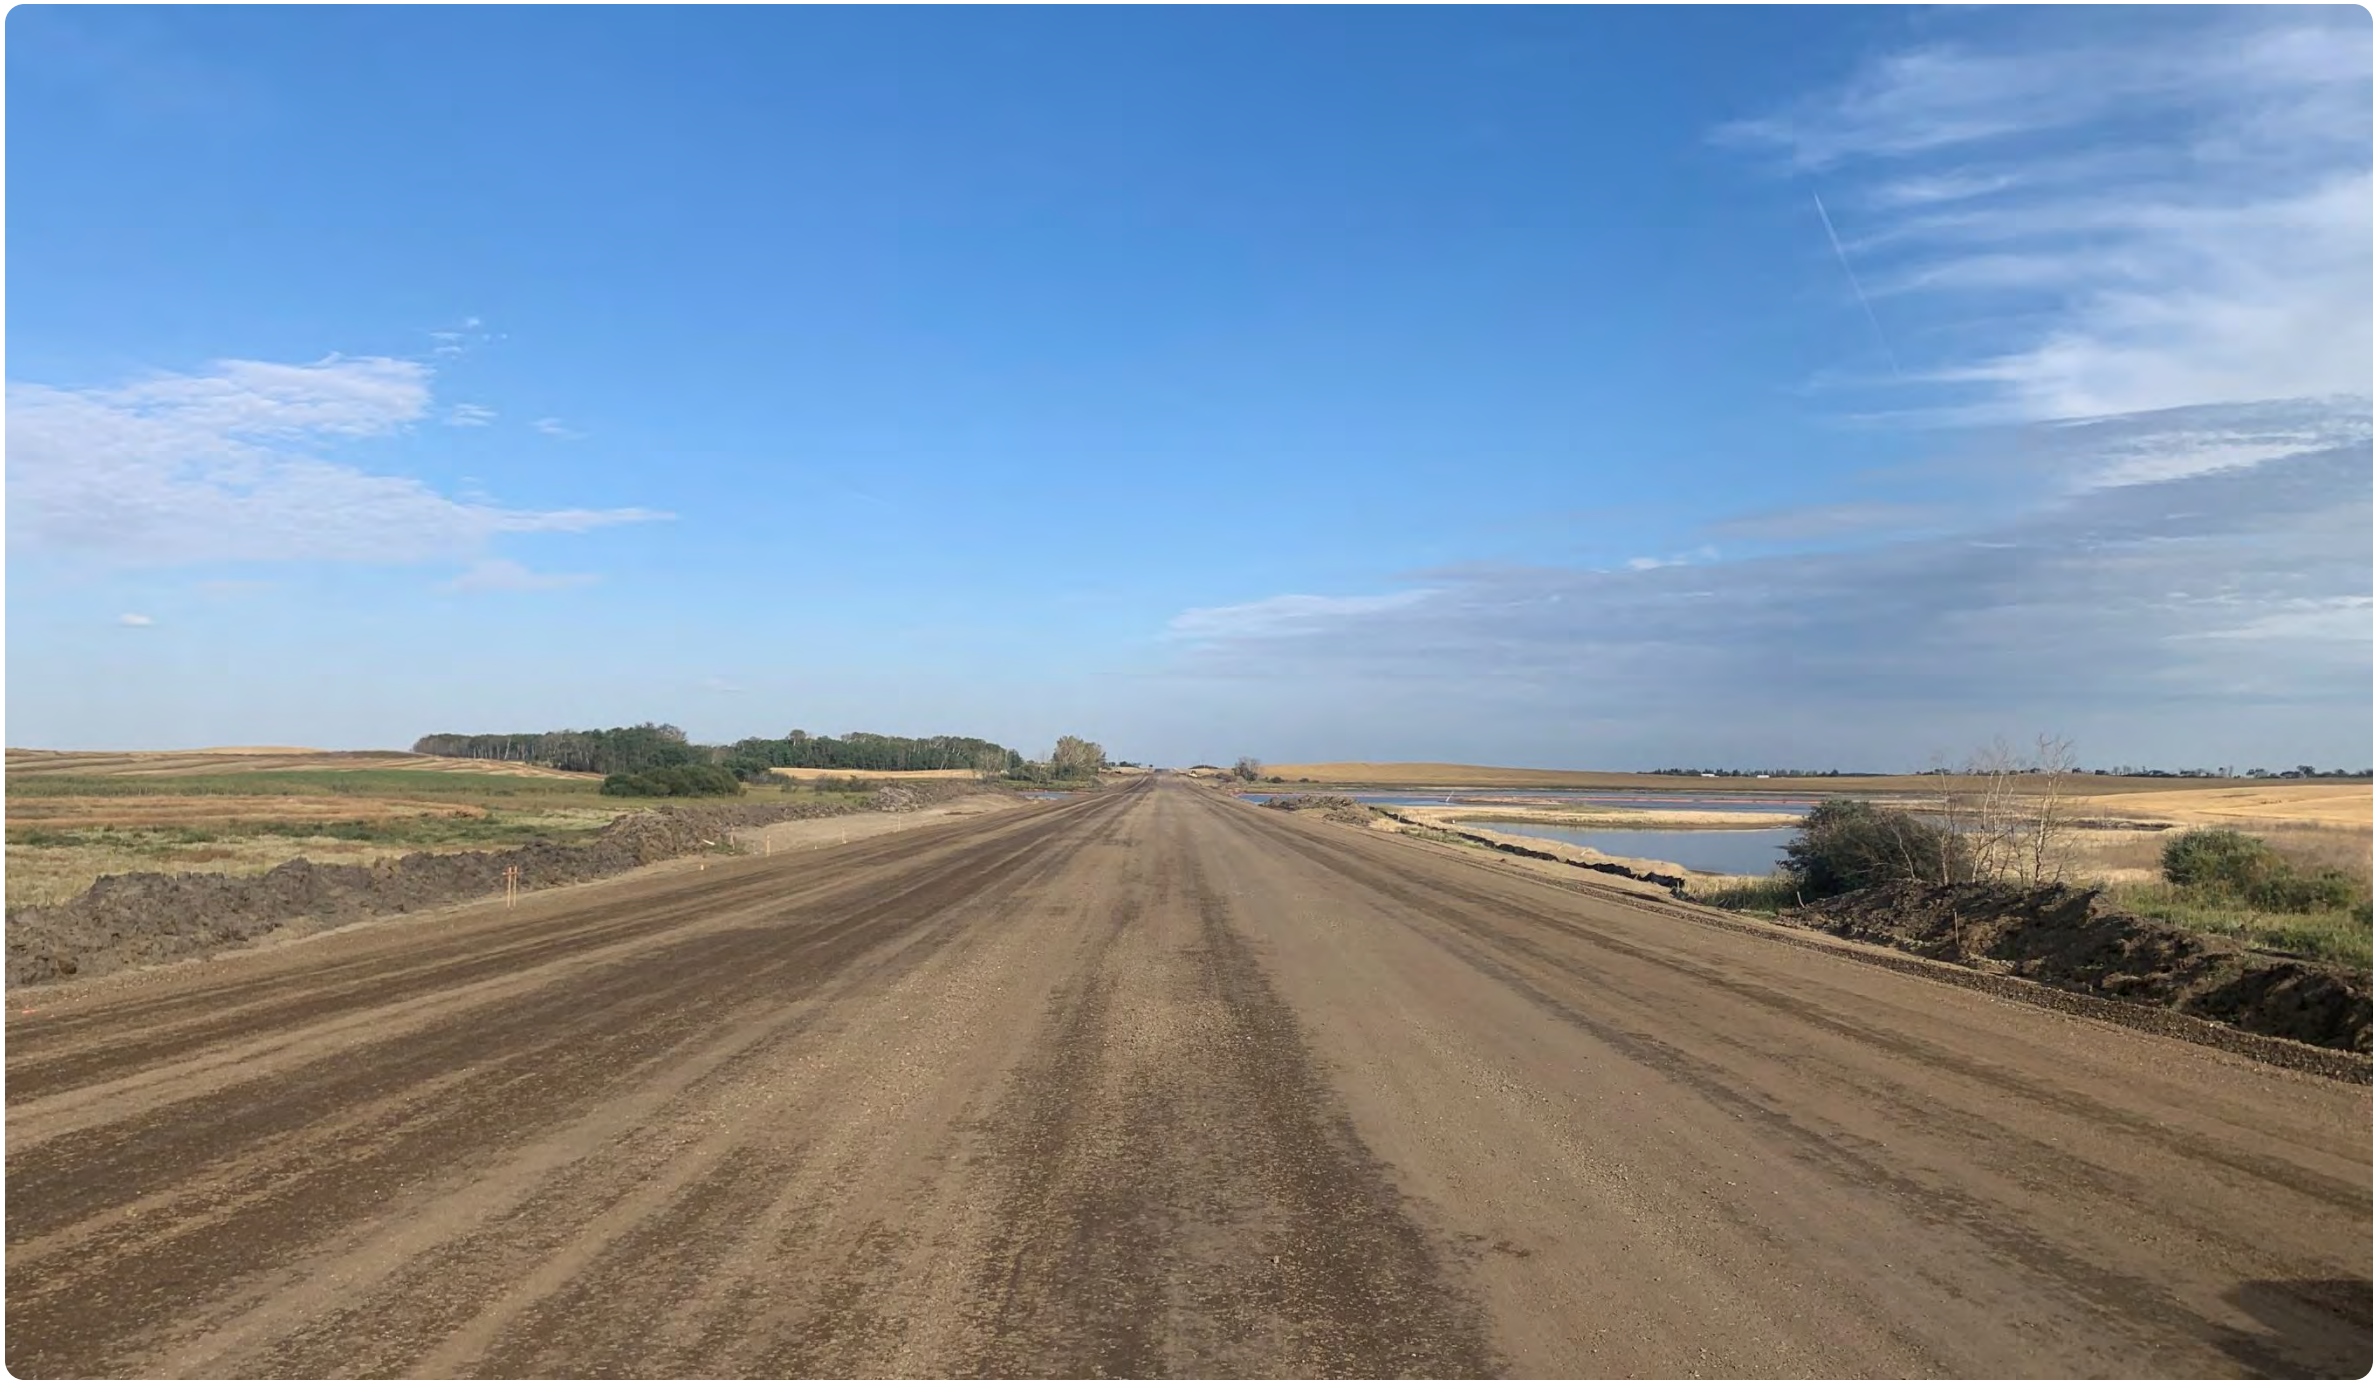
- Material substitution proposed by Contractor to utilize Des 2 CI 25 material for granular fill (rather than Des 6 CI 80);
- Layers kept separate and paid separate even though material was the same;
- Substitution aided in traffic accommodation once gravel was placed on existing Highway 14 surface.

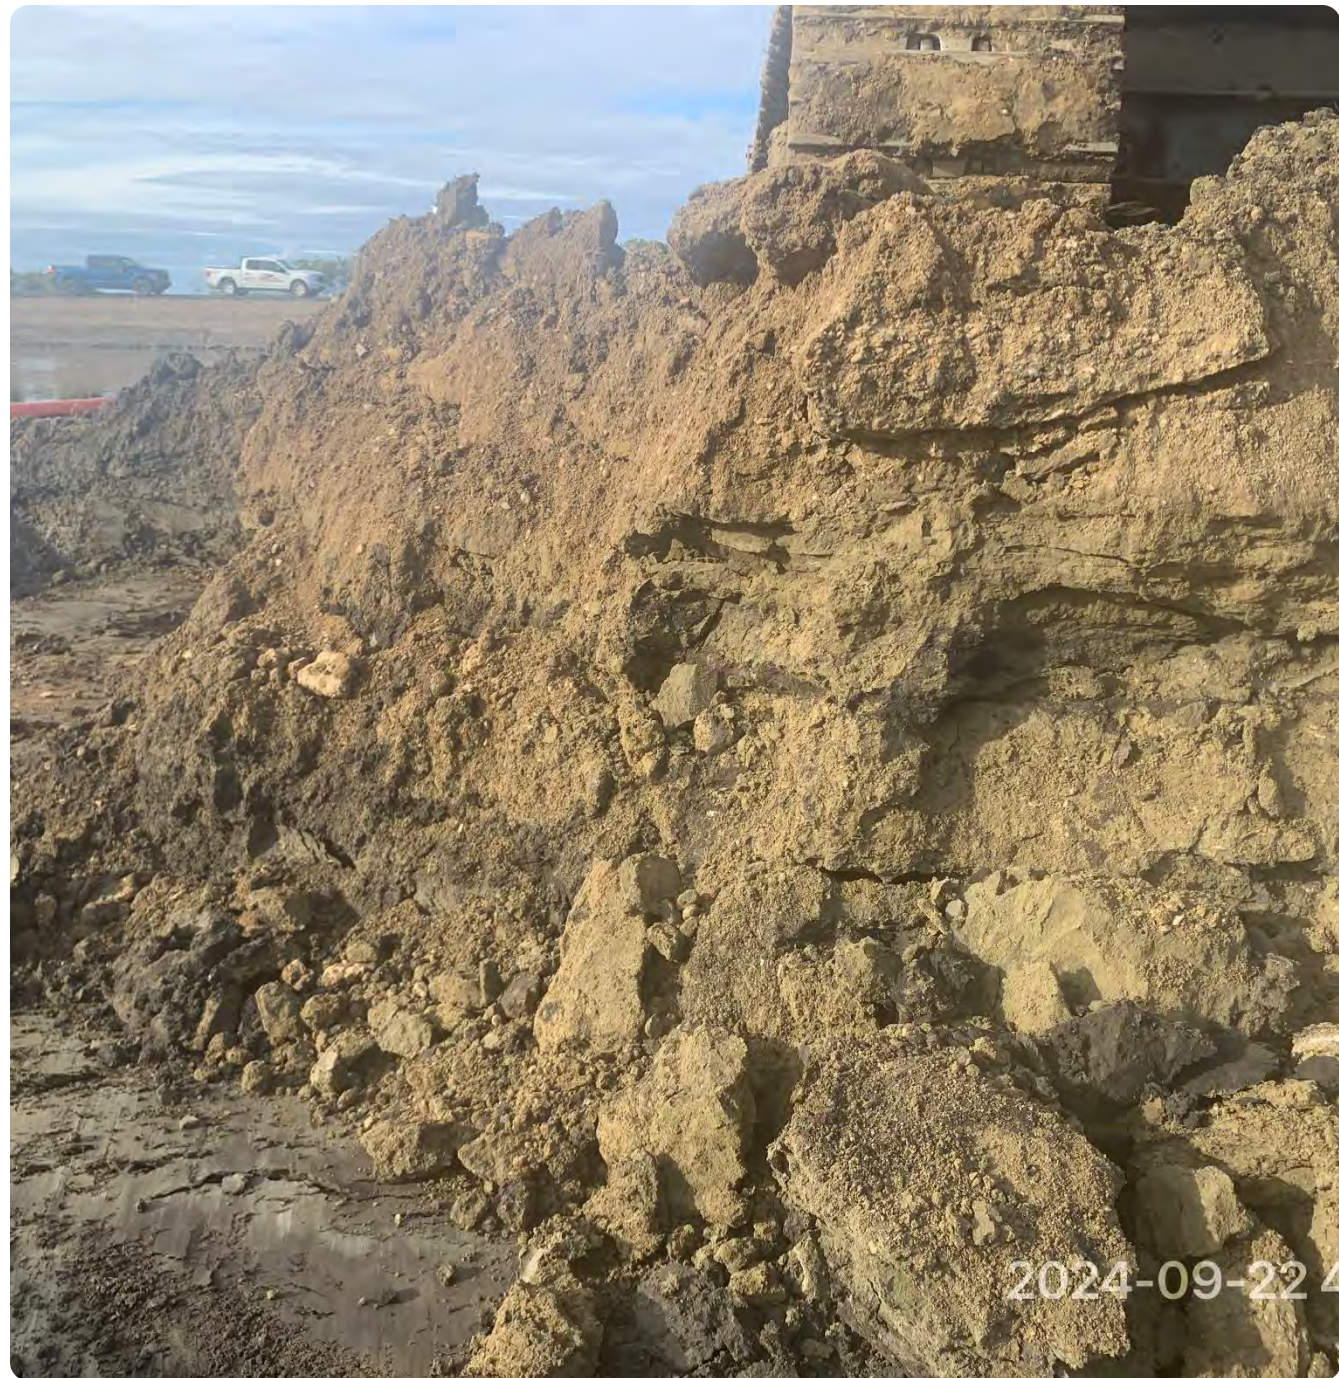
- Removal of Range Road 30 final step in construction;
- Existing Range Road 30 similar to Highway 14 – layer of non-organic material on top of layer of organics. Mixing of layers observed.
- Design assumed existing road material would be used in grade raise construction;
- Contractor offered a reduction in borrow quantity based on percentage of usable Range Road 30 material (site agreement).
- **Lessons Learned**
  - Tough to separate layers of good material from organics. Design quantities should have been more conservative in assuming how much material could be salvaged for embankment construction.
