# Bridge Replacement on an Active Landslide - Athabasca River Bridge

Dennis Bremault, P.Eng.

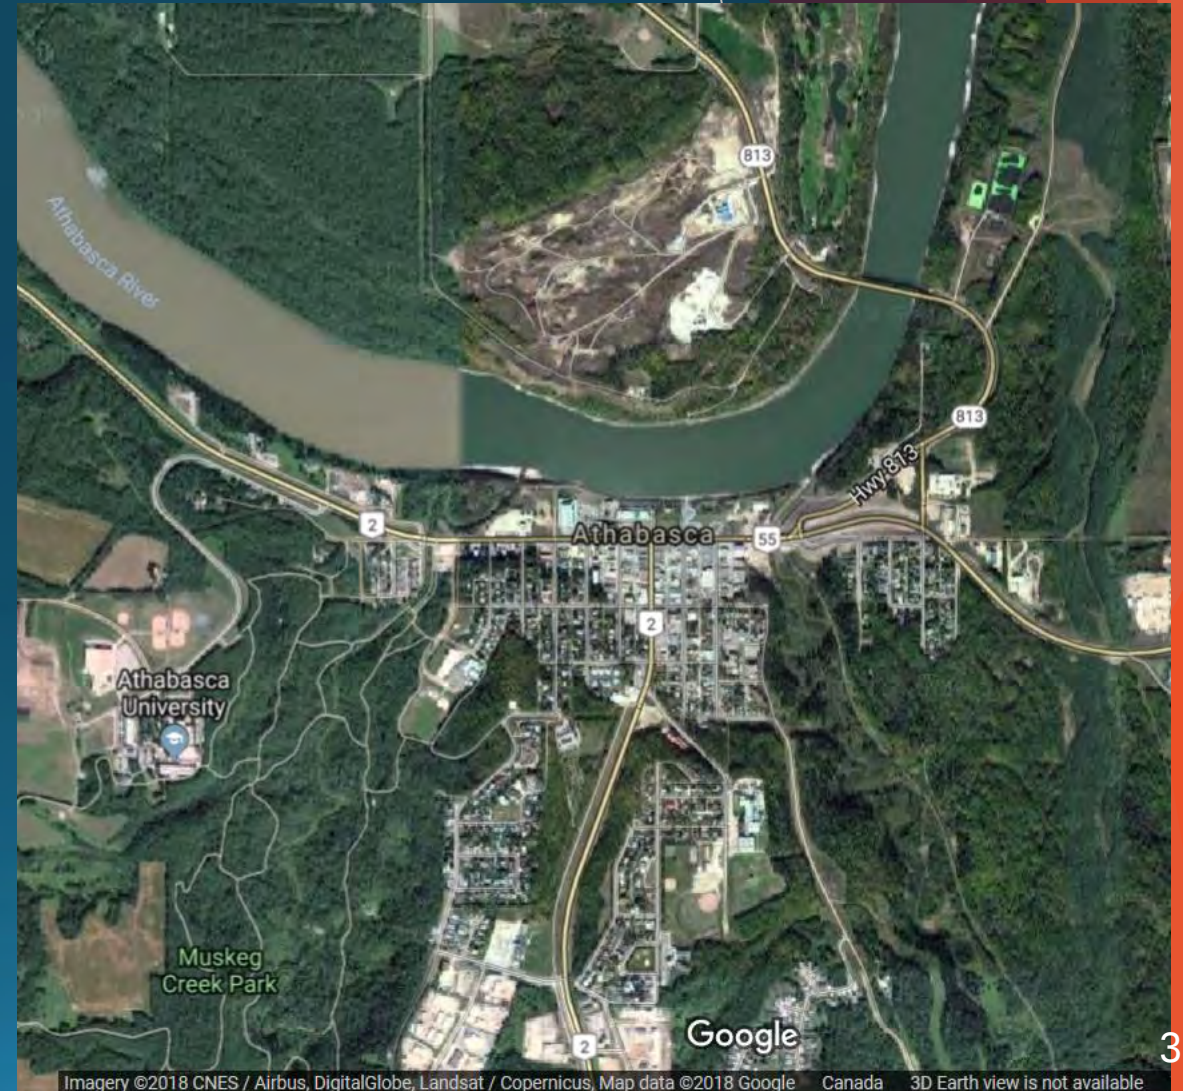
- ▶ History of Bridge Location
  - ▶ Town of Athabasca, Alberta
  - ▶ Important historical river crossing
  - ▶ Regular ferry service establish in 1905

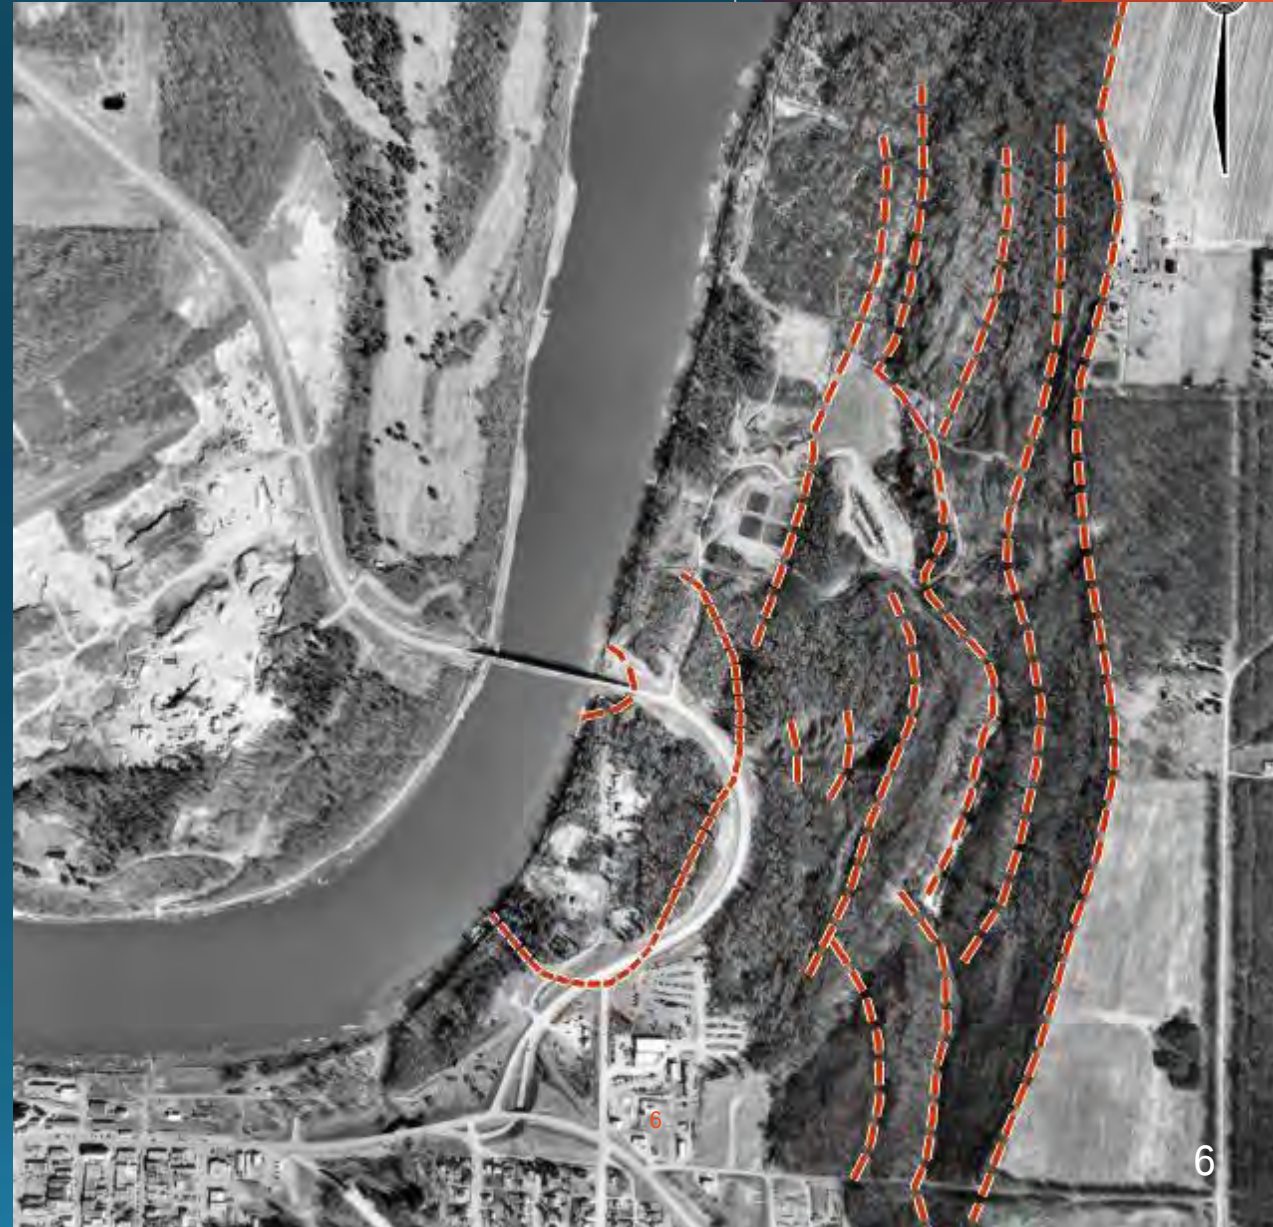
- ▶ Most Unique Design Challenge = Instability of the East bank
- ▶ Unable to avoid slope stability issues
- ▶ Unable to stabilize slope
- ▶ COWI tasked with designing a bridge on an active landslide
