Calgary

At-grade LRT Crossing Safety Enhancements Initiatives

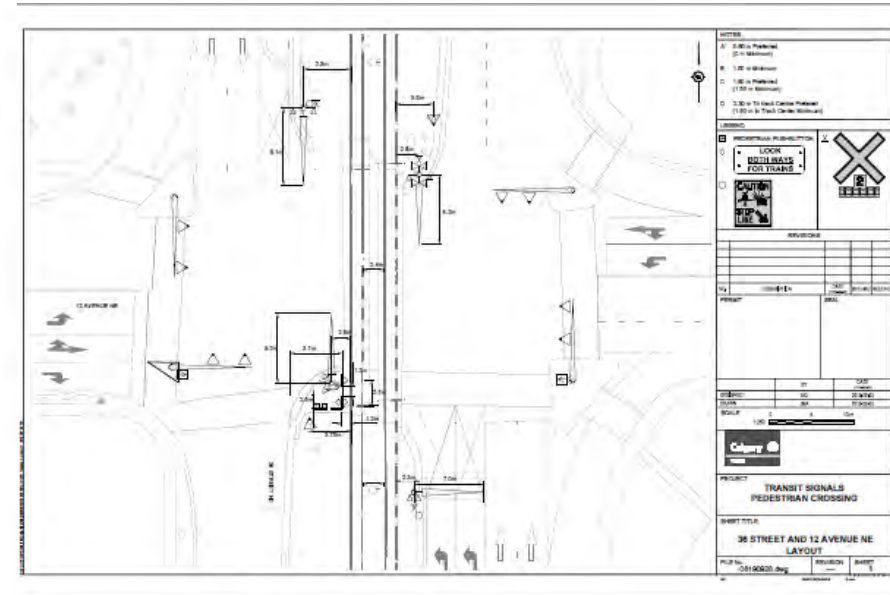
Crossing Inspection Reports

LRT Crossings – Field Inspection Worksheet

- No major civil changes to this intersection in the last years.
- No direct illumination
- No warning visible devices when pedestrian is standing in refuge area facing east (photo 5)
- 2 push buttons could be confusing (photo 6)
- Markings on southbound 36 street, not aligned with pedestrian refuge area
- Tripping hazard between plank and asphalt – uneven surface (photo 1)
- Narrow ramp on southeast refuge island (photo 2)
- Bedstead signs deteriorated (photo 3)

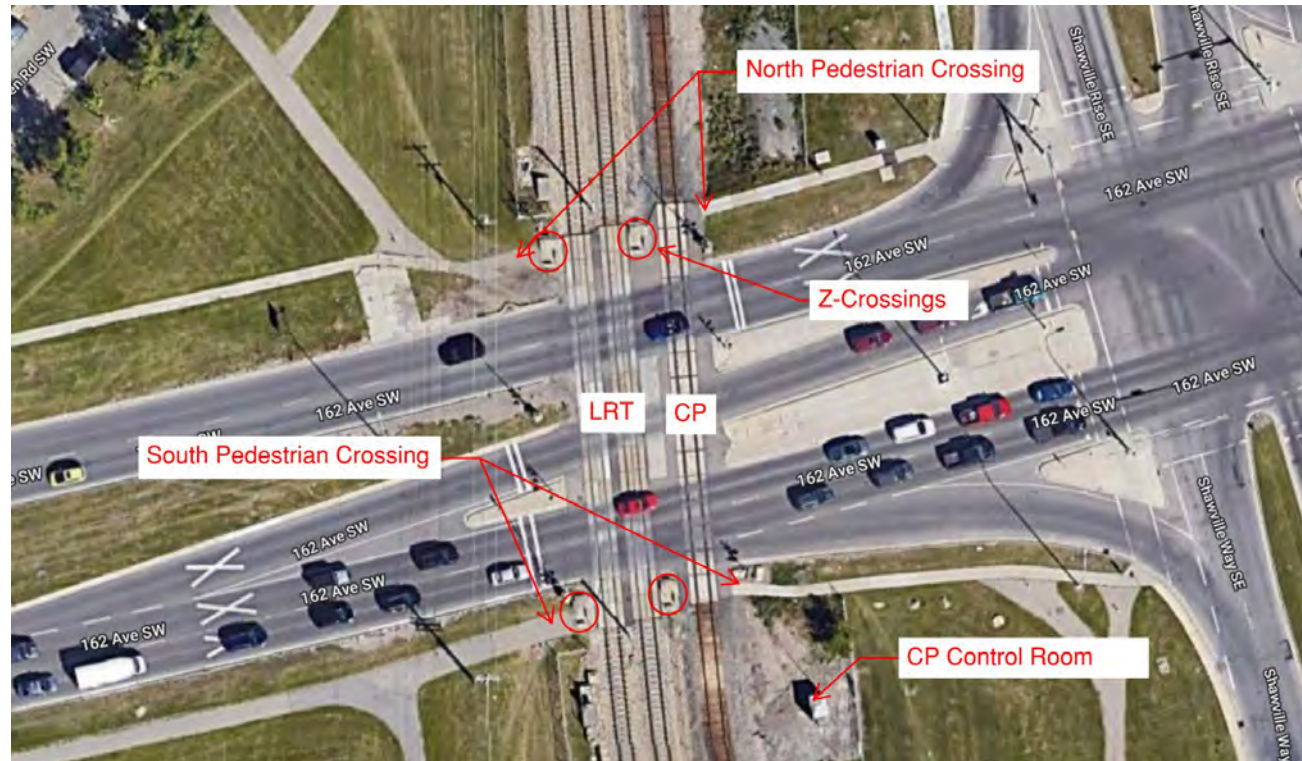
162 Ave Crossing Automatic Pedestrian Gates

- Pre-existing conditions:
 - LRT and CP crossings with 2 Z-Crossings
 - Low lighting conditions including CPTED concerns
 - Open public access to tracks
 - Inconsistent public realm features (i.e. sidewalks/MUP's)
 - No accessibility features

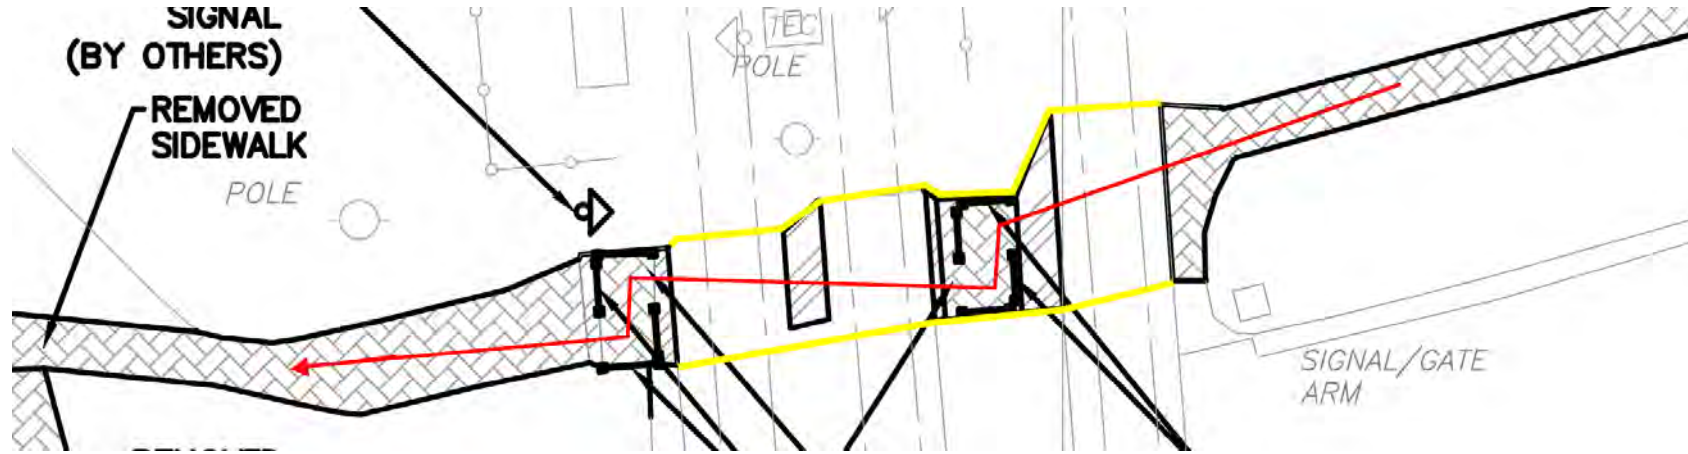
162 Avenue – North Crossing

BEFORE

AFTER

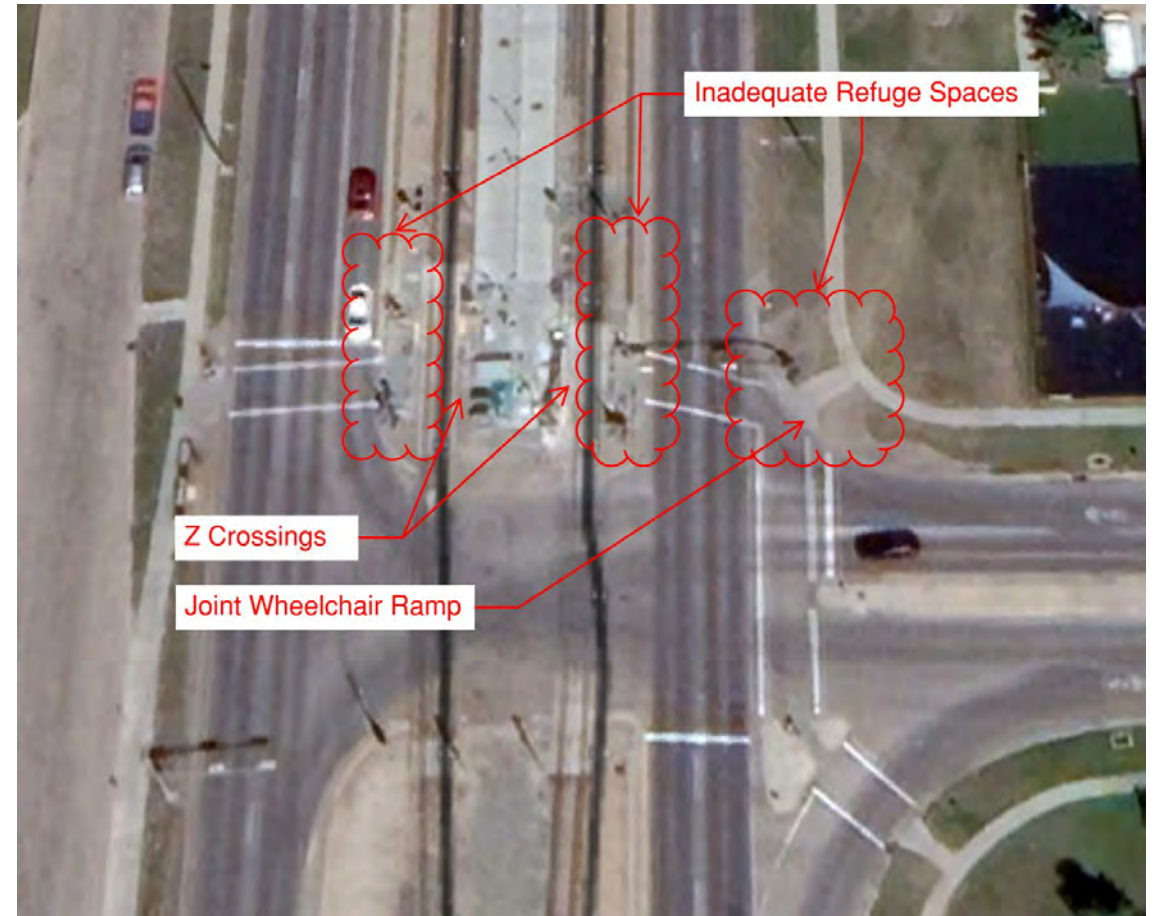
Whitehorn Station Pedestrian Gates + Station and Roadway Improvements

- Pre-existing conditions:
 - LRT Z-Crossings on south end of Whitehorn Station (east/west access)
 - Inadequate pedestrian refuge spaces
 - Joint wheelchair ramps
 - Sightline concerns / driver stress
 - No accessibility features

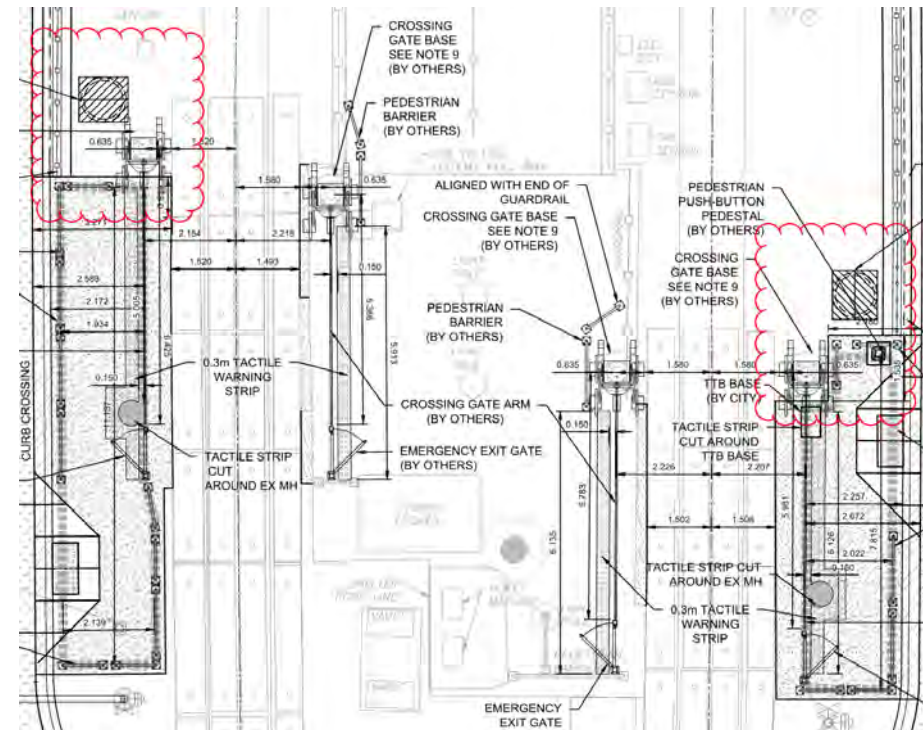
Whitehorn Station Pedestrian Gates + Station and Roadway Improvements

- Retrofit Challenges
 - Stormwater catchbasin proximity to refuge spaces
 - Gate arm base retrofits/splicing in accordance with existing infrastructure/utilities
 - Construction sequencing to ensure minimal delays to pedestrians, vehicle traffic, and LRT operations

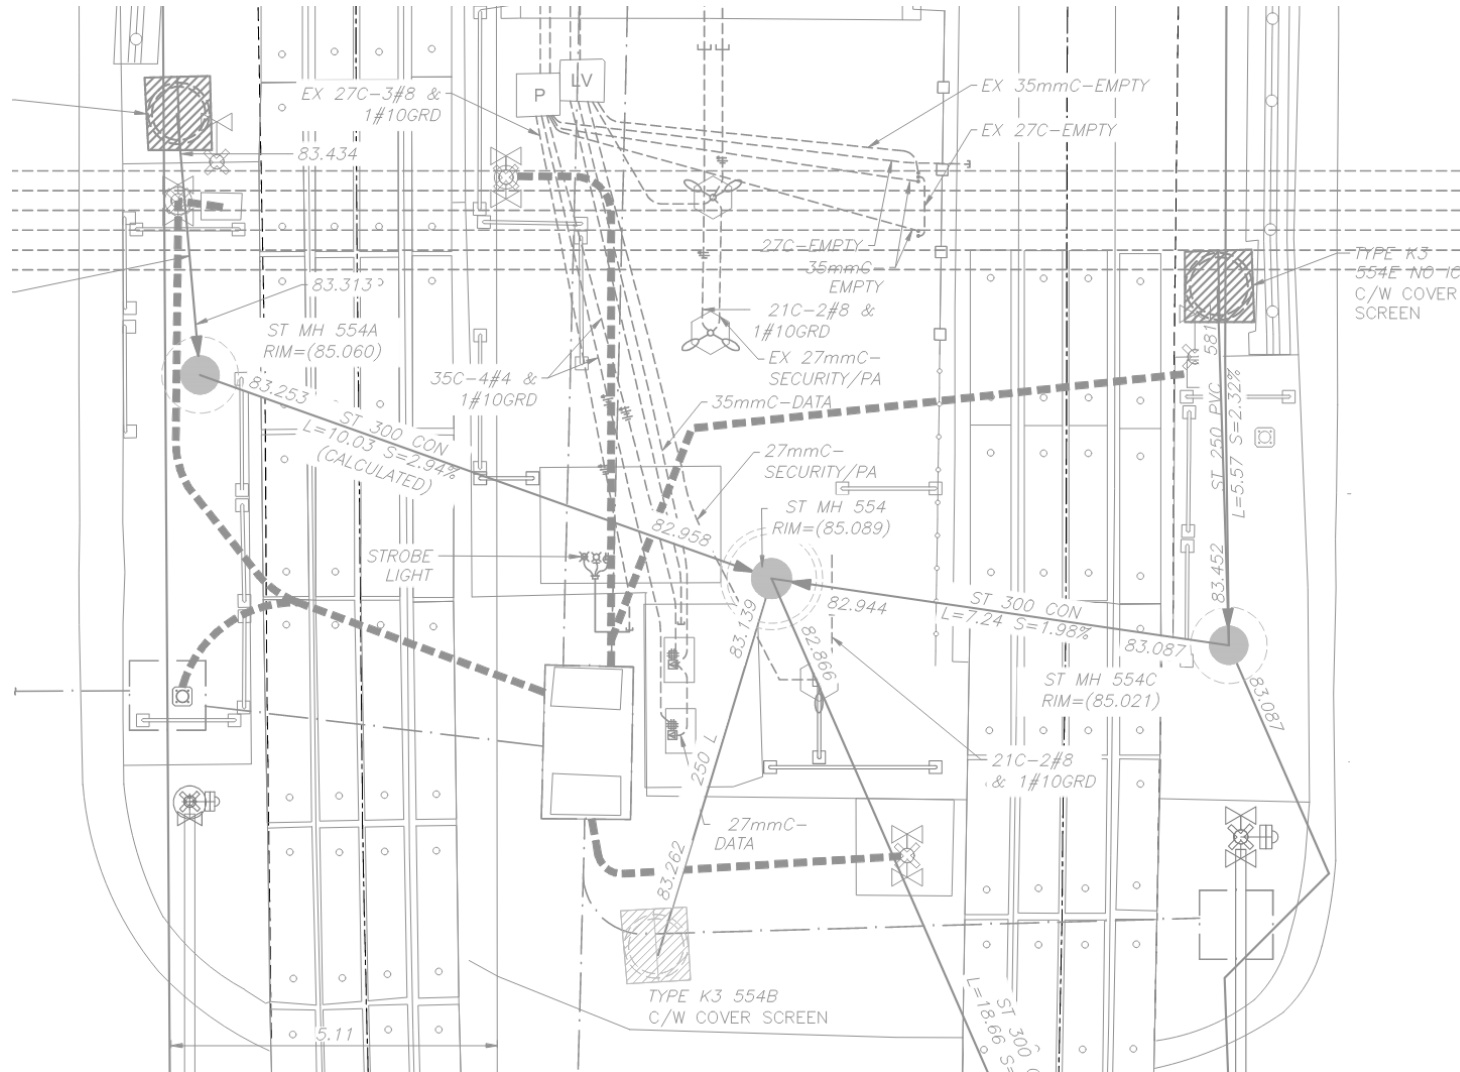
Whitehorn Station Pedestrian Gates + Station and Roadway Improvements

- Retrofit Challenges - Existing Utilities

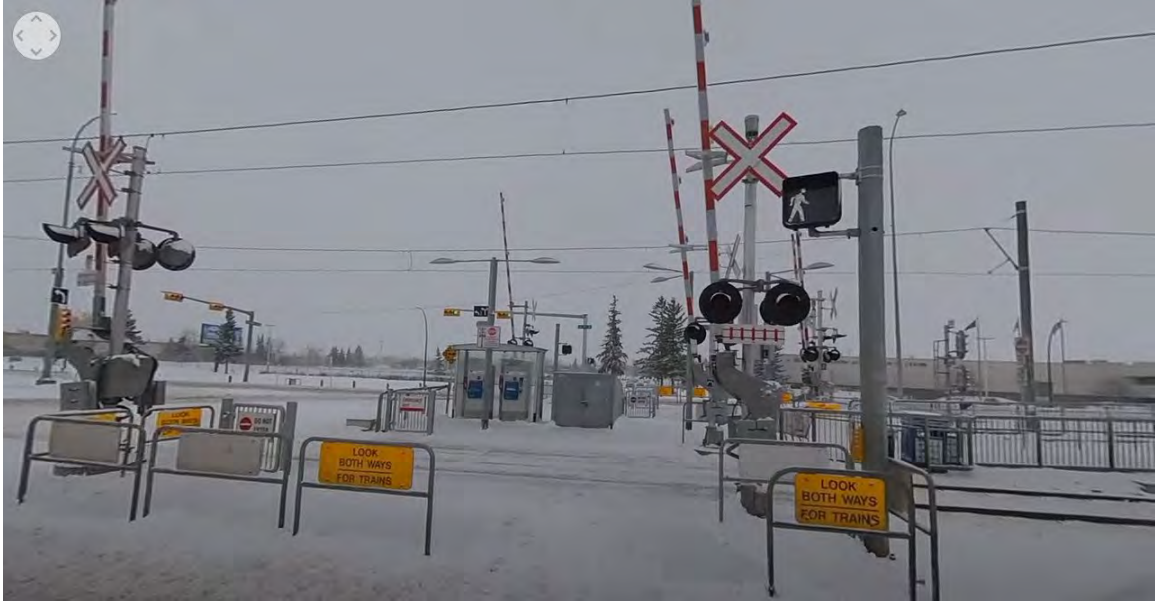
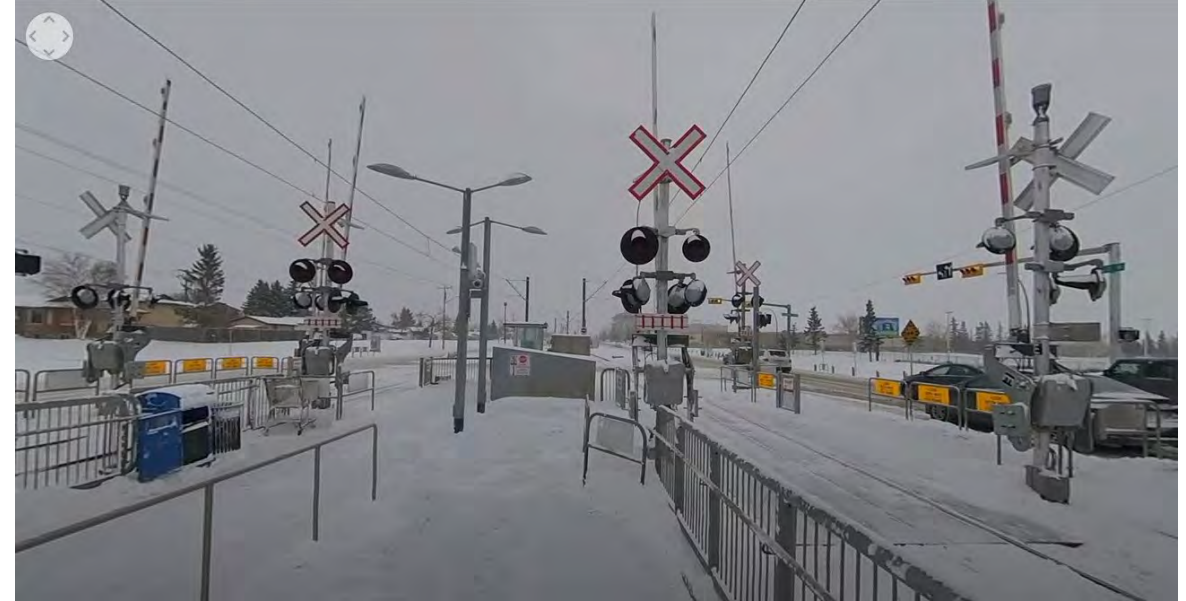
Automatic Gate Arms Installation Whitehorn PedX

- ❖ Automatic Pedestrian crossing gate arms for both east and west pedX
- ❖ Upgraded crossing controllers to be electronic
- ❖ New wayside cabinet cases – Power and Logic Cases
- ❖ Split crossing operation for IB and OB tracks
- ❖ TTSC upgrade for more visibility of the crossing

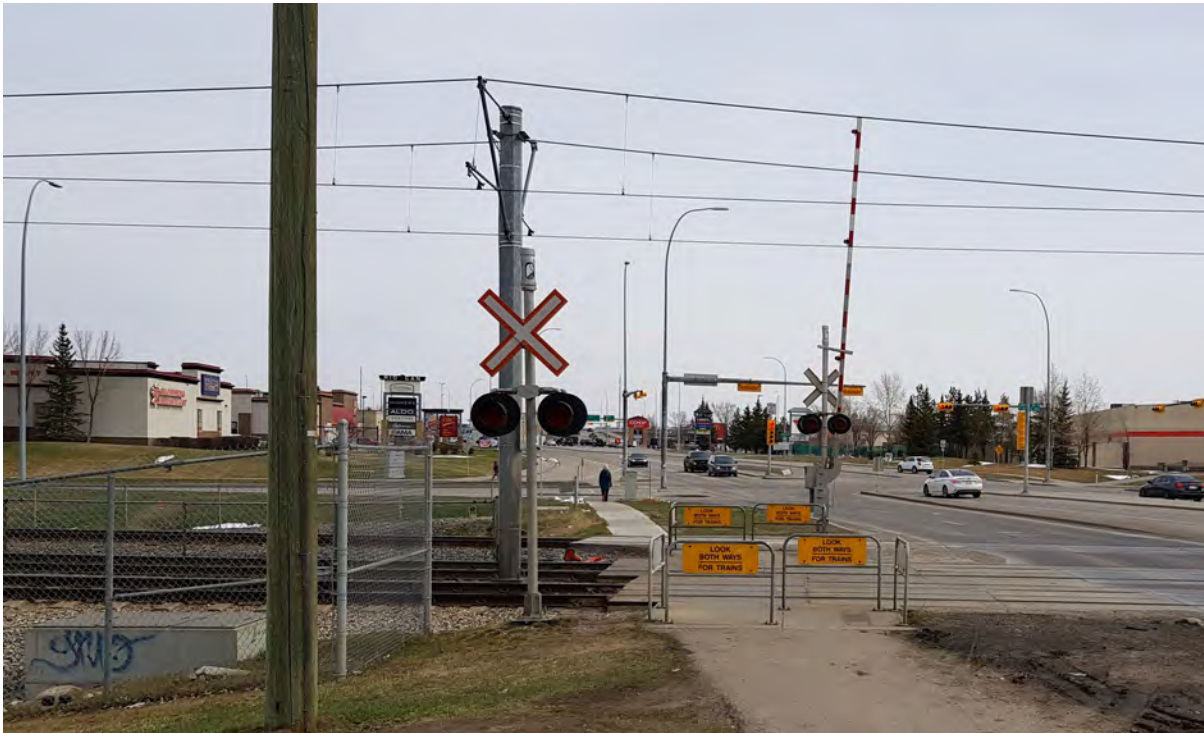
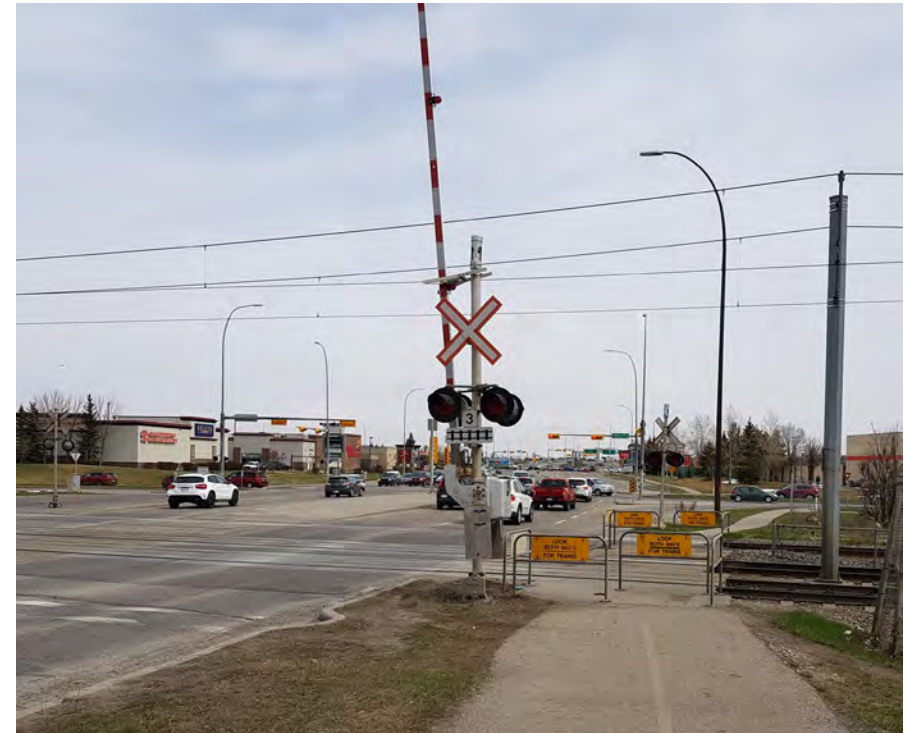
Initial conditions at 162 Avenue SW

- Add automatic pedestrian crossing gate arms for both north and south pedestrian crossings
 - Increase crossing surface due to 3-meter-wide approach path of MUP
 - Bedsteads, swing gates and signage to provide emergency exit path

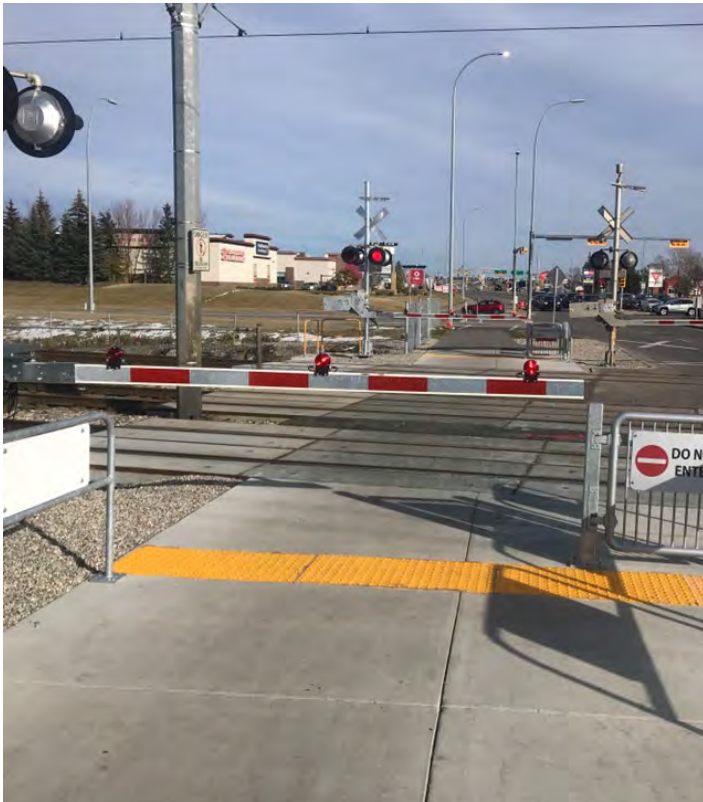
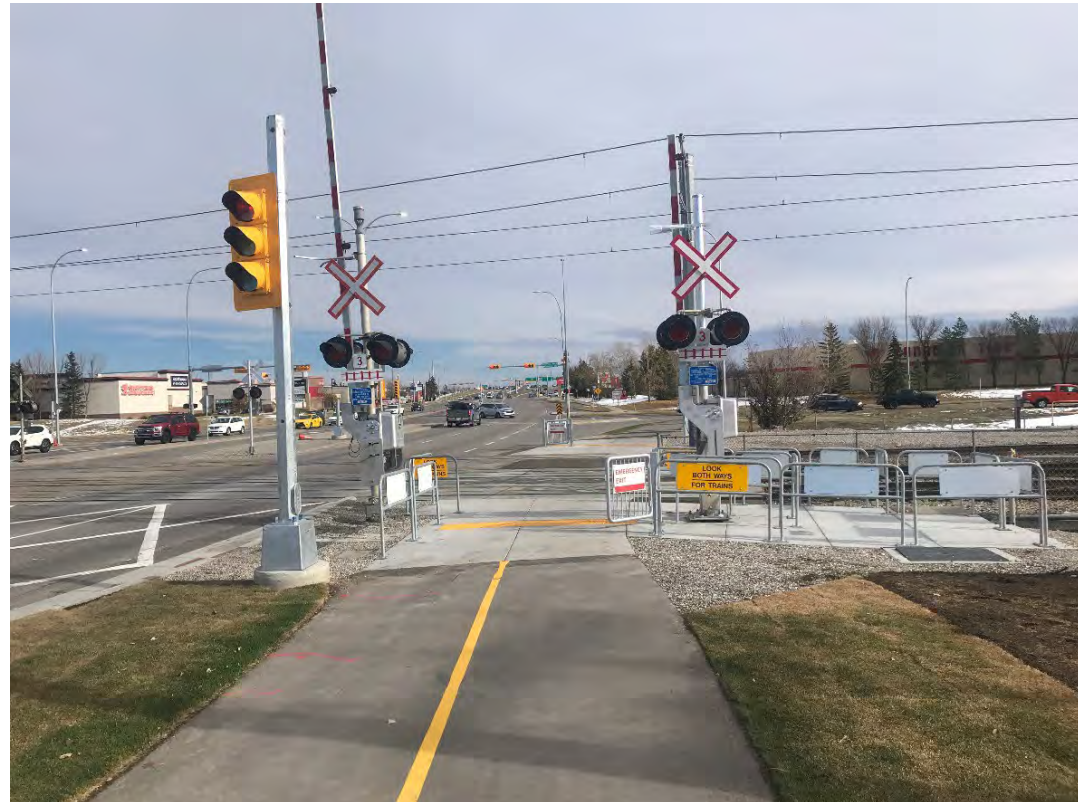
Revised conditions at 162 Avenue SW

- Due to changes, compliance with Transport Canada Grade Crossings Standards required
 - Crossing warning signals continue to be controlled by CP
 - Gate descent delay time increased for design vehicle (WB-20, Articulated Bus)
 - Pre-emption time increased to 61 s in advance of train's arrival at crossing

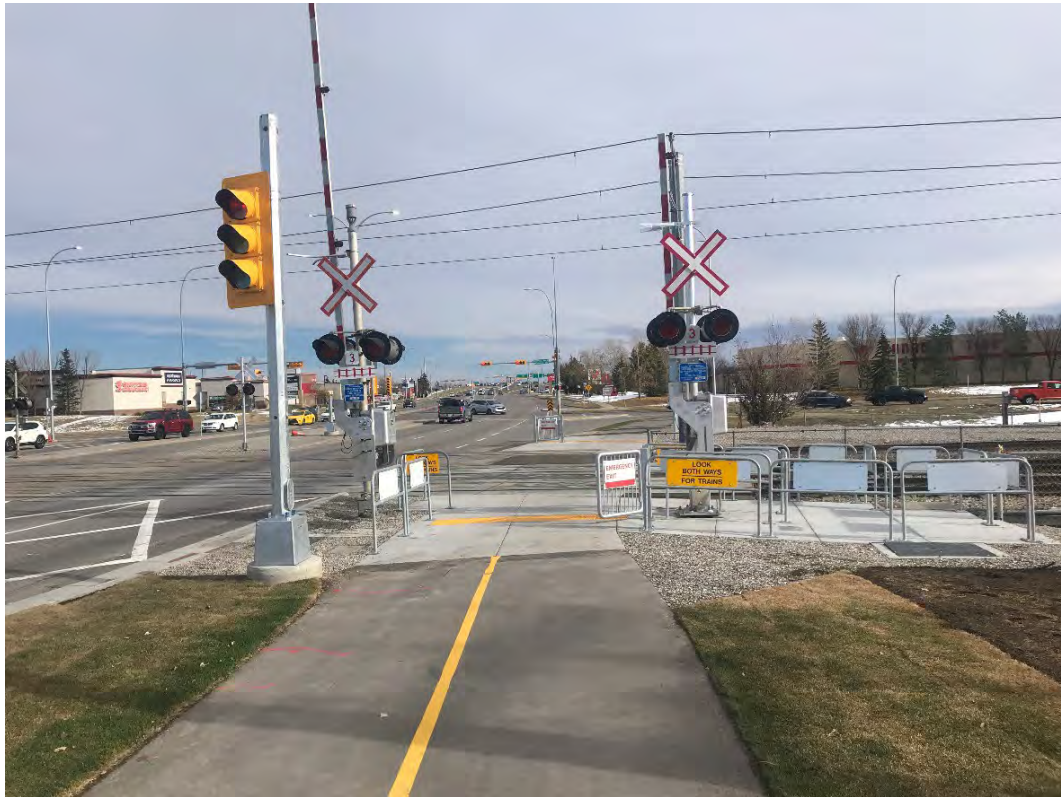
162 Ave SW Crossing Automatic Pedestrian Gates

- Traffic signal interconnection improvements
 - Pre-signals to keep the space between the main signal and tracks clear.
 - Conditionally red during pre-emption, red when warning devices active.
 - Pre-signal queue detectors to extend eastbound and eastbound left green durations if a queue is present.
