West Calgary Ring Road – DB1: Risk Management Through Design

February 28, 2023

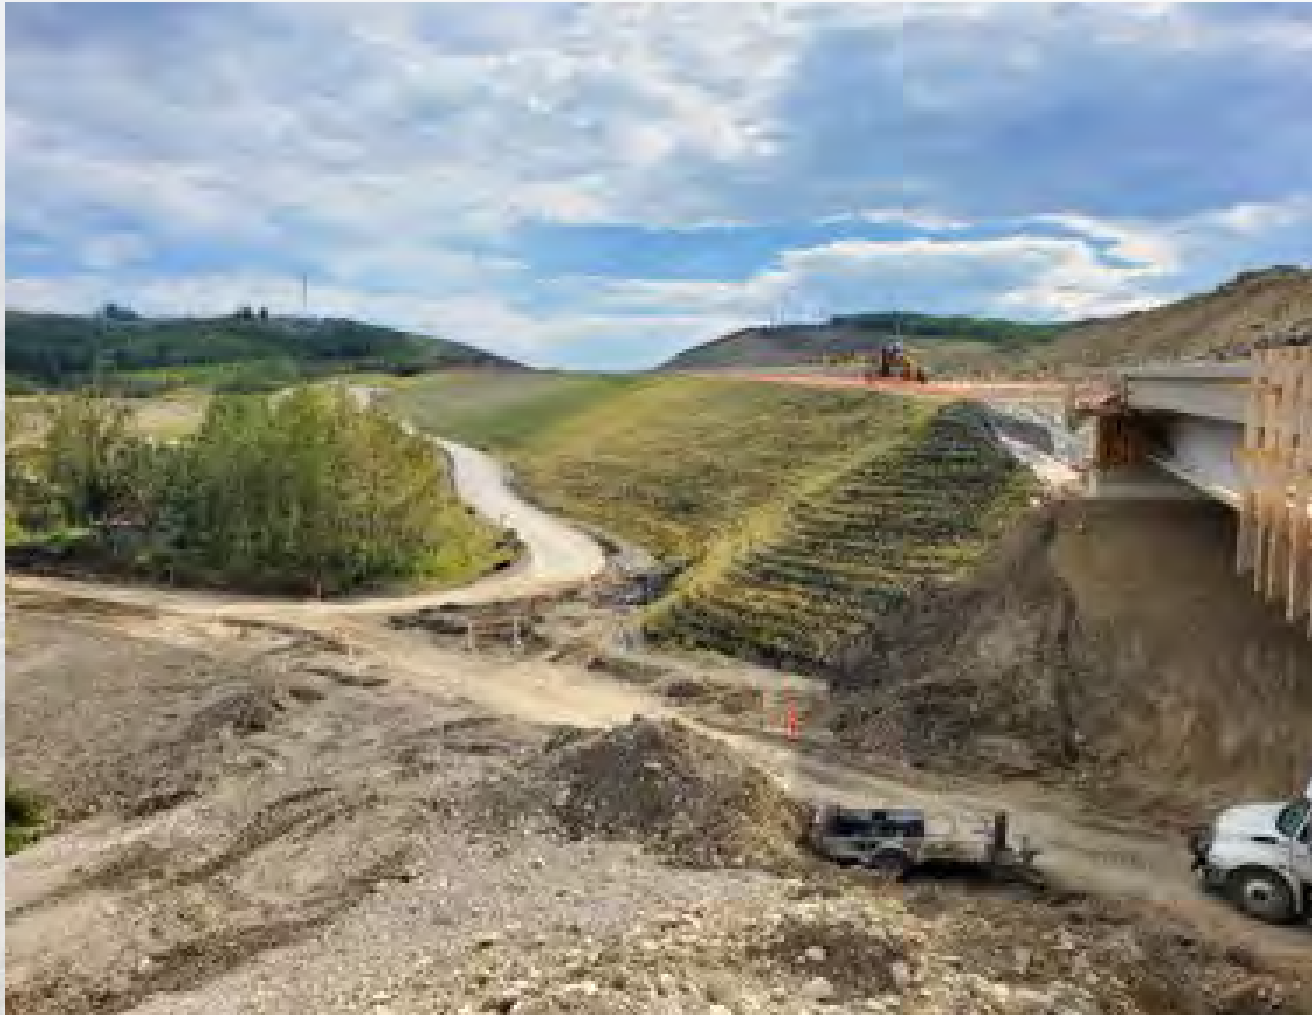
Managing Post-Award Geotechnical Risk Mitigation Reinforced Slopes

- Restricted Right-of-Way at five locations requiring retaining walls
- Reinforced slope options was considered in place of retaining walls to reduce cost and use available material
- Slope heights - 4m to 14m
- Slope inclination - 1.3H:1V to 2.9 H:1V
- High strength uniaxial geogrids as primary reinforcement, secondary geogrids, low maintenance seed mix, with or without wrap around.

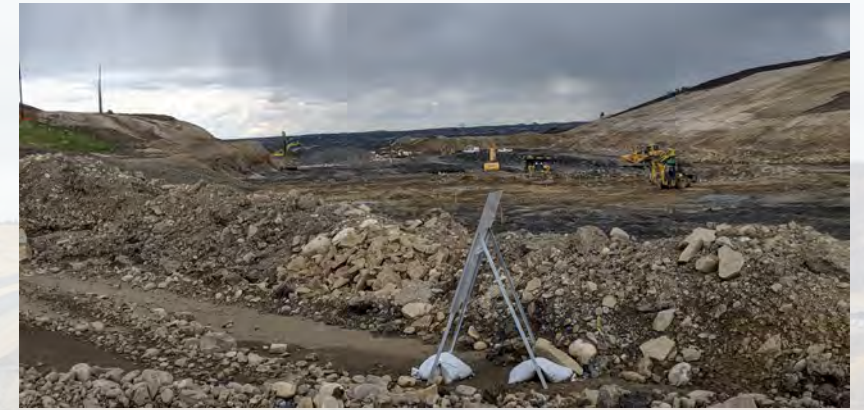
Paskapoo Excavation

- Risk
 - Bedrock excavation (quantity and rock strength), confirmed location unknown.
 - Groundwater springs.
- Design - mitigate risk through lifting profile.
- Construction – sideslope changes.
 - A bench required at transition from 3:1 to 2:1 slope. Excavation starts at top of slope and works down making location of bedrock critical.
 - Detailed investigation using probe holes.
