Baptiste Creek Bridge Landslide

Design and Construction of Remedial Measures

THURBER ENGINEERING LTD.

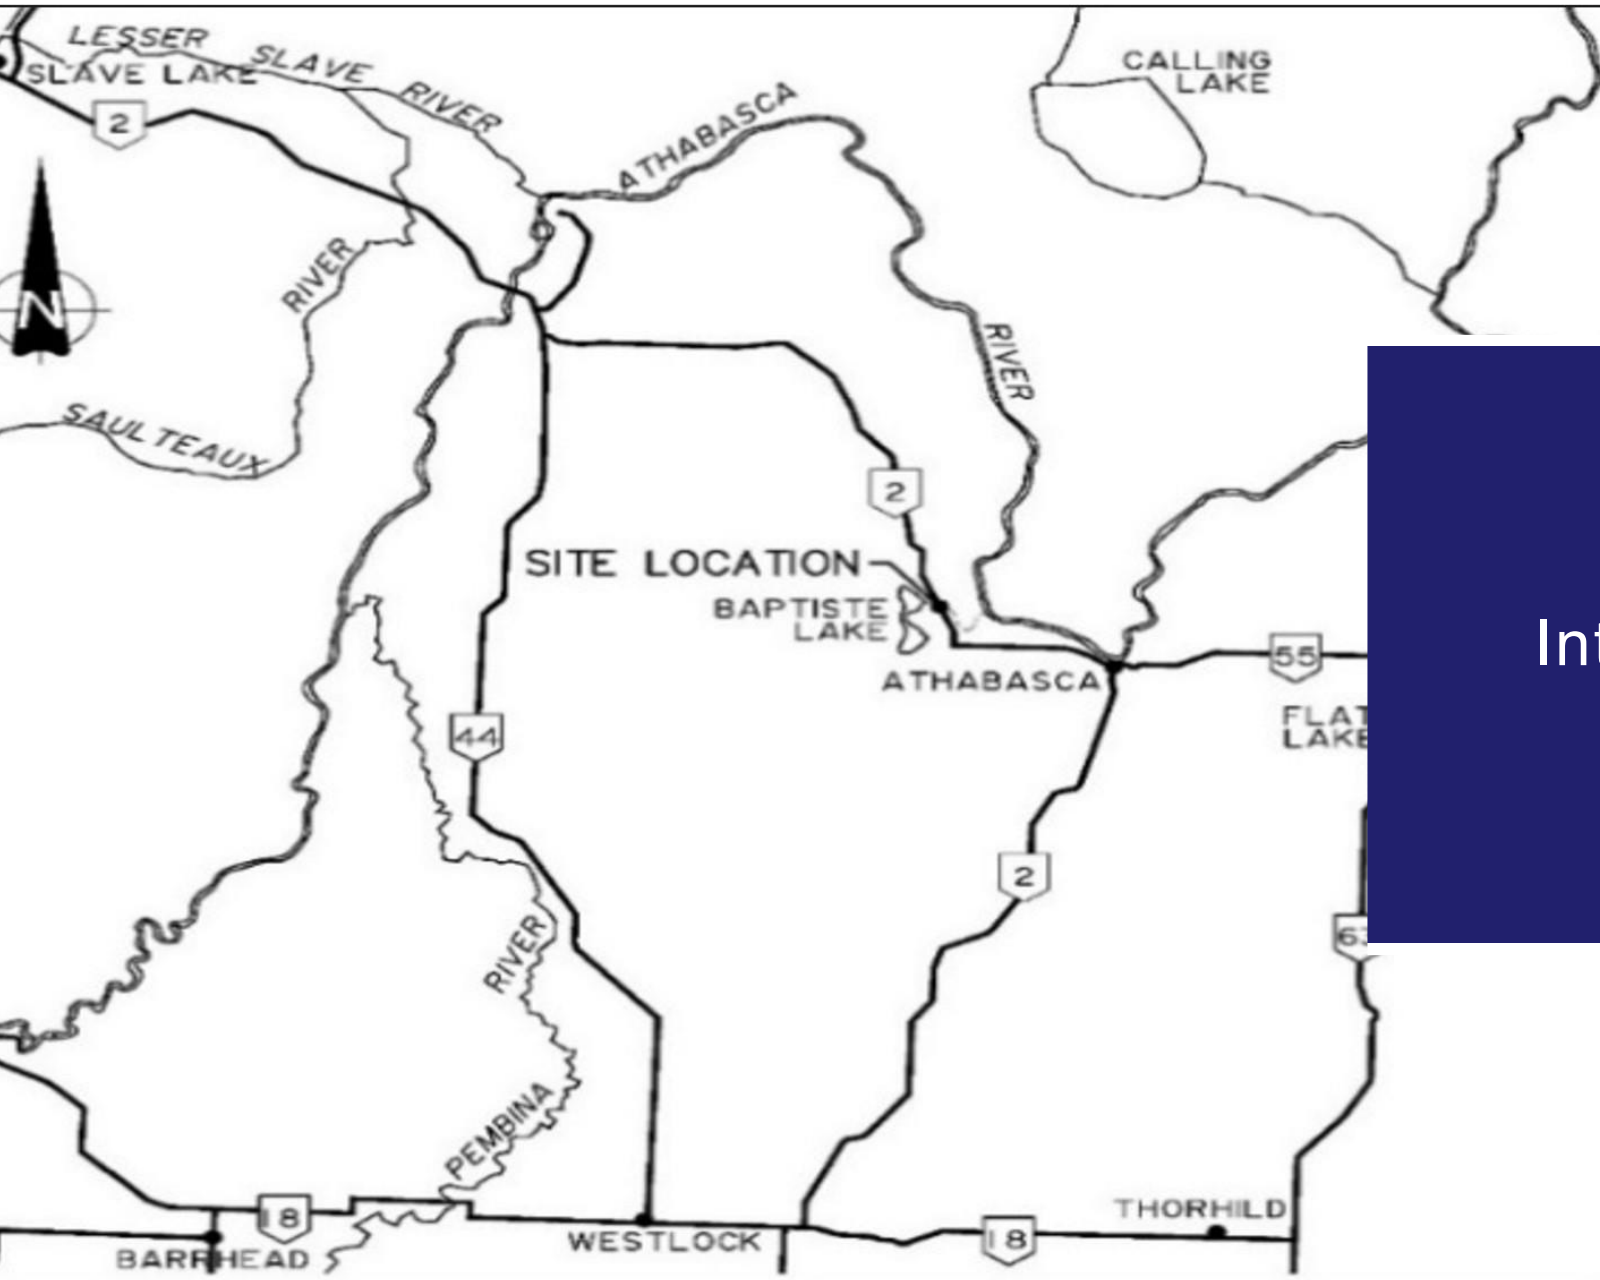
About the landslide

- Resulted in voids and a gap in the highway surface and exposed the underside of the wing wall and abutment seat
- Exposed two of the exterior pile casings
- Caused rotation of casings to jam against and restrain the piles movement during thermal expansion of the bridge structure
- Partially blocked the creeks channel
