CEA Transportation Connects Alberta Conference

Counteracting Microbial Induced Corrosion - Reed Narrows Bridge

Reed Narrows Bridge

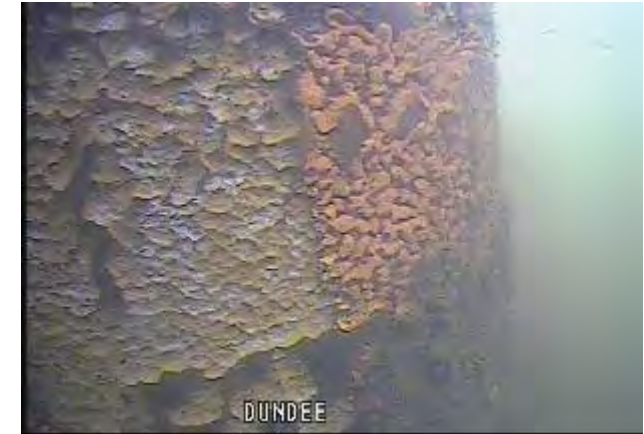
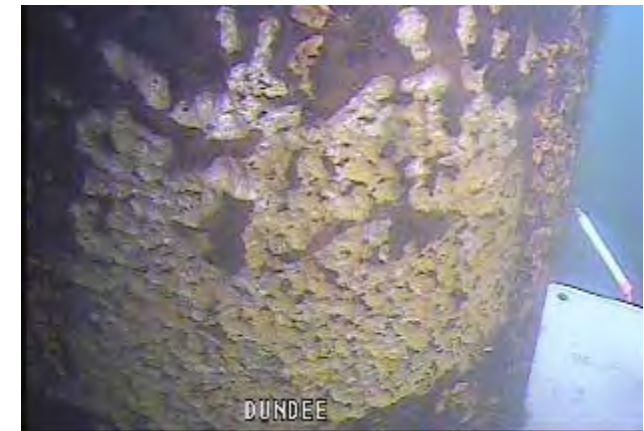
- **Definition:** “metal deterioration as a result of the metabolic activity of micro- organisms.”
- **Sulfate-Reducing Bacteria (SRB)**
 - Micro-organisms break down organic material
 - Properties between algae and fungi
 - Bacteria doesn't consume the steel, it reduces sulphate to hydrogen sulfate which corrodes the steel
 - Sulfate in water and sediment reacts with SRB

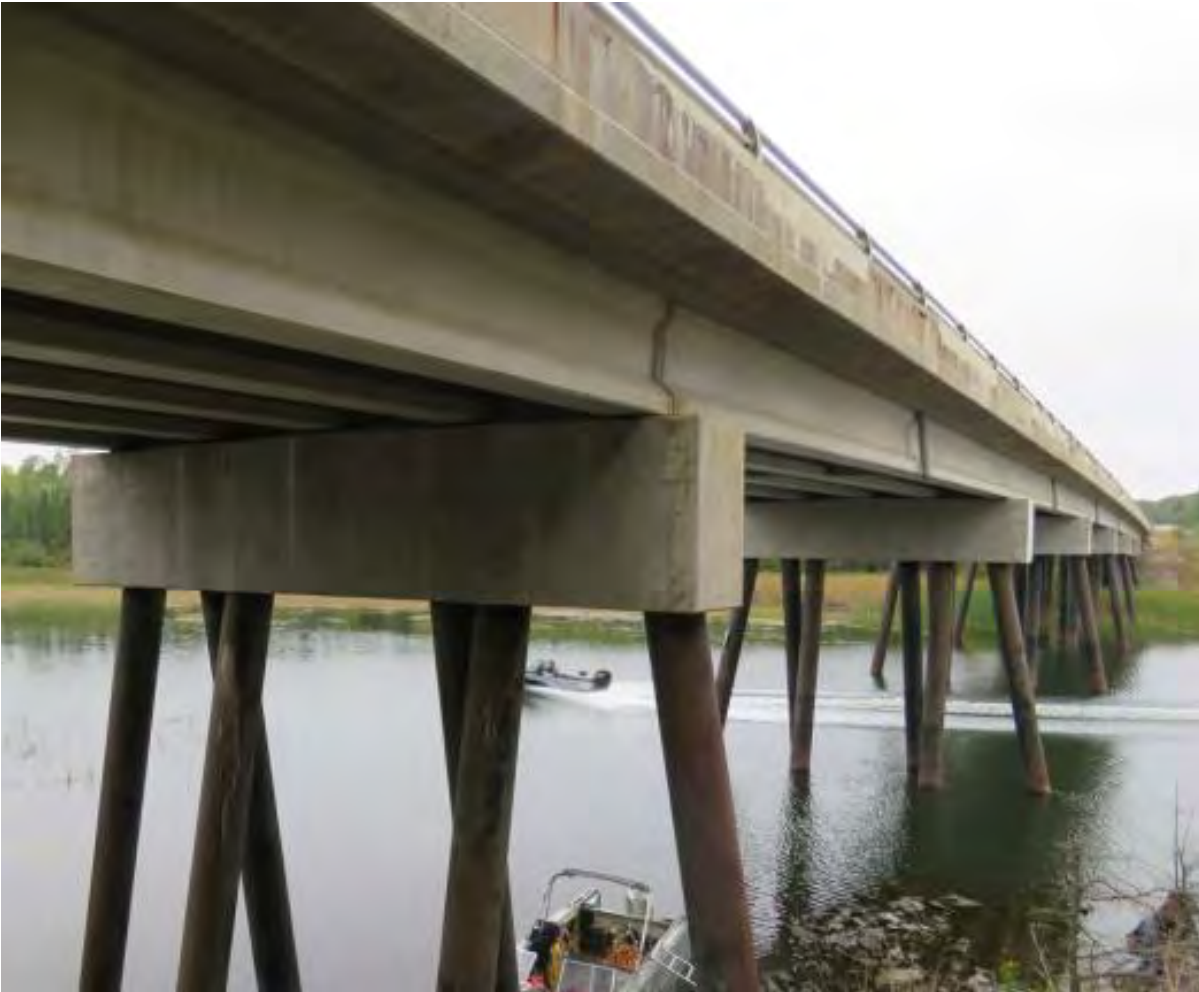
- 165m, 7-span precast concrete girder bridge
- Constructed in 1973
 - Deck and girders in good condition
 - ~30 years of service life remaining
- Substructure
 - 6 piers (pile bents)
 - 6 unreinforced concrete-filled steel tube piles per pier (36 total)
 - 610 mm outer diameter
 - 12.7 mm design steel wall thickness

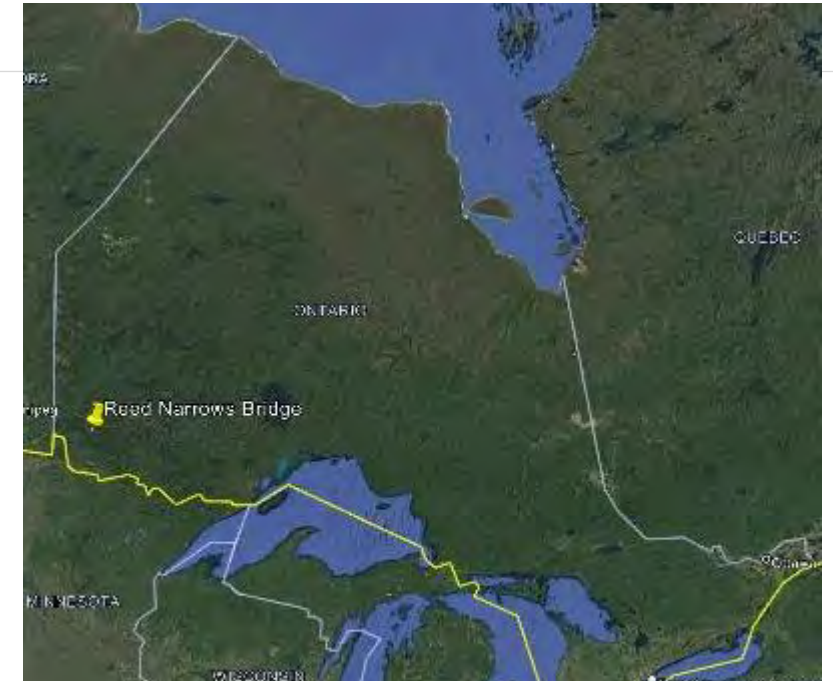
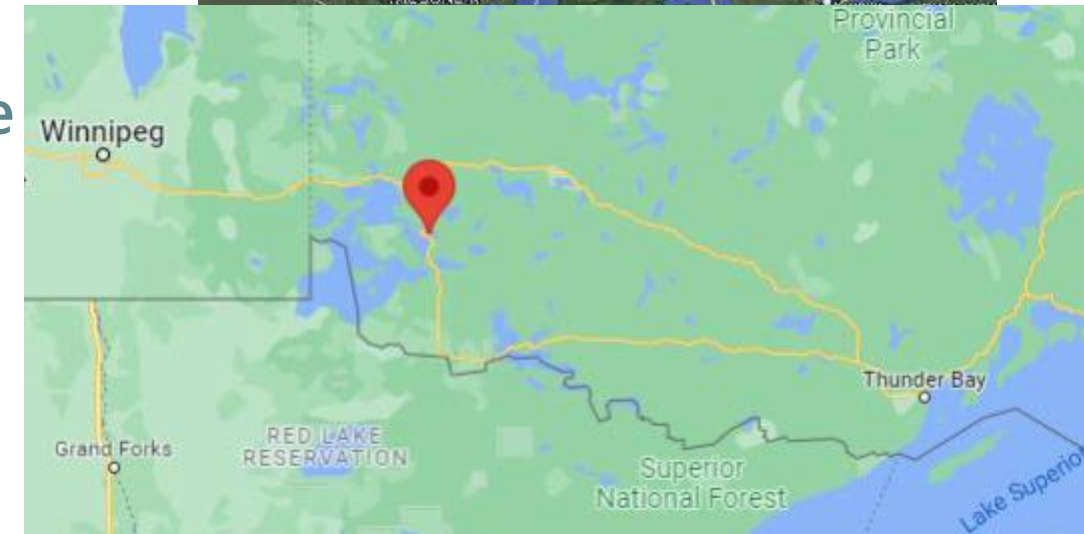
Reed Narrows Bridge

- **Lake of the Woods, Ontario**
 - Massive fresh-water lake with over 100,000 km of shoreline
- **Ontario Ministry of Transportation**
 - Highway 71 connects Hwy 11 to Hwy 17
 - Less than 100 km from Manitoba border
- **Water depth varied from 0.5 – 2.0m at the piers**
- **High recreational usage of the watercourse**
 - Navigation had to be maintained during construction
- **High fish and fish habitat sensitivity (cool water)**

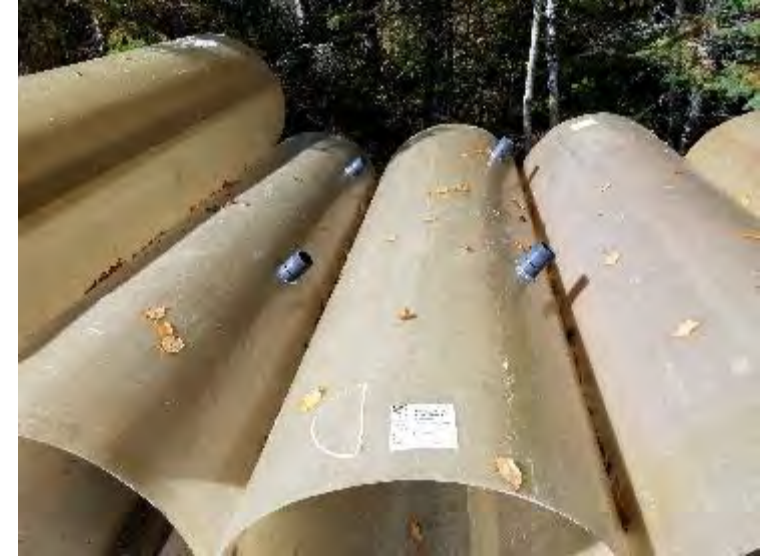
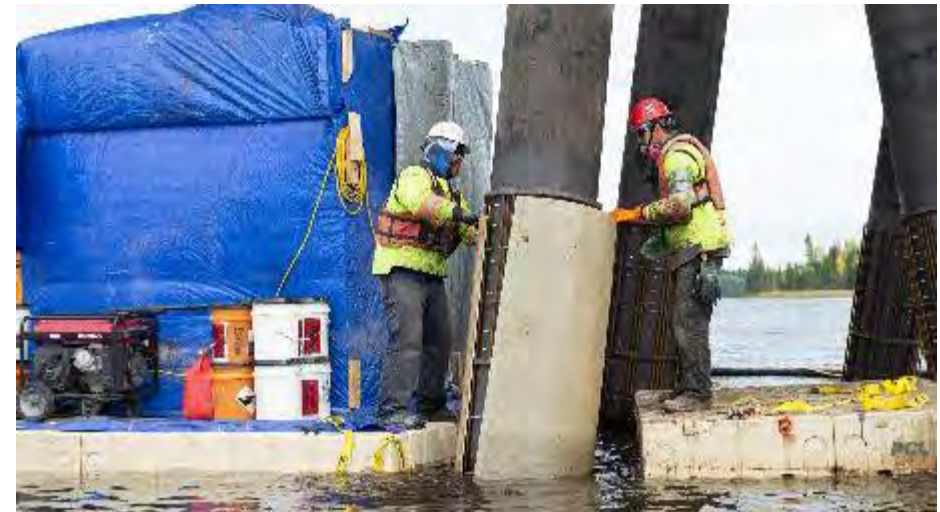
- **Fibre-Reinforced Polymer (FRP) Jacket**
 - 70 MPa (min.) ultimate tensile strength
 - 3 mm (1/8") thickness, manufactured in 1 piece
 - Extends 150 mm below riverbed for most piles
- **Adhesive Bond – multi-purpose marine epoxy**
 - >60 MPa at 28 days; must be compatible with the FRP
