Graves Bridge High Load Damage Repair

Tao Yong M.Eng., P.Eng.

Hossein Azimi Ph.D., P.Eng., PMP

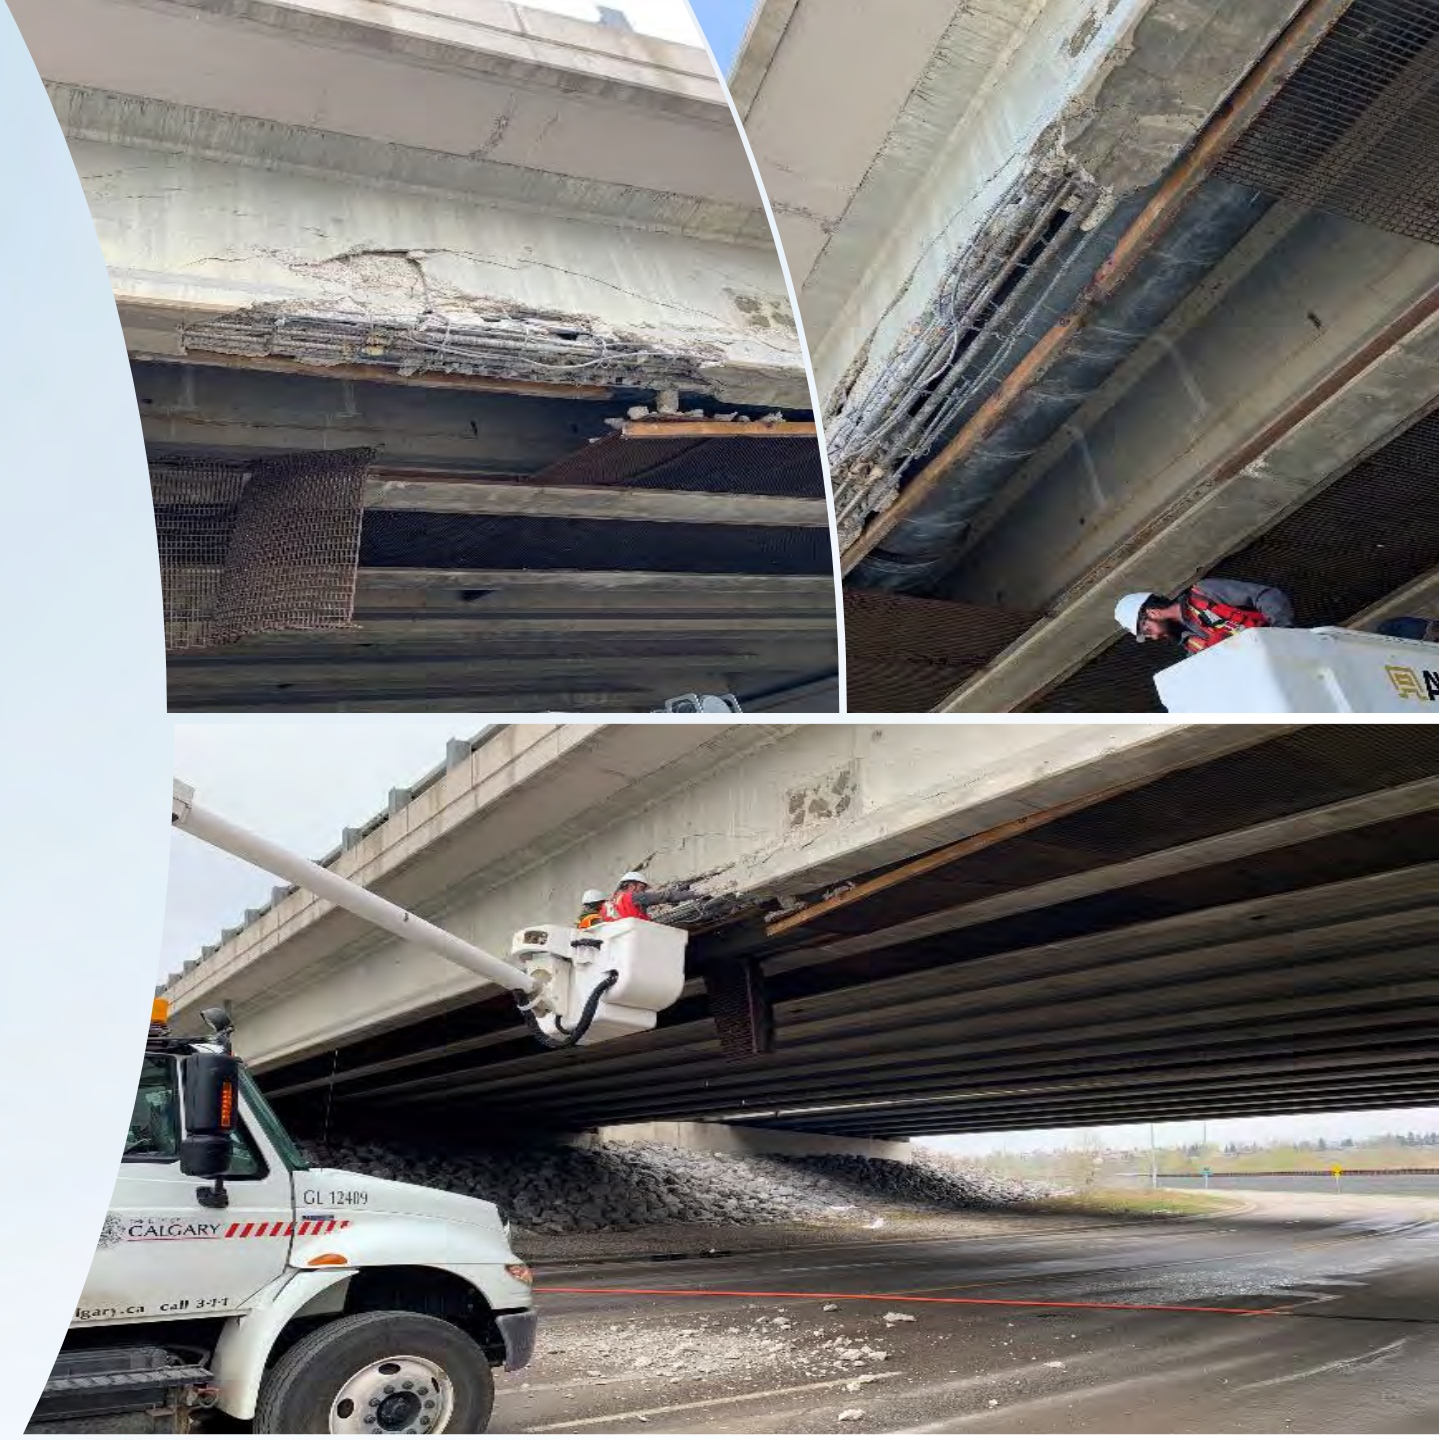
High Load Damage

- **Date:** High load damage occurred in May 2022
- **Damage Location:** The south exterior girder of the first span was severely impacted by a dump truck at about 1/3 of the span length measured from the pier

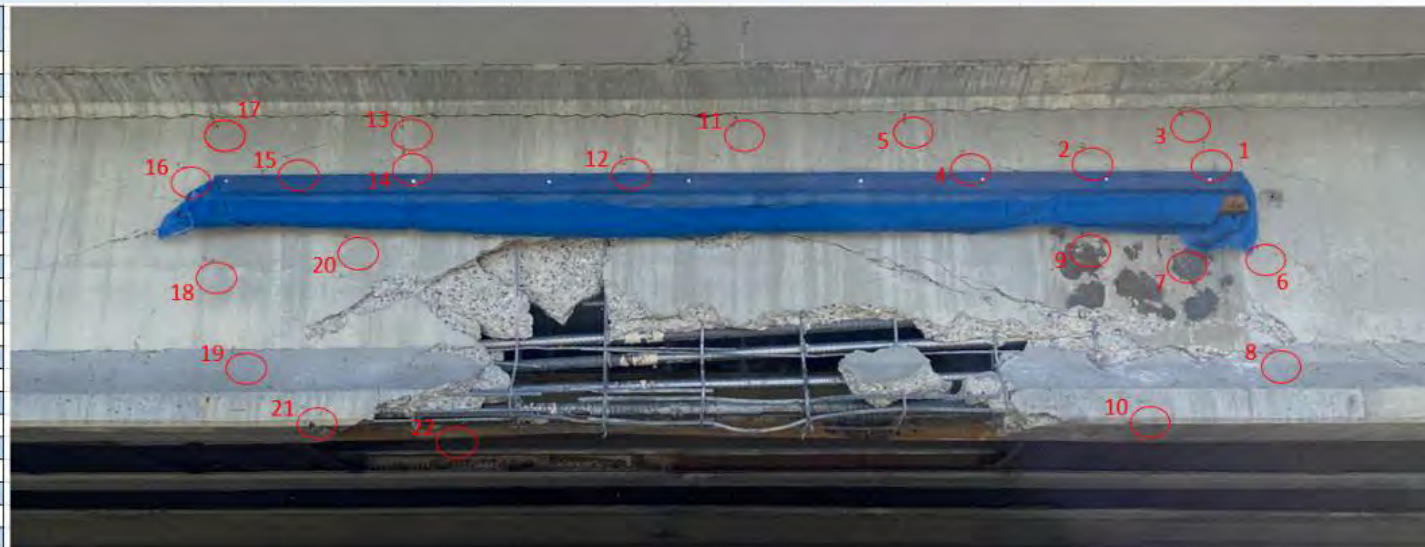
- **Damaged Condition**

- Mass crash and breaking at bottom flange and lower portion of the girder's web
- Extensive diagonal cracks at web
- Long full depth crack between top flange and web
- Part of post-tensioned tendons, stirrups, and reinforcing steels were exposed and debonded from concrete
- Concrete spalls extend ± 3.6 m while diagonal cracks extend about 10 m
- Crack width ranges from 0.1mm up to 7 mm

No.	Width / Height (mm)		Description
	18-May-22		
1	0.75	Crack width	
2	1.5	Crack width	
3	3	Crack width	
4	1	Crack width	
5	5	Crack width	
6	1.5	Crack width	
7	0.8	Crack width	
8	2	Crack width	
9	5824	Vertical height from road	
10	4960	Vertical height from road	
11	7	Crack width	
12	0.35	Crack width	
13	5	Crack width	
14	1.25	Crack width	
15	2.5	Crack width	
16	0.5	Crack width	
17	3.5	Crack width	
18	0.6	Crack width	
19	2.5	Crack width	
20	5749.5	Vertical height from road	
21	4906	Vertical height from road	
22	18	Duct to line on rebar
