CULVERT INSPECTION TO ASSET MANAGEMENT: Climate-Change Informed Capital Works Program Alaska Highway

Presented by: Tetra Tech Canada Inc.

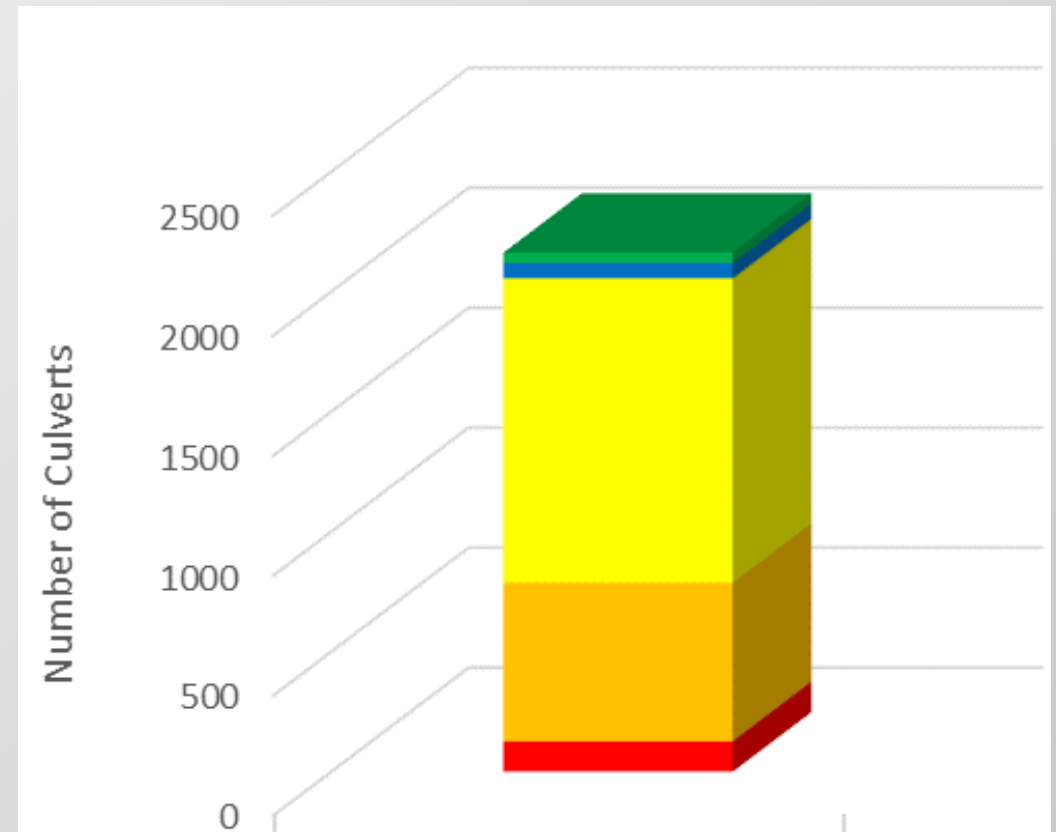
CURRENT STATUS

- The condition score is a weighted condition of all components in general.
- Culvert inspection identified backlog in terms of culvert replacement.

■ Excellent	43
■ Good	64
■ Fair	1269
■ Poor	660
■ Severe	126

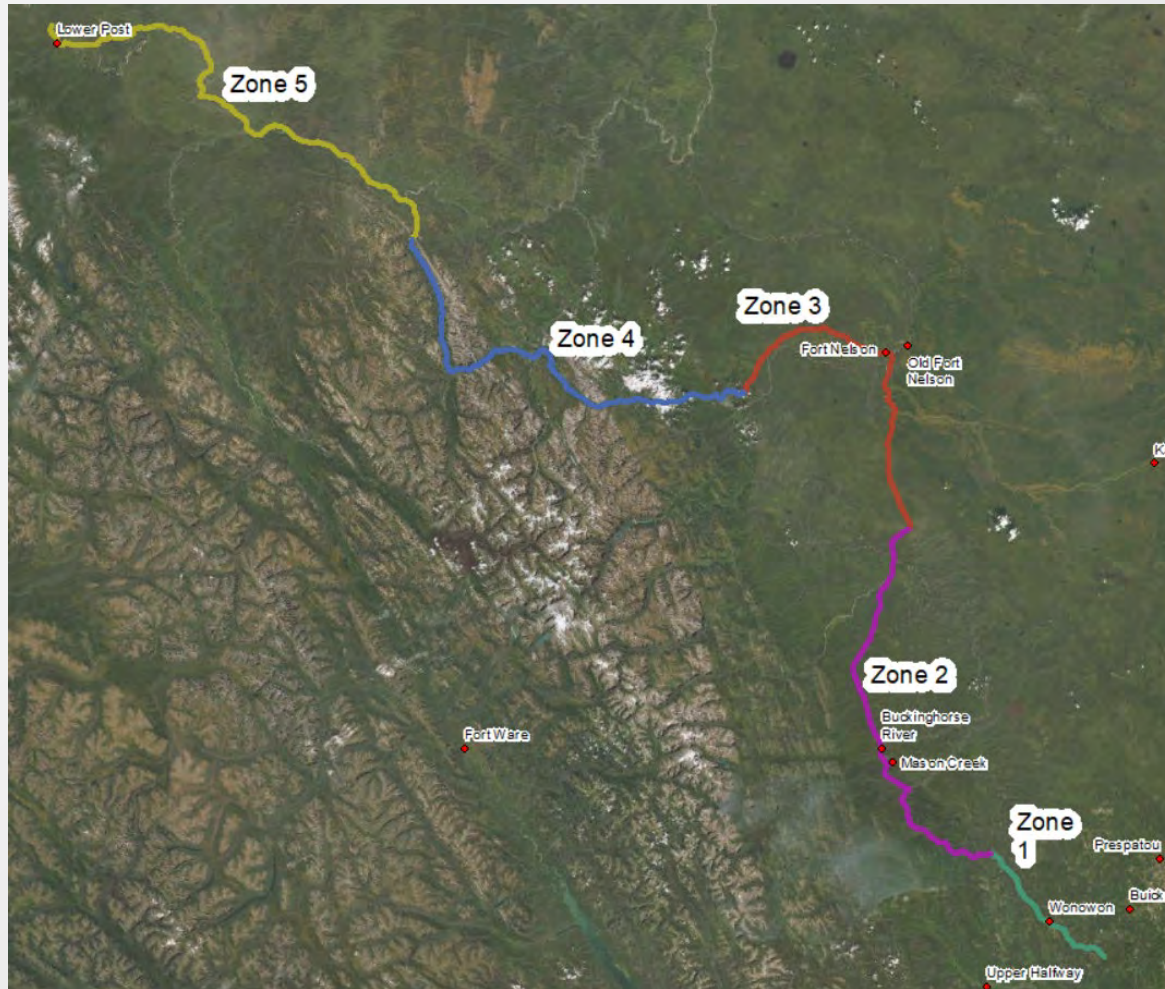
- Five Hydrological Zones delineated
- Flow equations for each zone developed using data from nearby stations

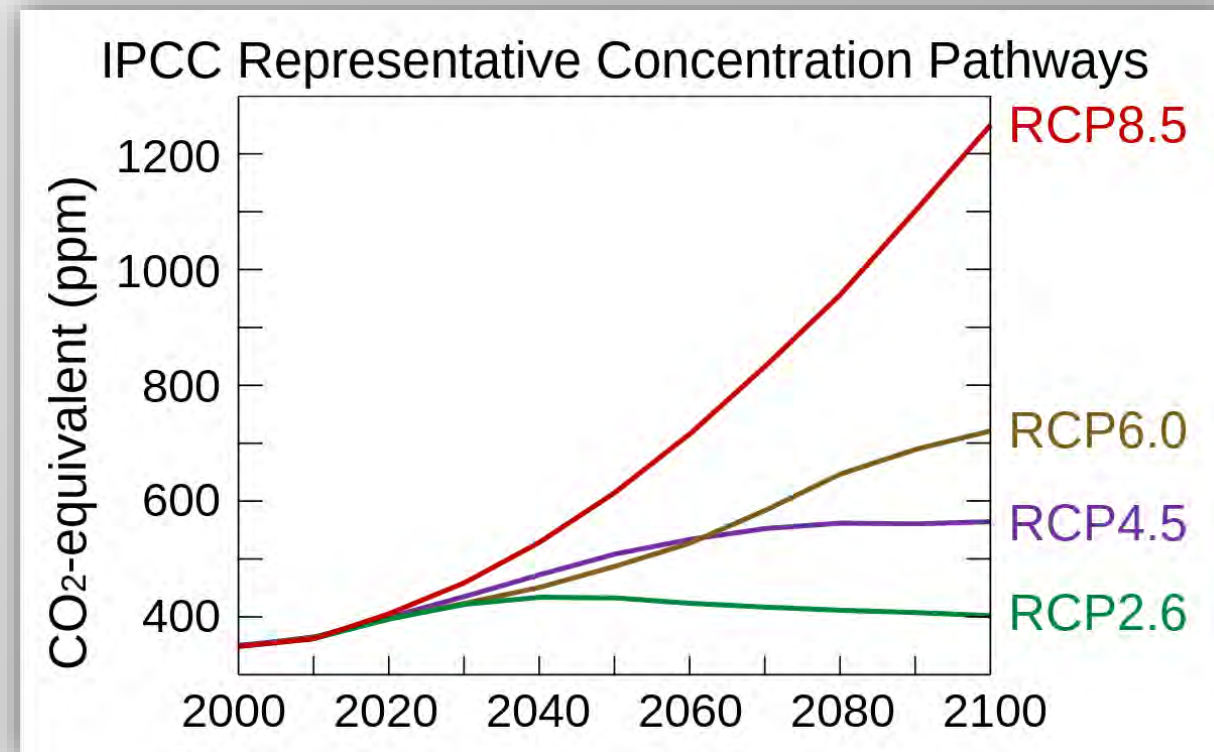
Model Ensemble for Western North America Region

- Climate models most applicable to the Western North America Giorgi Region from the Coupled Model Intercomparison Project Phase 5 (CMIP5)
- Moderate (RCP4.5) and High (RCP8.5) future emissions scenarios

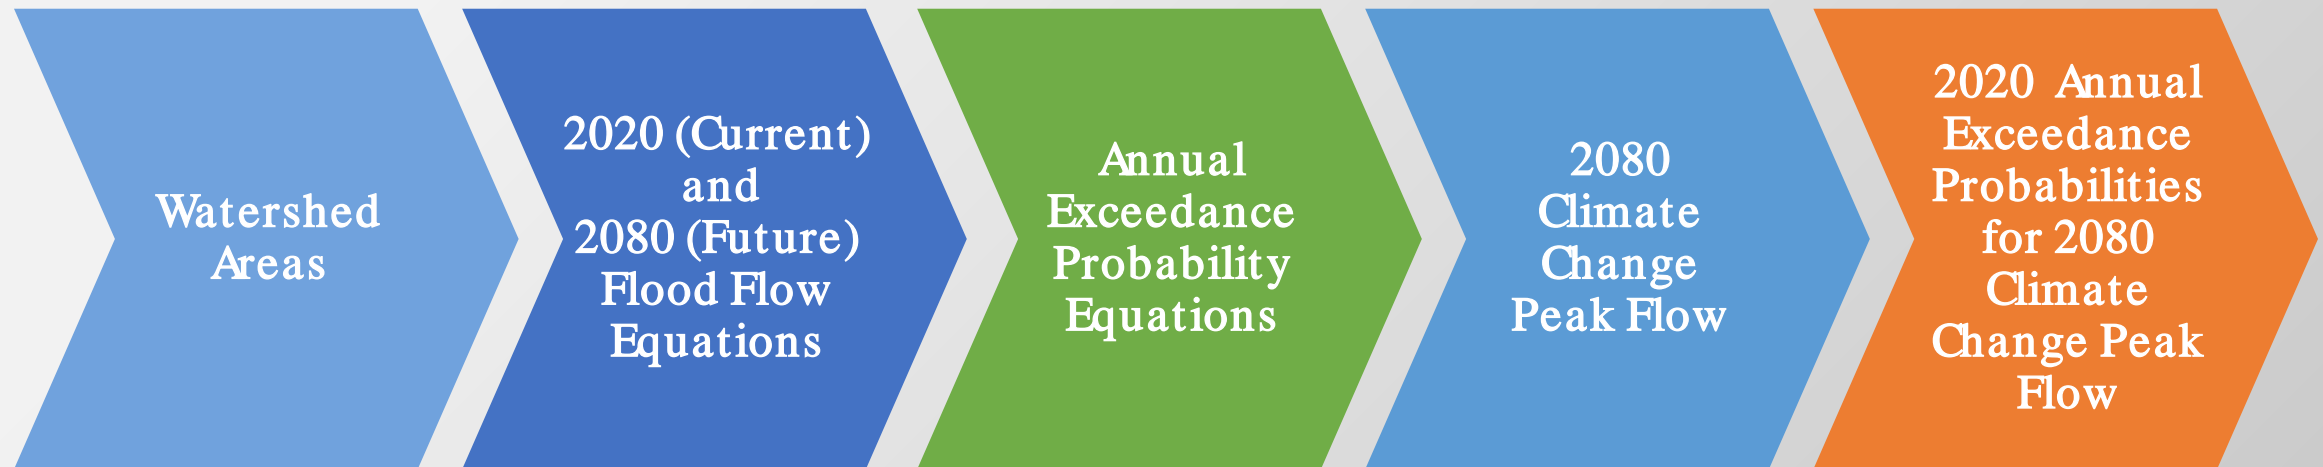
Watershed Areas to Annual Exceedance Probabilities and Climate Change Rate

- Watersheds delineated in ArcGIS

- Flood Flows Estimated from Watershed Area for 2-Year to 1000-Year Return Period

- Equation to predict Annual Exceedance Probability from 2020 and 2080 Failure Flows

- 2080 Climate Change Peak Flow Calculated for Adaptation Options for 100-Year to 1000-Year Return Period

- Site specific Annual Exceedance Probabilities in 2020 calculated for all adaption treatments for the 2080 climate change peak flow

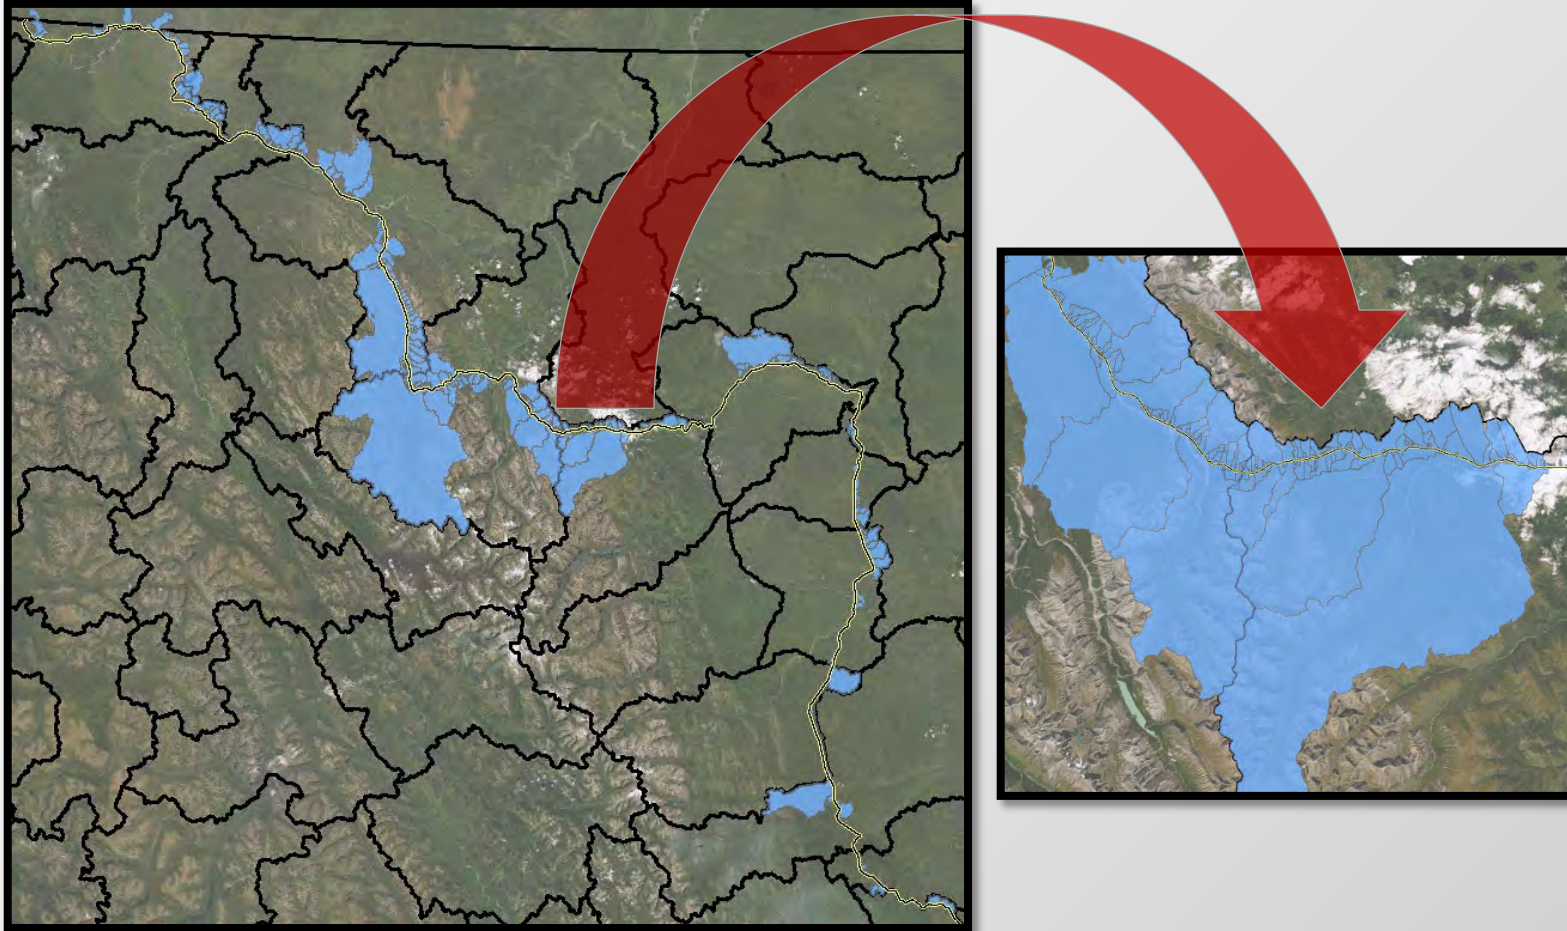
Hydrological Analysis: Watershed Delineations

Watersheds delineated
using 1:50,000 NTS
datasets

Typical Watershed Areas in ArcGIS

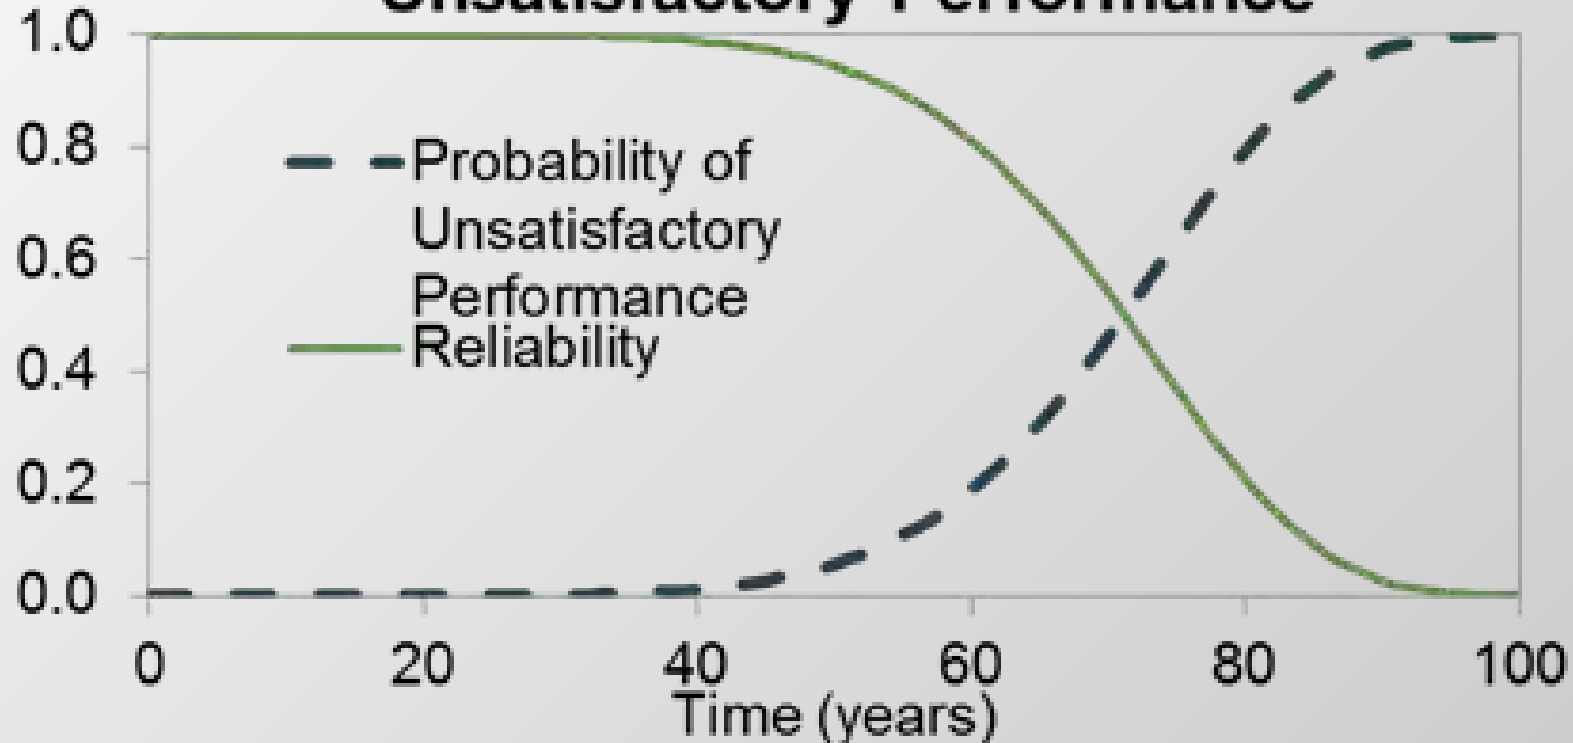
Reliability and Probability of Unsatisfactory Performance

$$\text{\$Risk} = \text{PUP} \times \text{\$Consequences}$$

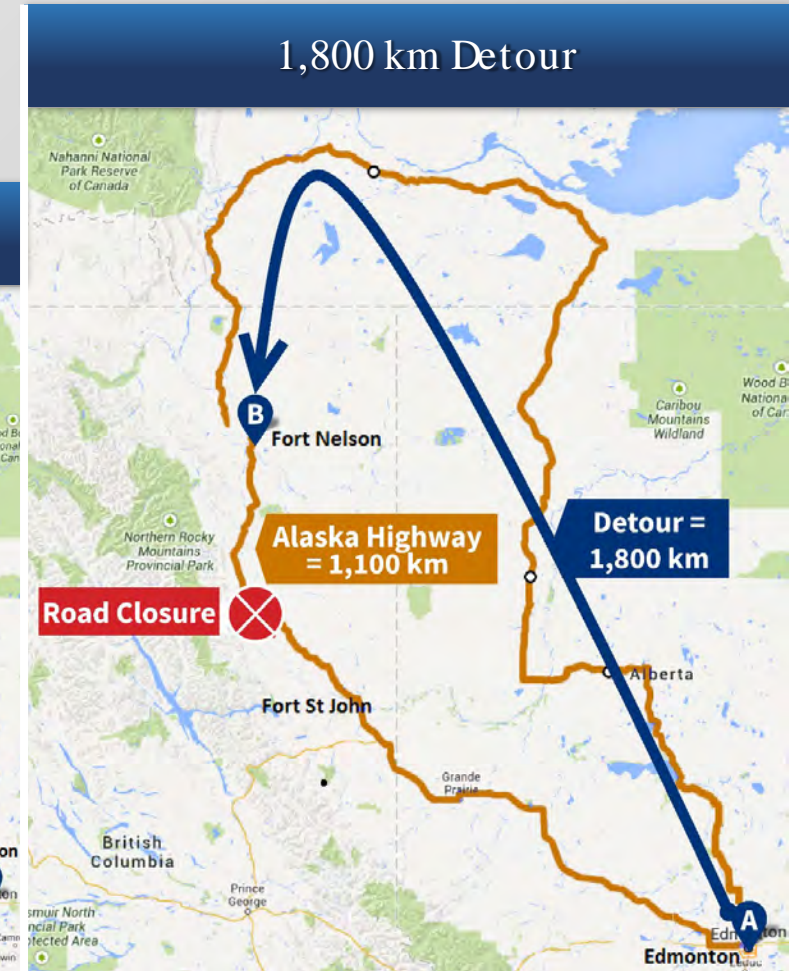
\$Consequence of Asset Failure

An asset failure resulting in a road closure can lead to long detours and increased routing costs.

The duration of closure as a result of failure depends on the length of the culvert and height of the culvert.

Around 33% of the length of the road has shorter local detours available within the project.

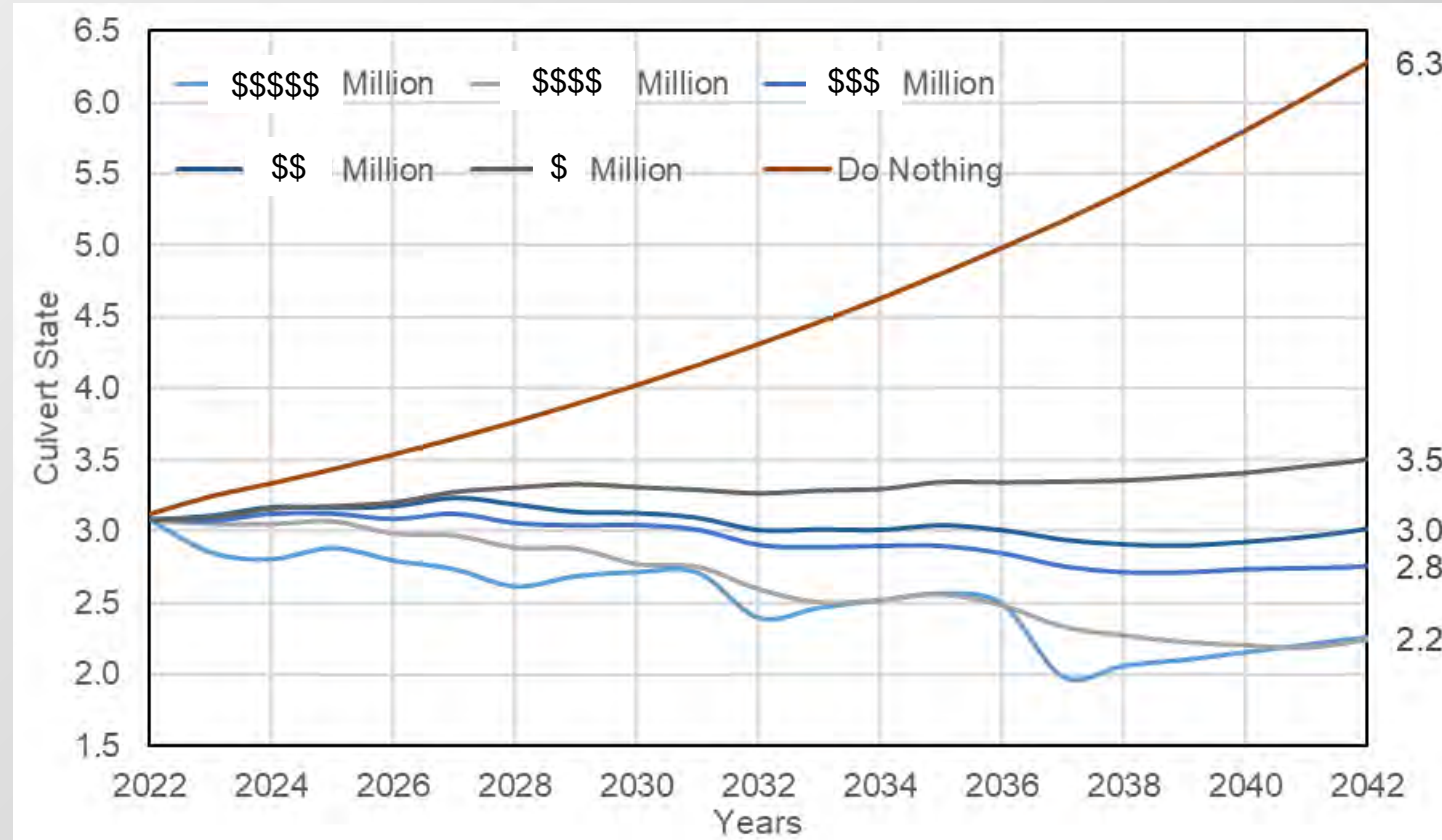
Alternative Budget Scenarios

- Annual average budget scenarios of \$\$\$\$\$, \$\$\$\$, \$\$\$, \$\$, and \$, were analyzed.
- The performance estimates of Culvert State were completed, and LCCA was carried out to determine an optimal program for analyzed budget levels using the defined benefits.

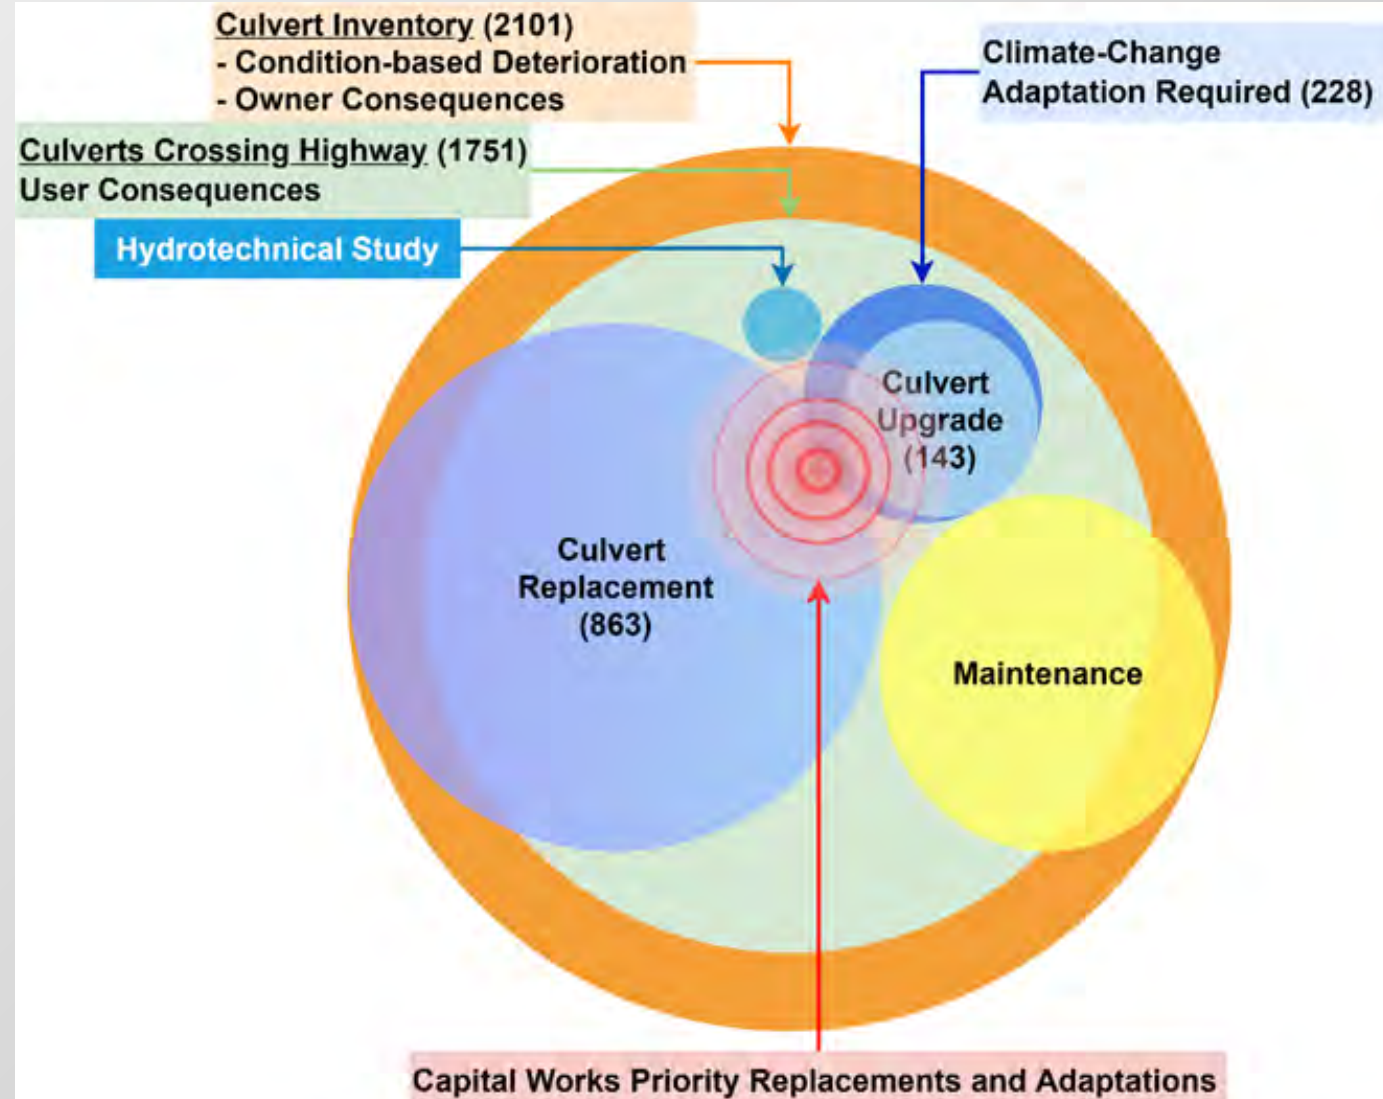
Capital Works Budget Analysis (Suggested Budget)

Network Summary

- Culvert Inventory (2101)
- Culvert Crossing Highway (1751)
- Climate Change Adaptation (228)

Treatments

- Culvert Replacement (863)
- Culvert Upgrade (143)
- Project Hydrotechnical study
- Maintenance
- Do Nothing
